Büro für Flugunfalluntersuchungen BFU
Bureau d'enquête sur les accidents d'aviation BEAA
Ufficio d'inchiesta sugli infortuni aeronautici UIIA
Uffizi d'inquisiziun per accidents d'aviatica UIAA
Aircraft Accident Investigation Bureau AAIB

Summary Report No. 1970

concerning the Marvel Schebler / Precision Airmotive
carburettor respectively float system faults in Switzerland

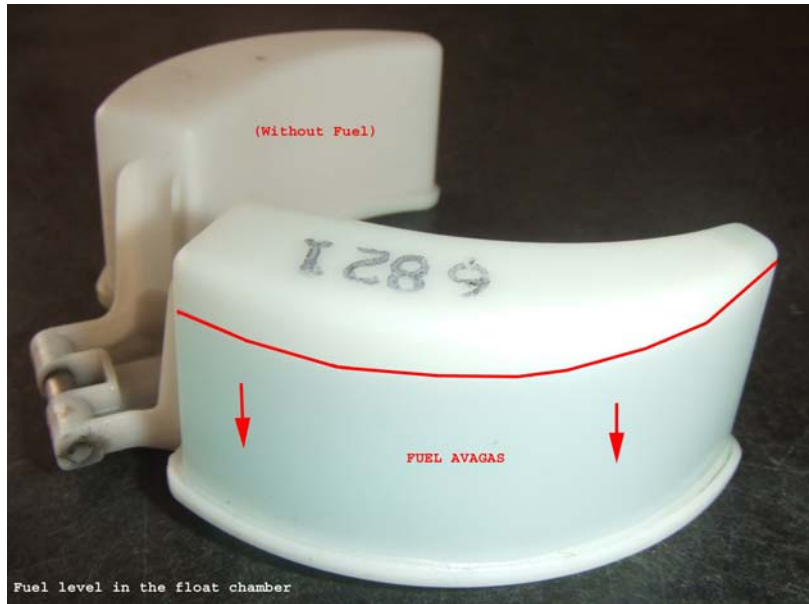
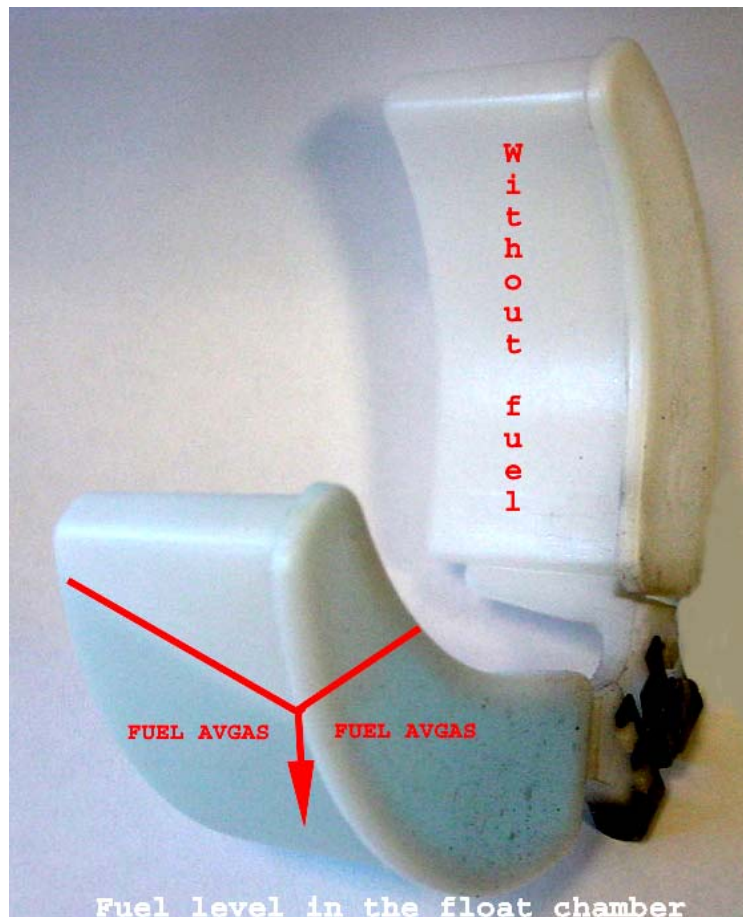
Fig. 2 and 3: Marvel Schebler/Precision Airmotive carburettor MA-4SPA, p/n 10-5217, s/n CK817178, aircraft HB-HEZ (Annex case 7). Float where one of the two plastic float chambers was filled to 80% with AVGAS fuel.

The plastic floats consist of two banana-shaped float chambers, whose cavity is sealed by a flat lid (see Fig. 2 and 3). It seems that leaks can occur at the weld points. These may be caused by

- defective welding
- fatigue of the welded seam as a result of intense vibrations
- brittleness of the welded seam due to ageing
- formation of stress cracks due to additives found in fuel, such as alcohol, oil or aromatic hydrocarbons, etc.
- the effects of temperature and pressure.

When the carburettor was examined, a large amount of AVGAS fuel was found in one of the elements of the plastic float.

The plastic floats with an air-filled float chamber of the Marvel Schebler/Precision Airmotive MA-4-5 und MA-4SPA carburettors must be replaced by an appropriate product within a limited period.
