# Swiss Transportation Safety Investigation Board STSB Annual Report 2025

**Swiss Transportation Safety Investigation Board STSB**

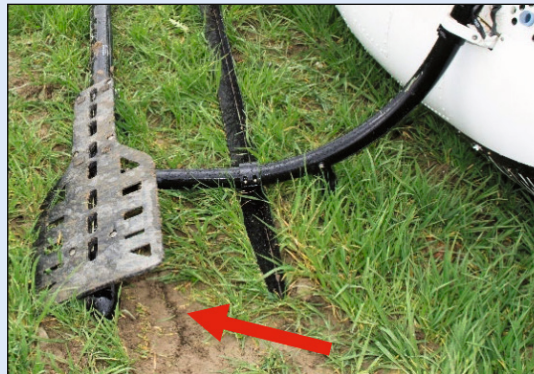
**Loss of control of the helicopter during take-off, Egg, 3 km south of Weinfelden, commune of Bussnang (TG), 12 March 2024**

A Bell 505 Jet Ranger X helicopter tipped onto its right side during take-off in a dynamic rollover.

The Bell 505 Jet Ranger X helicopter had been fitted with skid sink protection (bear paws) under a supplemental type certificate (STC). The supplement to the STC holder's flight manual does not contain any information regarding the procedures for checking the secure fit of the bear paws during flight operations. The procedures are described only in general terms in the *Instructions for Continued Airworthiness* (ICA). They should be carried out in daily and periodic inspections by trained personnel.

The loose screw connections on the bear paws went unnoticed for quite some time. The loose screws contributed to the accident, as the bear paws could rotate very easily around the skid, thereby becoming the pivot point for the dynamic rollover.

The helicopter was fitted with a high-mounted landing gear, had a calculated mass margin of more than 28 per cent, and was operated in wind conditions with light gusts of between 10 and 20 knots from the front left quadrant. This is the airspeed at which the transition to effective translational lift (ETL) occurs and inflow roll becomes more noticeable. Current theoretical principles and manuals on dynamic rollover do not take sufficient account of the fact that particular attention is required when a helicopter takes off in winds from the forward two quadrants and at speeds corresponding to the point of effective translational lift (ETL).

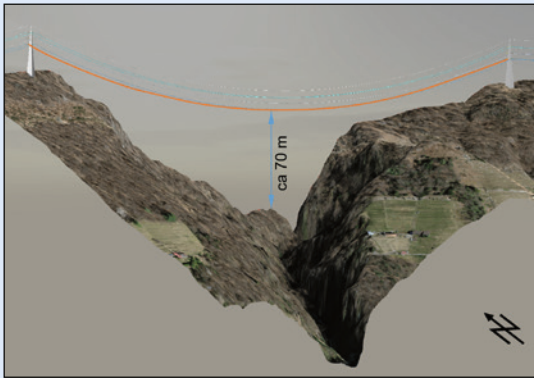
**Collision with an extra-high-voltage power line, Riale Carcale, commune of Gordola (TI), 16 March 2022**

During a transport flight beneath a live extra-high-voltage power line, a helicopter collided with the conductors whilst climbing vertically.

The relevant federal regulations do not address the impact of extra-high-voltage current on aviation operations, which was therefore not considered by the operator when compiling the risk analysis.

The FOCA should, in collaboration with the relevant authorities, verify whether risk analysis procedures also take electrical hazards into account when work flights are carried out in the immediate vicinity of live high-voltage power lines.

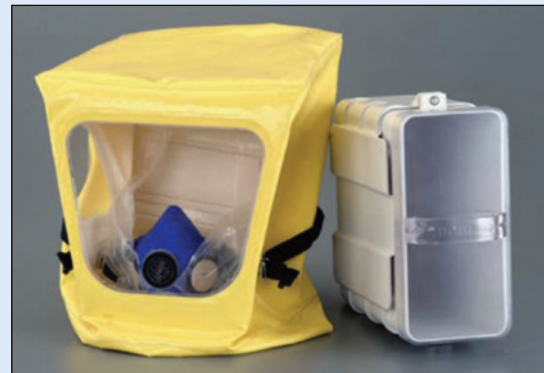
**Unusual odour detected over the English Channel, United Kingdom, 11 July 2023**

During the flight, an unusual odour became noticeable in the cabin of an Airbus A330-343, prompting the cockpit crew to don their oxygen masks and several cabin crew members to use protective breathing equipment (PBE).

Several cabin crew members reported significant difficulties in handling the PBE, both when unpacking, unfolding, fitting and activating the equipment, and during its subsequent use. Furthermore, some PBE was faulty and therefore either non-functional or only partially functional. The PBE was manufactured by Collins Aerospace with part number 119003-21.

The PBE devices of the same design which were tested as part of the safety investigation also displayed technical defects that compromised their safe use. Furthermore, trained crew members were unable to get the PBE functioning within a reasonable time.

The European Union Aviation Safety Agency (EASA) should, in cooperation with the United States' Federal Aviation Administration (FAA), take appropriate measures to ensure that PBE manufactured by Collins Aerospace with part number 119003-21, both when new and throughout its intended service life, does not exhibit any technical shortcomings or defects that could compromise the use of this PBE. Furthermore, the PBE must be designed in such a way that trained crew members can get the equipment functioning within a reasonable time.

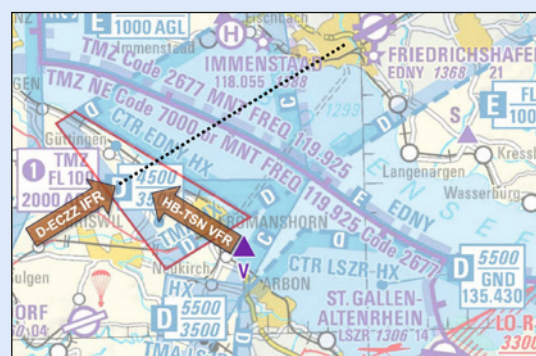
#### **Airprox over the Friedrichshafen terminal manoeuvring area, Germany, 18 September 2024**

An airprox occurred involving a Cessna C152 flying over the Friedrichshafen terminal manoeuvring area (TMA) under visual flight rules and a Cirrus SR22 approaching runway 06 at Friedrichshafen Airport under instrument flight rules.

The Altenrhein-Friedrichshafen area (ARFA) is a hotspot for dangerous approaches in class E airspace. For this reason, a Transponder Mandatory Zone (TMZ) exists for this area in conjunction with a listening watch (squawk) at the Alps Radar air traffic control. In Germany, it is compulsory to establish a listening watch, whereas in Switzerland it is voluntary. This involves considerable risks.

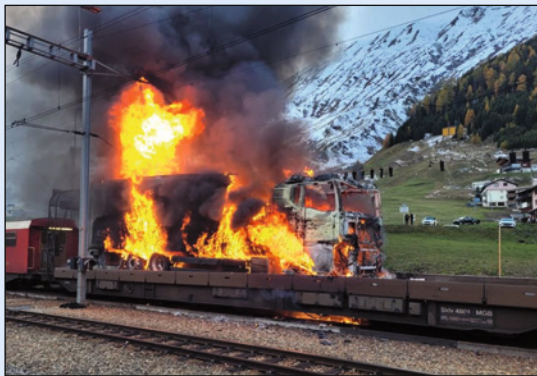
### HGV fire on car shuttle train in the Furka Tunnel (UR), 7 November 2023

On 7 November 2023 at 3.46 pm, whilst Matterhorn-Gotthard Bahn (MGB) car shuttle train No 2450 was travelling through the Furka Tunnel, a fire broke out in the HGV on the final ramp wagon. After exiting the tunnel at Realp station, the HGV driver was able to jump out of his cab through the left-hand door just before the loading ramp. He suffered severe burns.

The fire in the HGV in the Furka Tunnel was caused by an electric arc between the lorry's aerial and the overhead line in the area of the Rotondo track change. The resulting short-circuit current, which flowed through the HGV to the ground, caused the lorry cab to catch fire.

- The lorry's aerial had not been removed.
- During the visual inspection, it was not observed that the prescribed maximum loading height had been exceeded.

- The overhead line in the area of the Rotondo track change was mounted too low. Its height did not comply with the minimum height specified in the Oberwald-Realp loading profile.
- The loading regulations, MGB's internal specifications regarding the height of railway vehicles, the road signs at the loading ramps and the information on the MGB website differ from one another.
- Self-rescue by the HGV driver was almost impossible.
- Inadequate alarm systems and inconsistent instructions on how to respond in the event of an incident are confusing to users of the car shuttle train and pose a serious risk to life in an emergency.

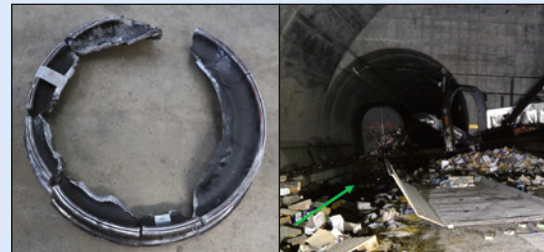
On 10 August 2023, approximately 10 km after entering the south portal of the Gotthard Base Tunnel, at tunnel kilometre 47, travelling at a speed of approximately 90 km/h, a fragment of the right-hand wheel disc of the first axle on the eleventh wagon in the direction of travel broke away. The freight train travelled approximately 7 km in this condition, as far as the Faido multi-function station. The locomotives and the first 13 carriages continued to travel on the tracks. The front section of carriage 14 crashed into the tunnel bulkhead. The rear section continued along the connecting line, broke through the safety gate leading to the east tunnel, and came to a halt there at an angle.

The wheel disc fracture was the result of thermal overloading of the wheel tread; excessive residual tensile stresses caused vertical fatigue cracks to form, which then extended to the wheel web and caused the wheel disc to fracture.

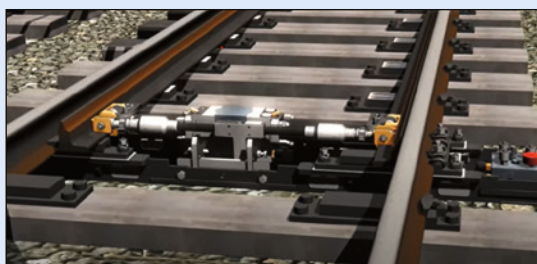
gle beneath wagon 11, destroyed the monoblock concrete sleepers and all Hydrostar point machines. The rails and the crossing were also badly damaged. The front part of the train passed the points still in a straight position. The rear section was diverted onto the connecting track in the direction of the east tunnel tube. This led to the derailment and collision with the tunnel bulkhead.

The Hydrostar turnouts are equipped with a hydraulic drive that transmits the changeover forces to all point and centre locks hydraulically. In the design concept of this type of switch, the locks and the tongue connecting rod, which serve as a fall-back level for the point locks, are located above the top edge of the sleeper.

If part of a wagon or a derailed axle hangs below the top edge of the rail, there is a risk of these parts coming into contact with the point locking device or the tongue connecting rod, potentially damaging or even ripping off these components.

As a result, the switch blades, which are no longer locked in place, can move if they are shaken by passing trains. Unlocked points can lead to derailments.

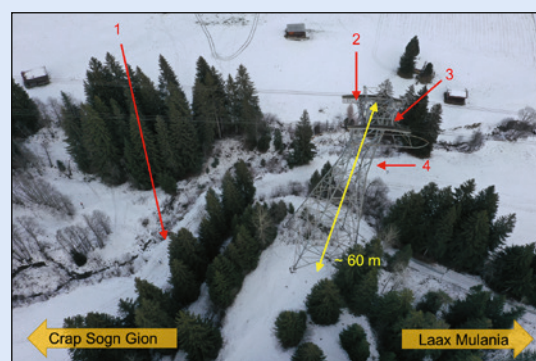
### **Fall of a trainee cable car mechatronics technician from a cable car tower in Laax (GR), 19 December 2022**

At 14:24 on 19 December 2022, in Laax (GR), a trainee cable car mechatronics technician was struck and dragged along by the drive unit of cable car cabin 2 as it passed by whilst he was working on tower 2, which is approximately 60 metres high. He first crashed into the front edge of the cable car cabin and then fell to his death.

- 1) Site of fall
- 2) Work platform, cabin 2 side
- 3) Work platform, cabin 1 side
- 4) Cable car tower 2

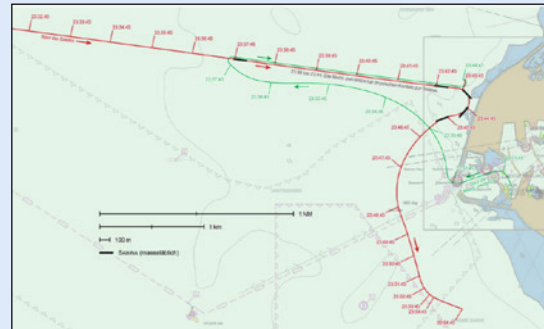
The multi-purpose freighter SABINA ran aground off the coast of Bornholm at night after sailing with the bridge unmanned for an extended period, the crew having been unable to take control of the vessel in time.

The impact of the guarantees provided by the Swiss Confederation and the Federal Office for National Economic Supply (FONES) on the SMNO's oversight activities was problematic from a safety point of view. The fact that the Swiss Confederation acted both as supervisory body (SMNO) and as guarantor (FONES) led to a persistent conflict of objectives and interests. The order by the supervisory body to suspend operations for safety reasons had the potential to harm the government's financial interests, with sums running into millions per ship. The enforcement of safety regulations, backed up where necessary by effective financial penalties, was enough to cause shipping companies financial difficulties under certain circumstances. The SMNO stated that it felt as though its hands were tied and it was constrained in its actions. It had reportedly come under pressure from senior officials within the Federal Administration and from persons connected with the FONES not to take any measures against shipping companies that would have a serious financial impact on them. The SMNO bowed to pressure and refrained from imposing appropriate sanctions on shipping companies for a breach of the rules. This contributed to the body's failure to exercise effective regulatory oversight. The system of state guarantees coupled with state oversight inherently involves this conflict of objectives and interests. However, in legal terms, the roles of the FONES and the SMNO were appropriately separated and clearly defined. The situation became problematic from a safety perspective because the SMNO felt it was being subjected to undue pressure from other bodies within the Federal Administration, which prevented it from carrying out its oversight duties properly. The authority to which the SMNO reports – the Directorate of International Law at the Federal Department of Foreign Affairs (FDFA) – may not have been aware of this problem, and if it was, did nothing to resolve it.
