# Final Report Nr. 2037 by the Federal Aircraft Accident Board

concerning the serious incident (AIRPROX)

involving the Tupolev Tu-154M aircraft, registration UN85713

on 8 February 2007

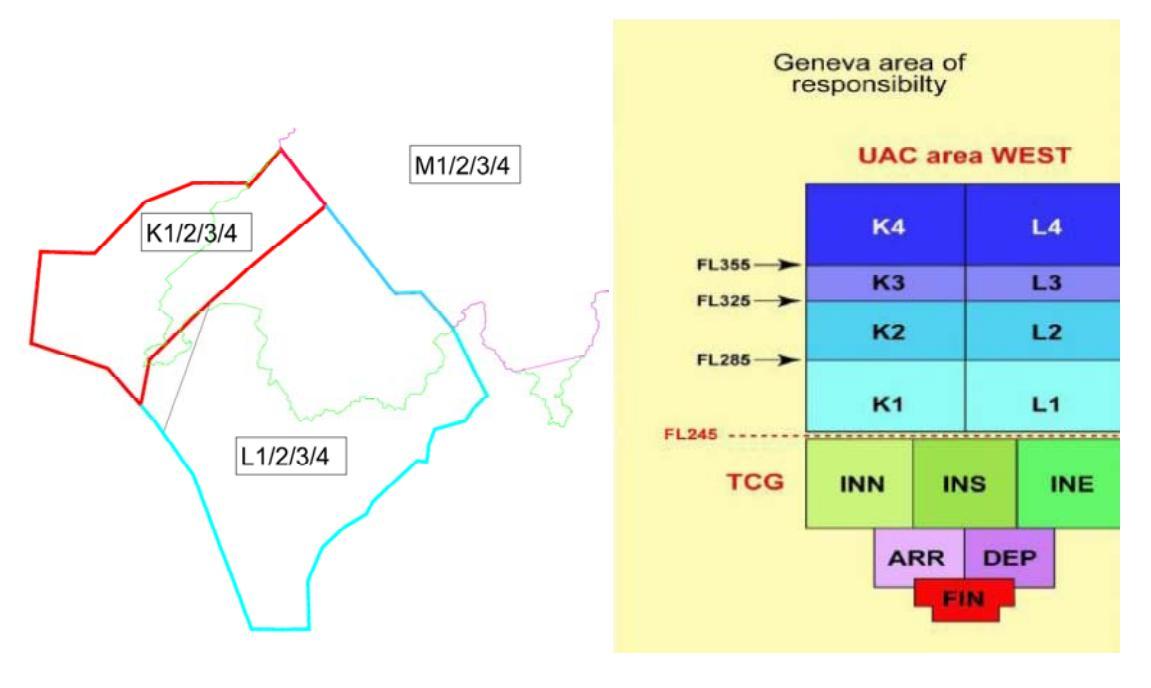
Fig. 1

At the time of the incident, the configuration of sector KL12, which combines four sectors, incorporated flight levels FL 245 to FL 324 inclusive. This grouping is usual for this time of day. The three control positions in charge of the sector KL12 airspace were manned by a trainee radar controller, a supervising radar controller (coach) and a radar coordinator. The trainee occupied the centre position, whilst his coach was sitting to his left and the radar coordinator to his right. The three control positions are each equipped with a radar screen.

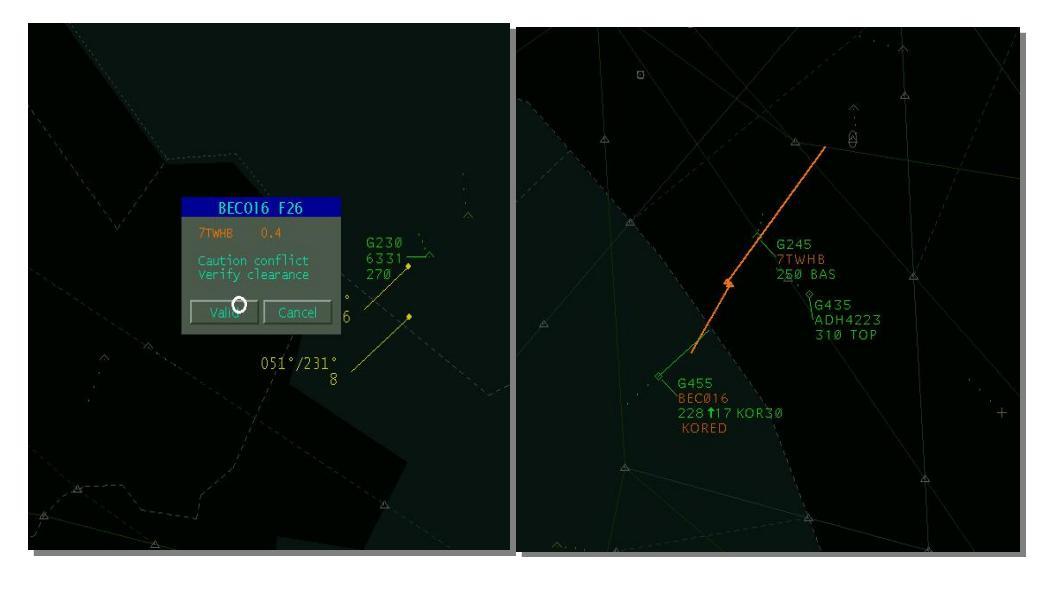
Fig. 3

On clearing flight BEC 016 to flight level FL 260, the trainee entered this flight level into the system. This caused a DST alert window to open on the radar screen; it warned the trainee of a conflict between aircraft 7T-WHB and flight BEC 016. At the same time a visual alert was activated on the radar labels; the crossing point as well as the speed vectors were displayed on the screen. The trainee validated this information by clicking on the VALID function about a second later; the window closed and the vector alerts of the aircraft involved disappeared.

Figure 3 shows the DST alert window. It should be noted that the distance between the two aircraft at the time of maximum convergence is calculated and displayed in this window (0.4 NM).

Figure 4 shows the speed vectors and the crossing location.

According to his statements, the trainee accepted this alert by validating it, but without being fully aware of the content.

When carrying out the individual settings for the radar screen, the trainee chose the "fixed position" mode for the opening of the DST window. Consequently, when the conflict between BEC 016 and 7T-WHB was reported, the window opened on the extreme right of the screen, whilst the conflict was occurring on the left. This decentring of the information may have caused the trainee to make an error, attributing this alert to the conflict which was occurring in the Aosta region and which he had already resolved. This may explain the fact that the trainee validated the alert without being fully aware of the content. Furthermore, it is possible for a controller to validate a DST window inadvertently. It is unacceptable for the alert to disappear if a conflict has not been resolved. The system does not repeat the alert if the controller validates the information.

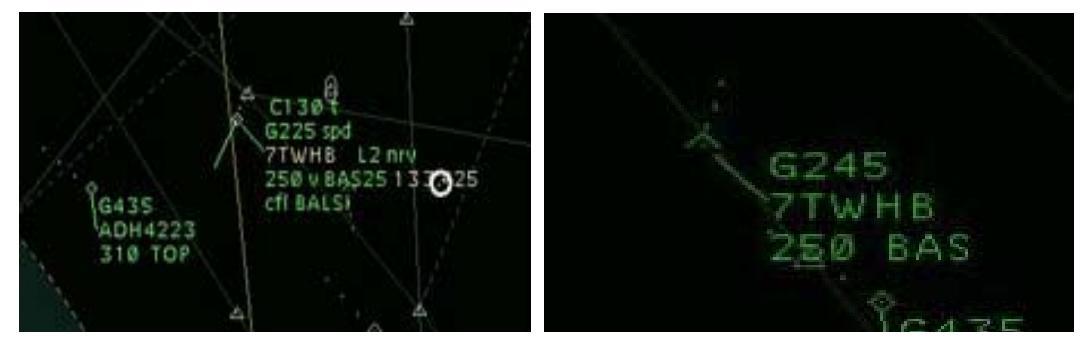
Fig. 5

Figure 5 shows the position symbol of aircraft 7T-WHB in AoC (diamond) and figure 6 in non-AoC (half-diamond).
