# Final Report no. 2124 by the Swiss Accident Investigation Board SAIB

concerning the accident involving the Schweizer 269C helicopter, registration HB-XYI

on 19 November 2009

Unterbärgetal, municipality of Burgdorf/BE

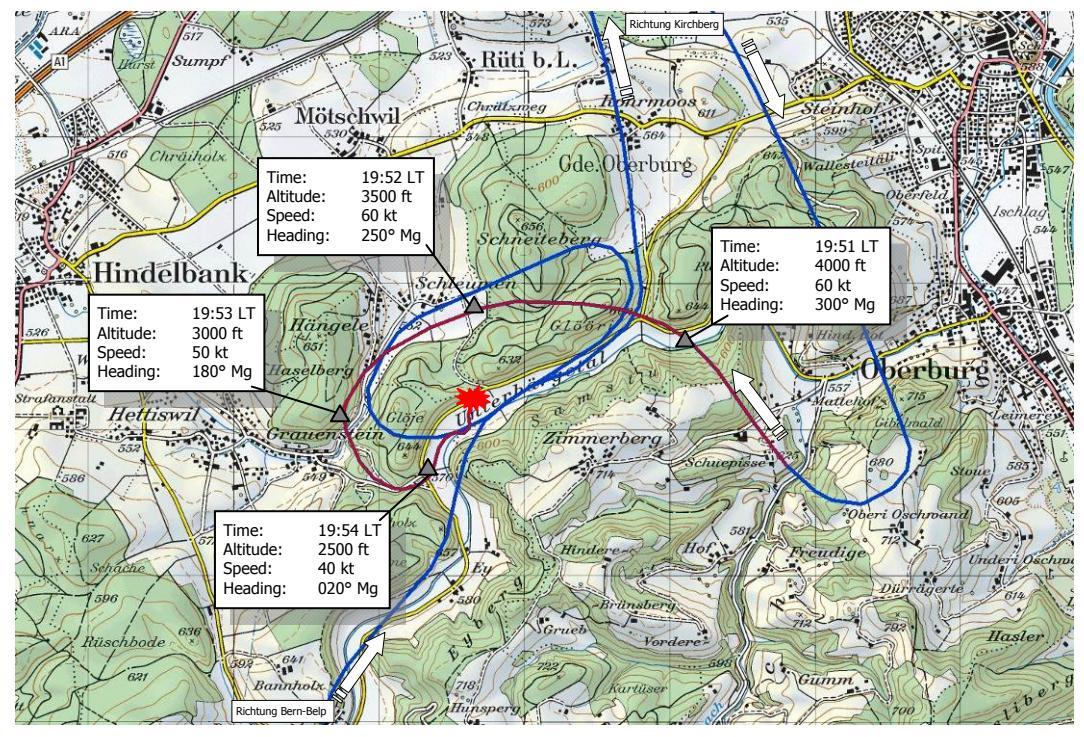
Figure 1 - Flight path of the last 5 minutes 1:50 000 (marked in red)

Blue approach: Red approach: Reconnaissance circuit Approach in the five minutes prior to the accident

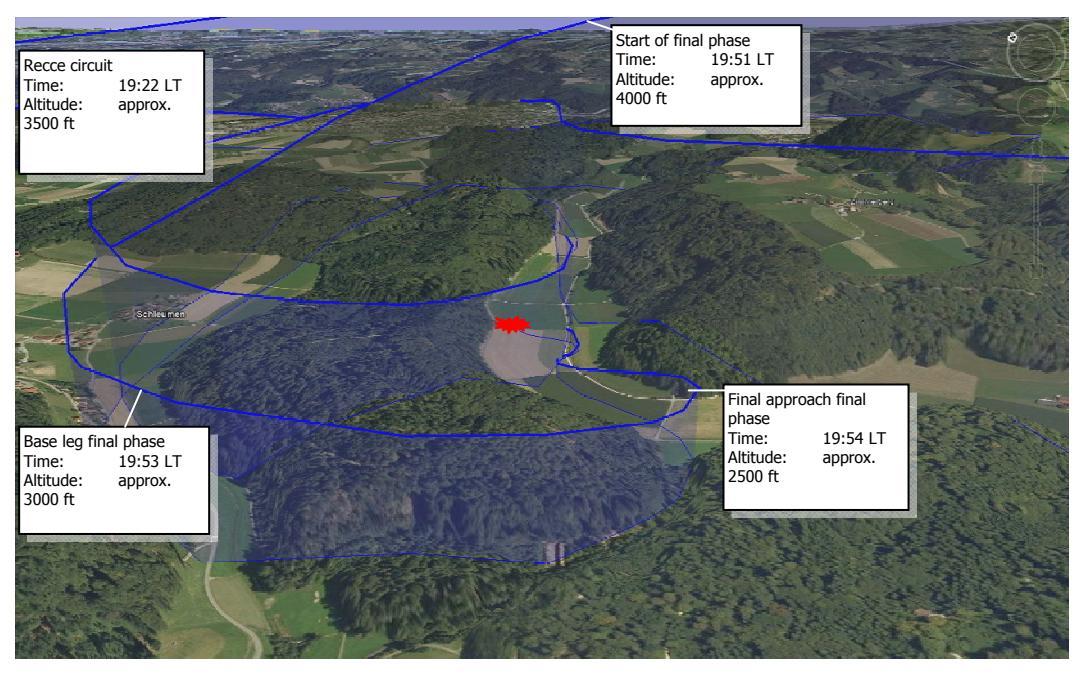
The approach was initiated in the direction of Schleumen from an altitude of approximately 4000 ft AMSL, descending above the 2172 ft AMSL high "*Glööri*" ridge, in order to subsequently turn onto the base leg at the south-west end of Schleumen at approximately 3000 ft AMSL. At this altitude, a few vehicle head-lights could be discerned on the main road in the Unterbärgetal valley. Using the available light sources from the vehicles on the main road, the crew was able to determine some altitude references. The planned landing area was visually perceived as "black" meadow. The highest obstacles in the immediate approach area were at elevations of 644 AMSL or 2113 ft AMSL.

Figure 2 - Different flight paths of the two approaches - reconnaissance circuit and final phase

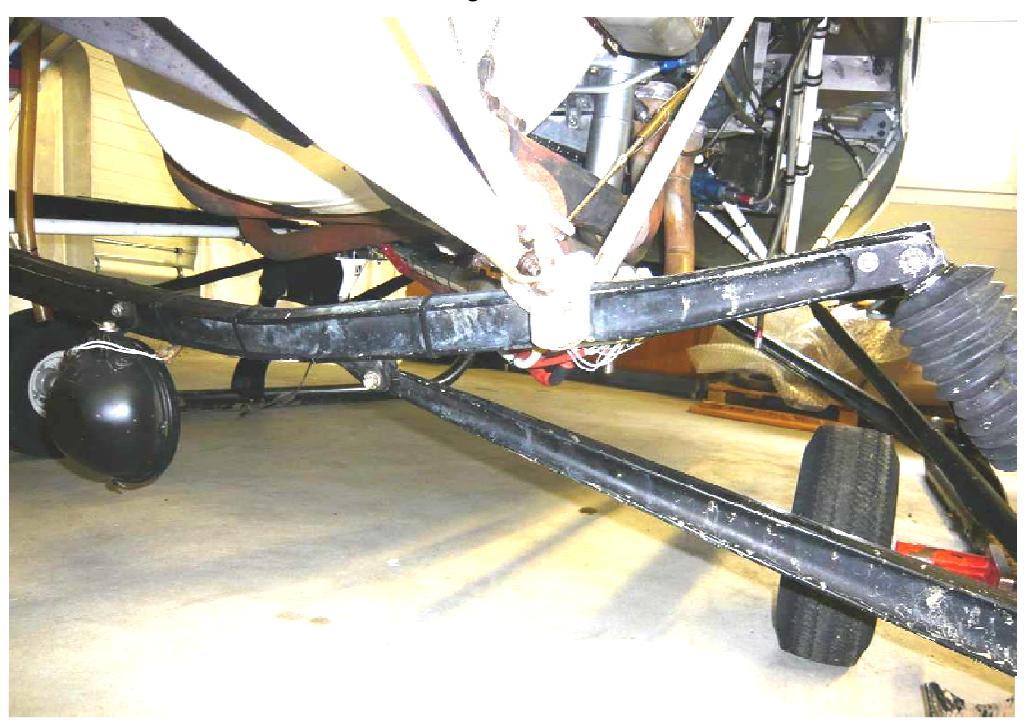
The landing gear and the central structure were severely deformed as a result of the helicopter's hard impact. The rear cross-member of the landing gear exhibited considerable downward bending.

Figure 3 - Bent landing gear

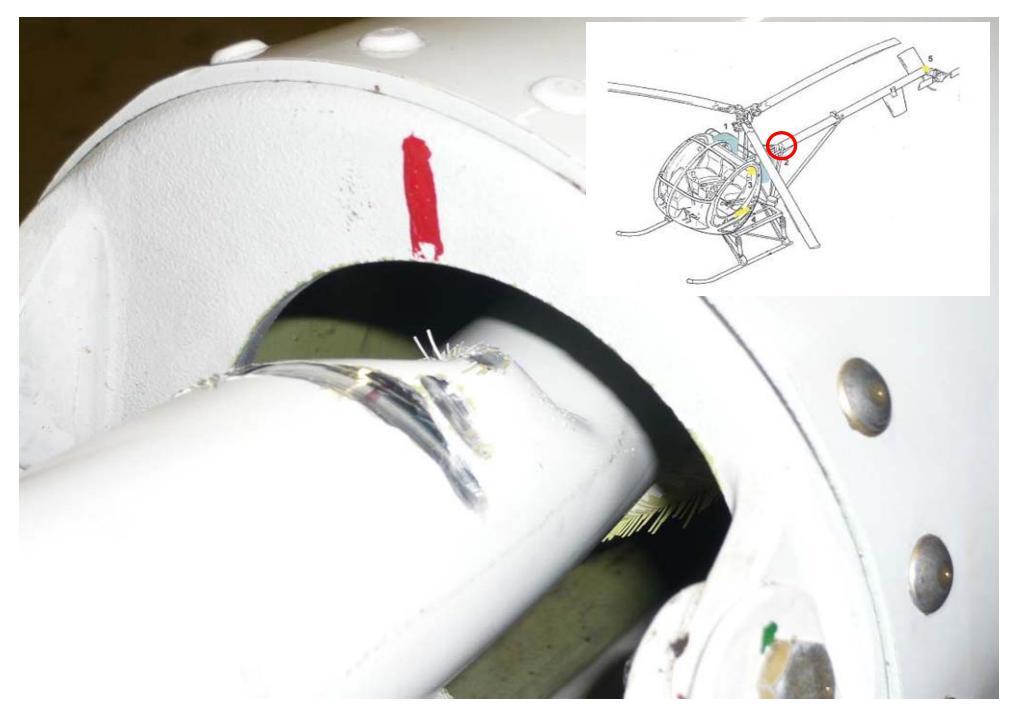
The tail rotor shaft exhibited serious deformation/torsion and was fractured in the area of the central structure/tail boom attachment.
