Final Report No. 2142 by the Swiss Accident Investigation Board SAIB

concerning the accident involving the K-1200 K-MAX helicopter, registration HB-ZEH

on 2 October 2007

in Strit, municipality of Illgau/SZ

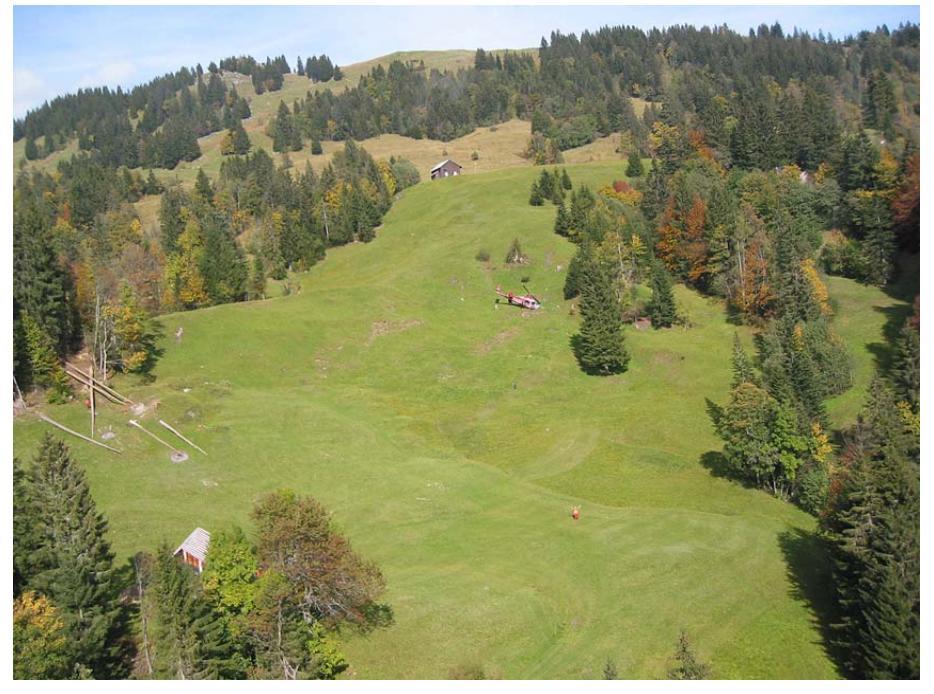
Figure 3 – Aerial photograph of the accident site with wreckage and load pick-up area

The site of the accident was in hilly, sparsely wooded and steep terrain at approx. 1320 m AMSL (see figures 3 and 4).

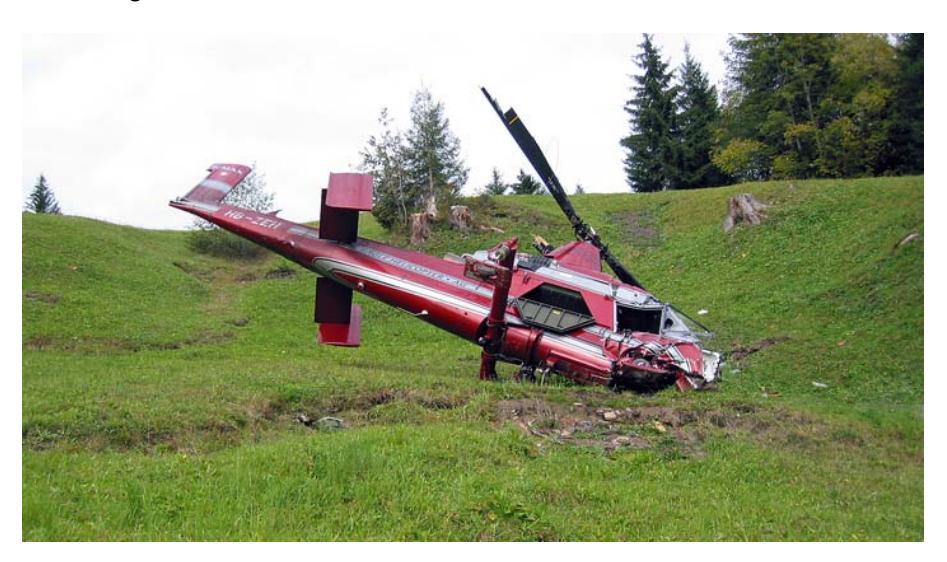
Figure 4- Final position of the wreckage

The impact of the helicopter was violent. This is evident from the deformation of the robust frontal structure. Part of the left section of the main gear dug into the earth and stabilised the wreckage. The rotor blades were destroyed on impact with the ground.

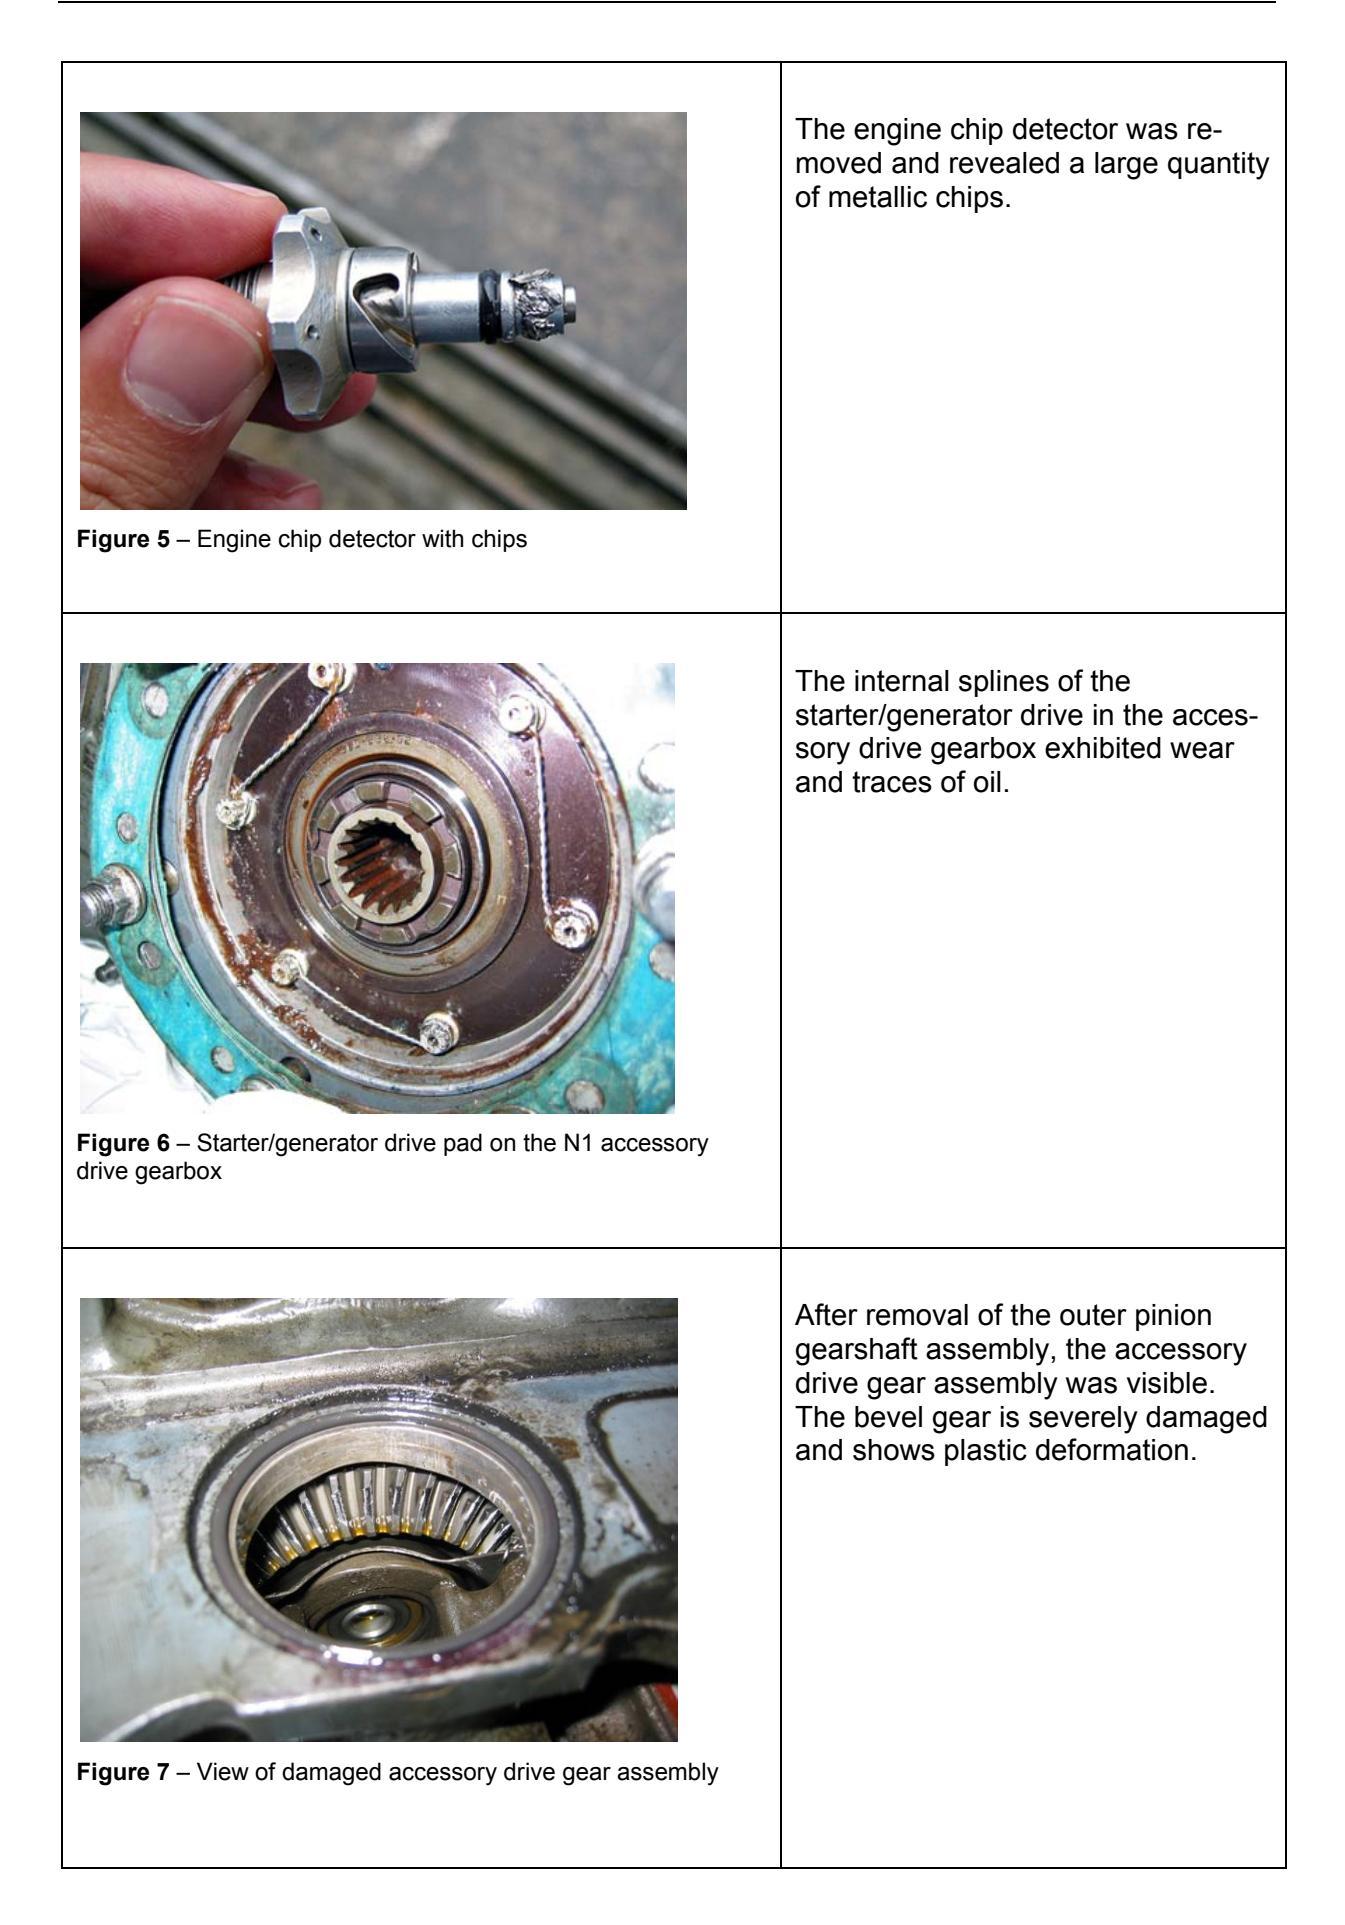
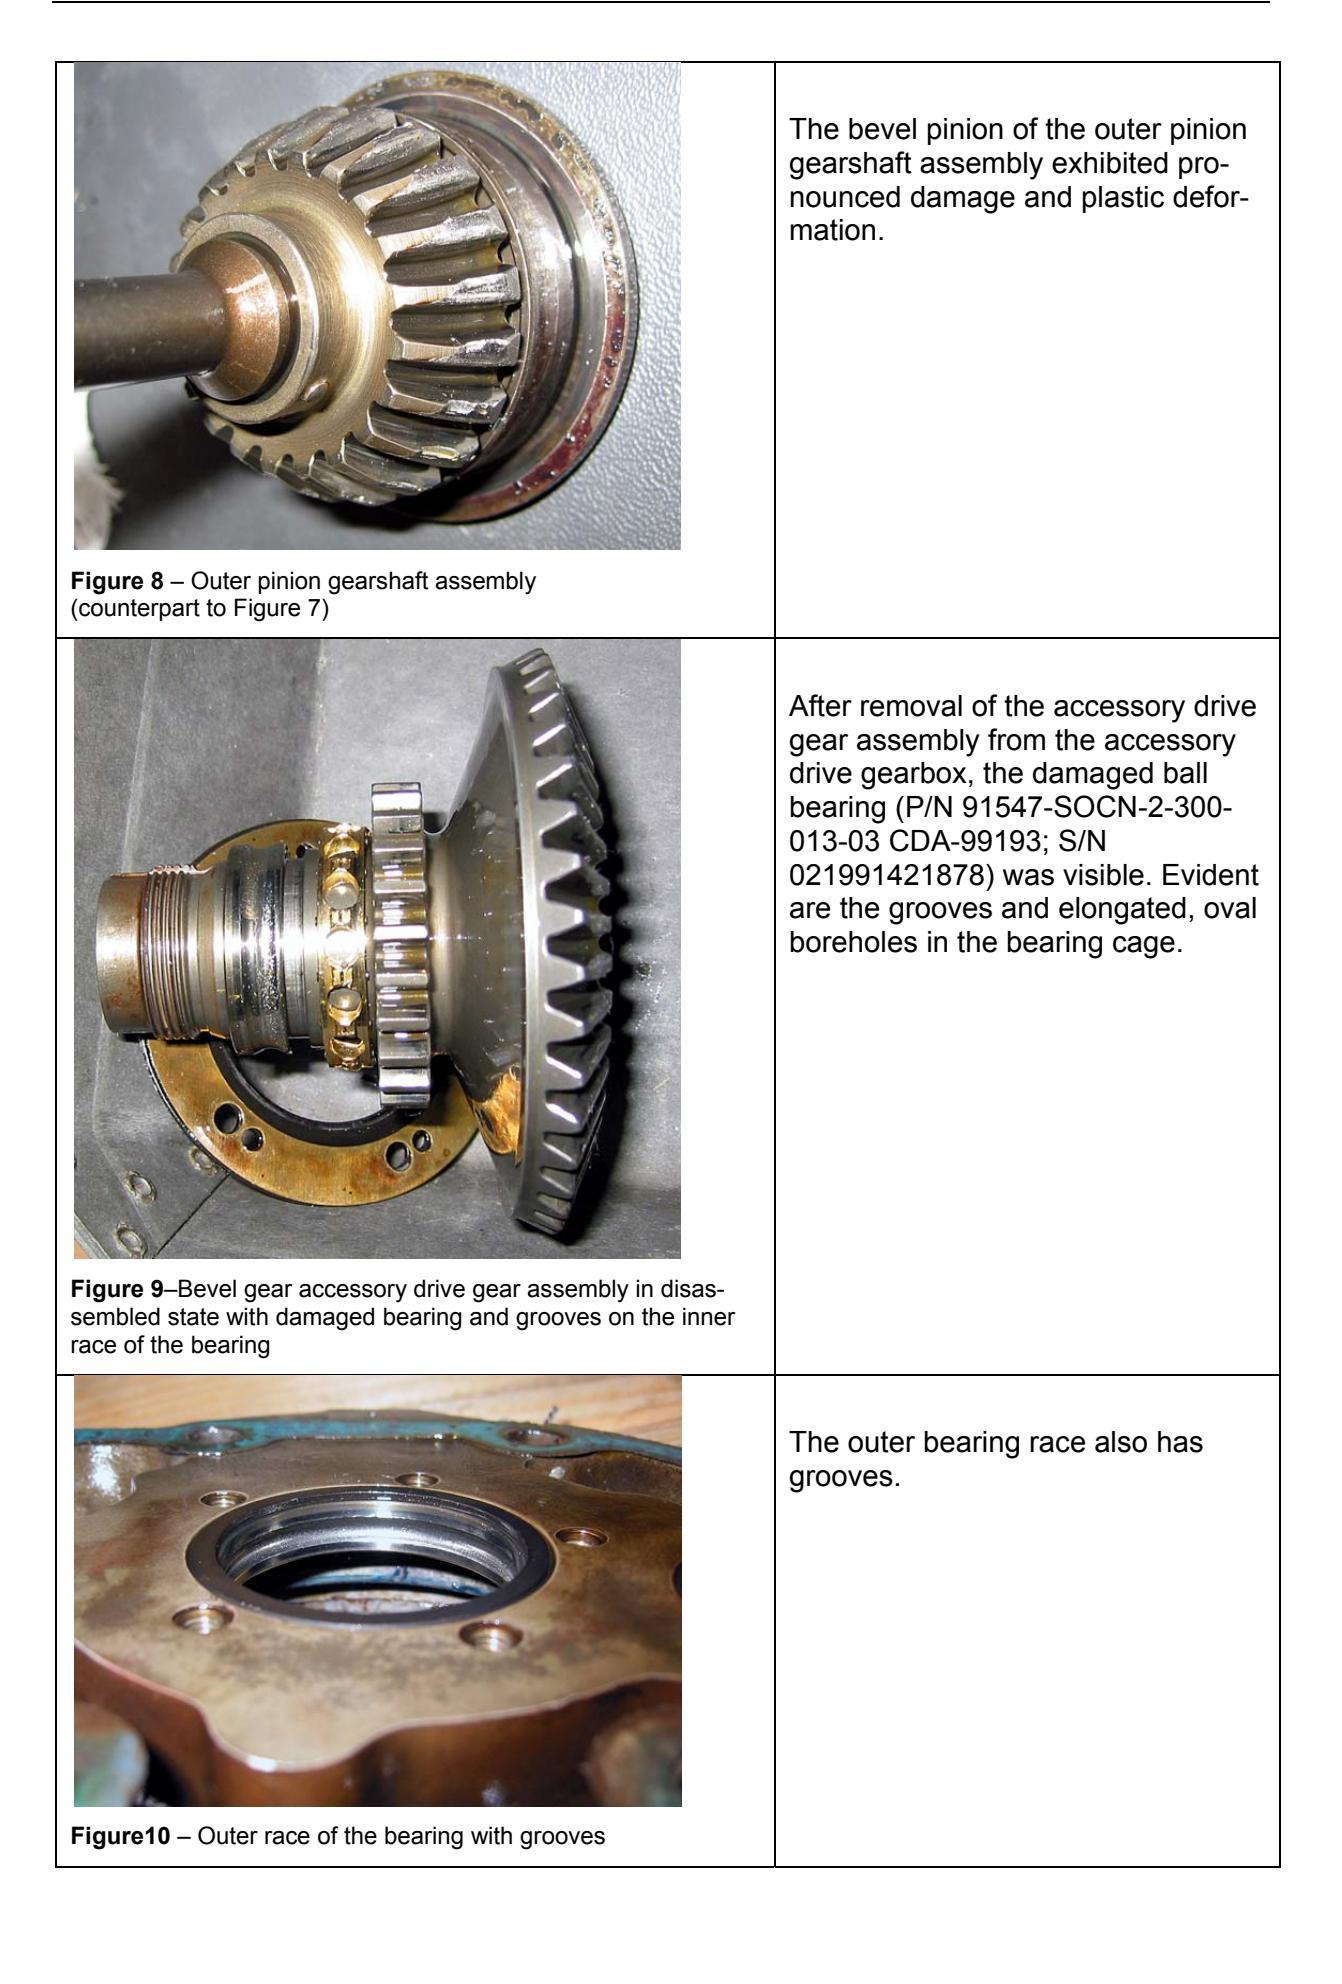
- The power turbine could be rotated freely by hand.
- The N1 accessory drive gearbox was removed. It was found that the accessory drives could not be driven by turning the accessory drive shaft. In particular, axial play in the accessory drive gear assembly was found.
