Final Report no. 2210 by the Swiss Transportation Safety Investigation Board STSB

concerning the accident involving the Cessna 172 aircraft, registration HB-CPL

on 26 April 2013

1.2 km north-west of Bex aerodrome (LSGB) / VD

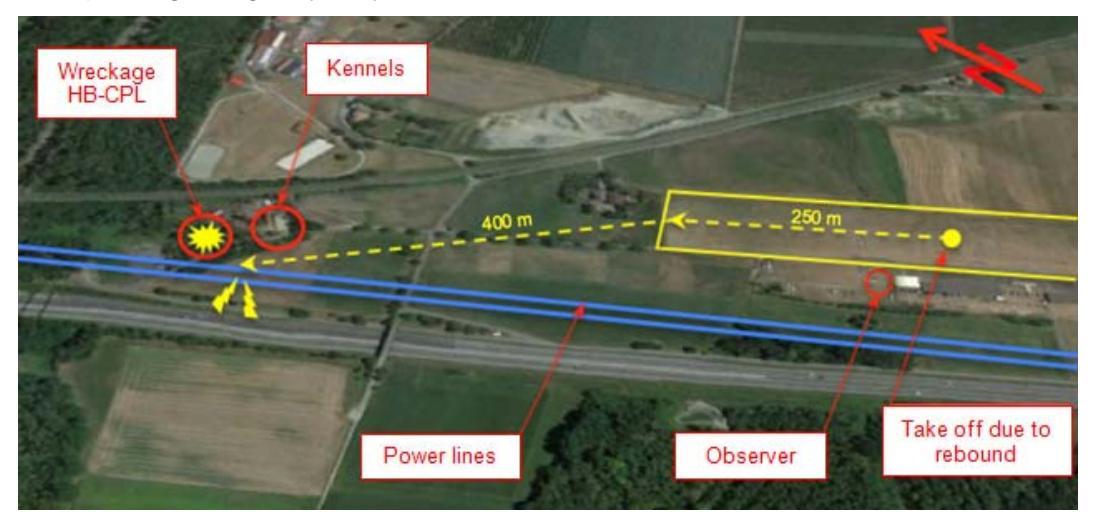
Fig. 1: Overall view

The aircraft first made contact with the grass runway with its nose wheel. It rebounded and contacted the ground a second time in the bowl-shaped part of runway 33. The pilot then decided to go around and increased power. According to his statement the engine was: '*a bit slow to pick up*'. Two-thirds of the way along the runway the aircraft lifted off and the pilot did not retract the flaps. He flew over the last third of the runway at a height of approximately thirty metres, at low speed, gaining only very little altitude.

The flight instructor at the edge of the runway (Fig. 1) observed the go-around and made the following statements:

- a striking lack of power, engine speed estimated at 1800 rpm
- the flaps remained in the landing configuration
- the aircraft was flying very slowly and hardly climbing at all

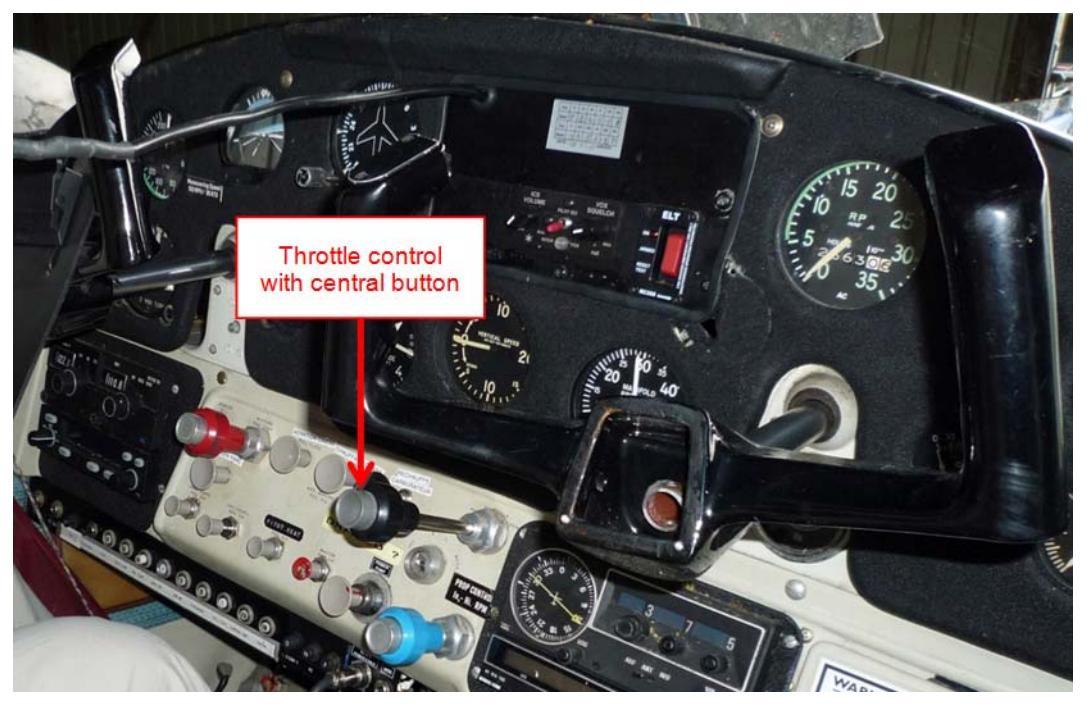
Fig. 2: Instrument panel of HB-CPL

The throttle could be operated in two ways. One was to slowly vary the power by screwing or unscrewing the control. The other required pressing the central button and keeping it pressed down (Fig. 2). This disabled the screw mechanism, allowing faster conventional linear adjustment. The travel of the central button was 8 mm. A relaxation of 3 to 4 mm from the "down" position re-activated the screw system and caused the linear movement to stop.

The throttle was found to be set at approximately the half-way position. The manipulation of this control, which was central and equipped with a screw, represented a significant change from the Robin HR20 aircraft which had been used for the pilot's basic training.

During the go-around, it is likely that the pilot released the central button before reaching the full power position, causing premature locking of the control. The fact that the pilot did not realise this halfway position or discern the lack of power can also be explained by a state of intense stress.

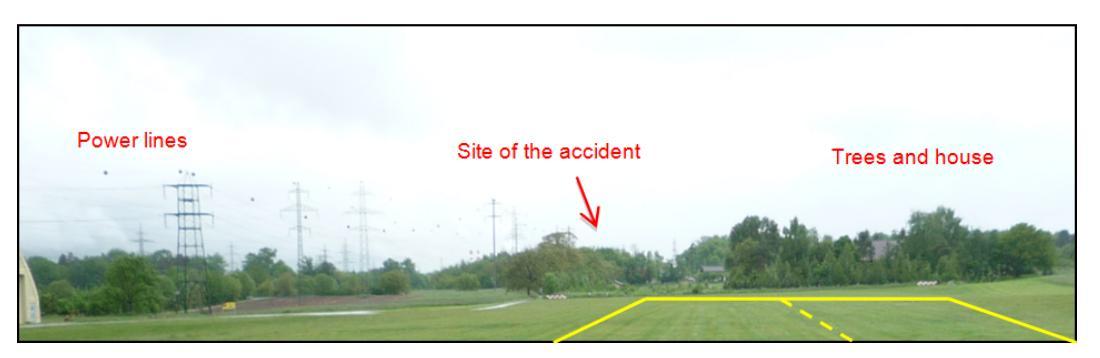
Fig. 3: View from two thirds along runway 33

The pilot turned slightly to the left in order to clear the lowest wooded area at the end of the runway (Fig. 3). A few seconds later, he heard the stall warning, pushed on the stick and saw before him a high-voltage power line running parallel to the runway. The aircraft travelled approximately 650 m from the point where the go-around was initiated and was positioned close to the kennels situated in the small forest located along the extension of the runway.

The accident occurred in a small forest, close to the motorway and situated on the runway 33 extended centreline. It housed kennels consisting of several buildings and was crossed by two high-voltage power lines. These power lines ran parallel to the runway centreline and were located approximately 150 m to the side of it. The terrain between the runway and the forest was flat and partially wooded. The first trees and the house located after the end of the runway constituted obstacles during take-off. To the left of the runway centreline was an area where the tops of the trees were lower.

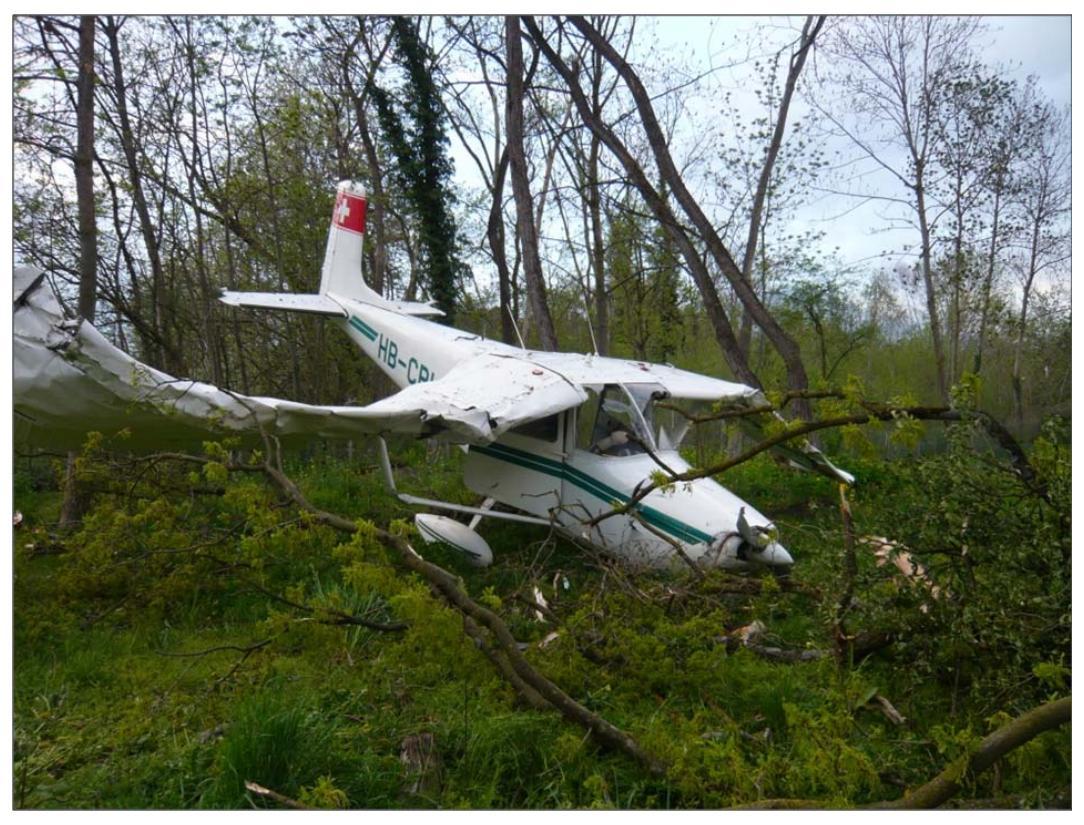
Fig. 4: Position of the wreckage

The underside of the left wing made contact with the upper cable of the highvoltage power line. This earth conductor cable is equipped with orange marker spheres. The aircraft banked to the right and the propeller touched the no. 1 phase conductor. The latter is on the north-east side of the line, 3.7 m below the earth conductor (Fig. 7). Electrical arcing ensued, damaging the no. 1 phase conductor, the propeller and the underside of the left wing. A few fractions of a second later the circuit breakers cut the current. The no. 1 phase conductor, which was damaged, severed and in a whiplash effect wound itself around the right leg of the landing gear. This decelerated the aircraft, which rotated in a clockwise direction around the yaw axis. The conductor severed again and the aircraft fell into the trees below, severing the no. 2 phase conductor in passing, located 4 m below the no. 1 conductor. Large branches were broken, cushioning the fall of the aircraft, which impacted the ground with a negative attitude. The nose gear leg broke and folded under the fuselage (Fig. 4).

The fuselage, which suffered little damage, was pointing east. The nose gear was broken and folded under the fuselage. The wings were badly damaged by large branches.

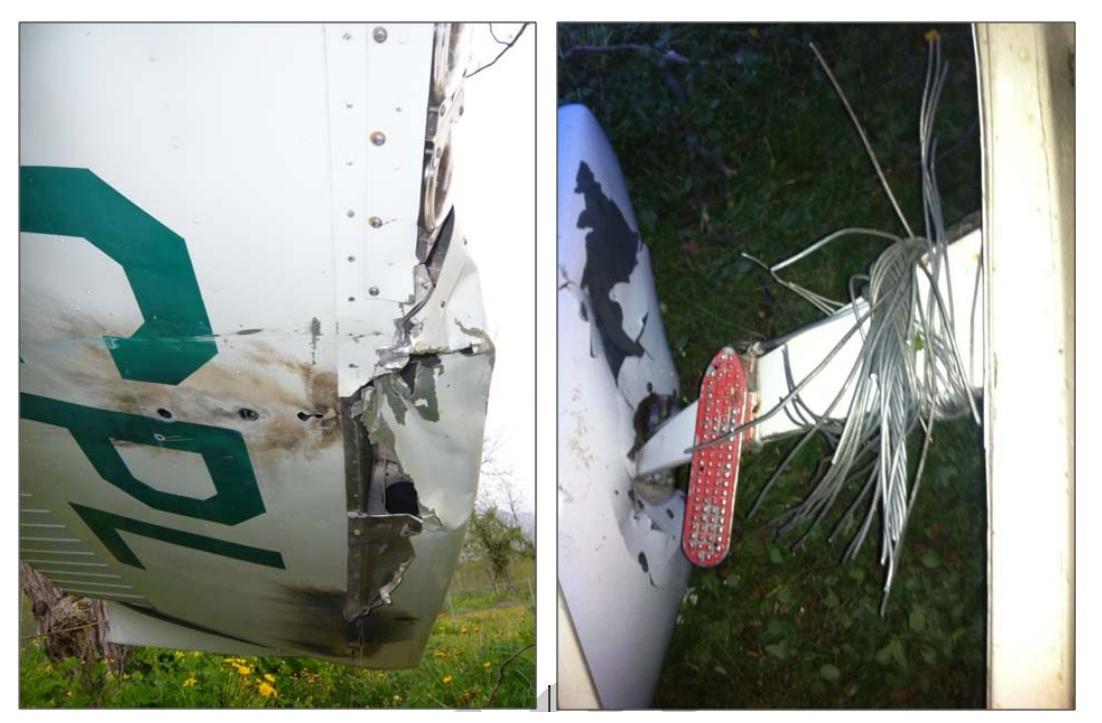
Fig. 5: Puncture holes in the underside of the left wing

The underside of the left wing had several puncture holes due to electrical arcing. They were located approximately 1 m away from the left fuel tank. A segment of the no. 1 phase conductor of the power line was wrapped around the right leg of the landing gear.

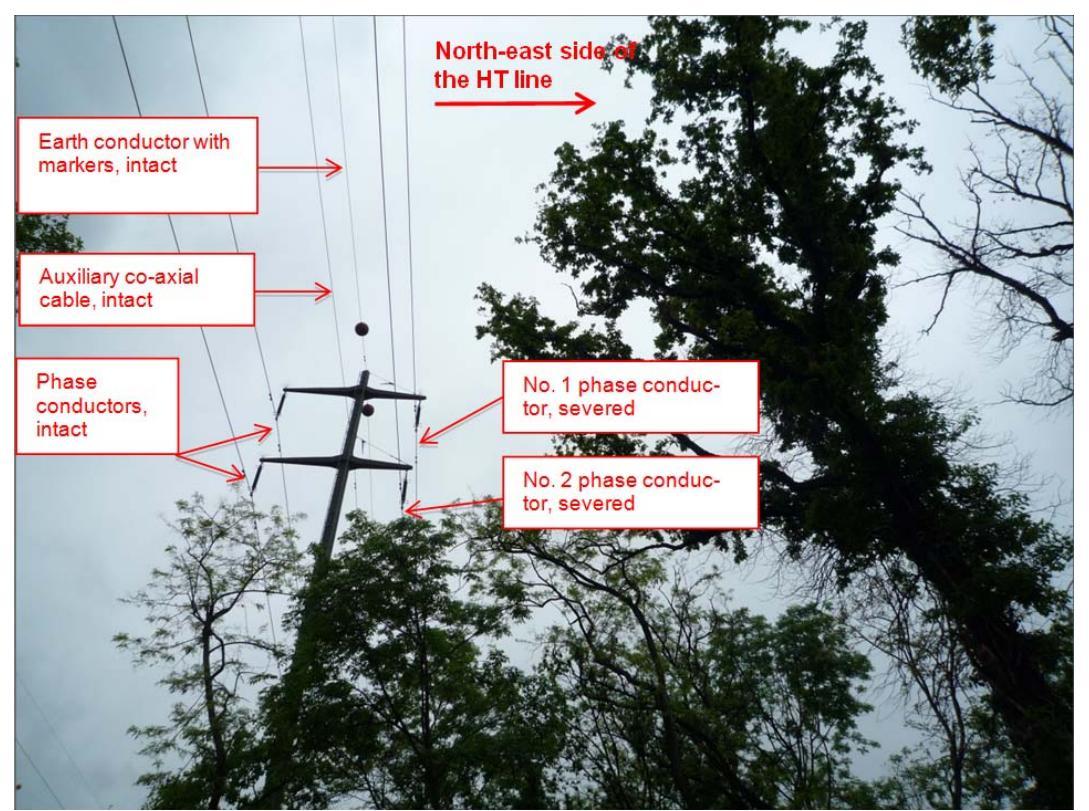
Fig. 7: Pylon and cables after repair. View from the position of the wreckage.

The line damaged in the accident was a 132 kV high-voltage line. It consisted of four phase conductors supported by insulators, an earth conductor fitted with orange marker spheres and an auxiliary coaxial cable. In the section of damaged line, the conductors were supported by two reinforced concrete pylons approximately 30 m high and 227 m apart. One of the pylons was positioned in the forest where the accident occurred (Fig. 7); the other was near the end of runway 33.

The data obtained from the repair company made it possible to establish that the phase no. 1 and no. 2 conductors were severed approximately 60 m before the pylon located in the forest and at height of 21 m and 17 m respectively. These Aldrey conductors³ have a cross-sectional area of 550 mm² and a tensile strength of 162 kN. The reinforced concrete supports of the insulators were damaged.
