Final Report No. 2355 by the Swiss Transportation Safety Investigation Board STSB

concerning the serious incident involving the A220-300 aircraft, HB-JCC,

on 15 July 2018

at Porto Airport (LPPR), Portugal

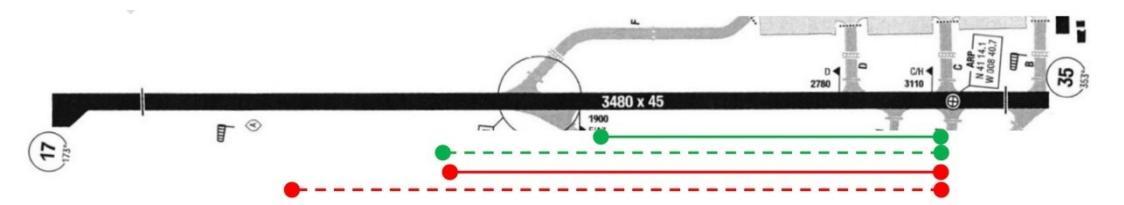
Due to the slow acceleration, the CMD checked the set takeoff power. He then realised that it was too low and pushed the throttles forward. The data shows that the speed was 109 KIAS at this time and that the throttles had been set at a TLA of 28.5°, equivalent to an N1 power output of 76.6 %. According to the flight crew's statement, they became aware almost simultaneously of the CONFIG SPOILER warning, which illuminated for four seconds. The copilot responded to this warning at once, voicing that the spoiler lever was in the retracted (RET) position. The CMD briefly considered aborting takeoff. However, as he had exceeded speed V₁ (117 kt) in the meantime, he decided to continue the takeoff roll. The aircraft took off 52 seconds after takeoff was initiated, at a distance that was 1.5 times the length of the calculated takeoff distance, and approximately 1000 metres before the end of the runway.

Figure 1: Distance from start of takeoff roll until lift-off with the correct power setting (green line); with a power setting as it was in the serious incident (red line). Additionally: the respective accelerate stop distance (ASD) (dotted line).

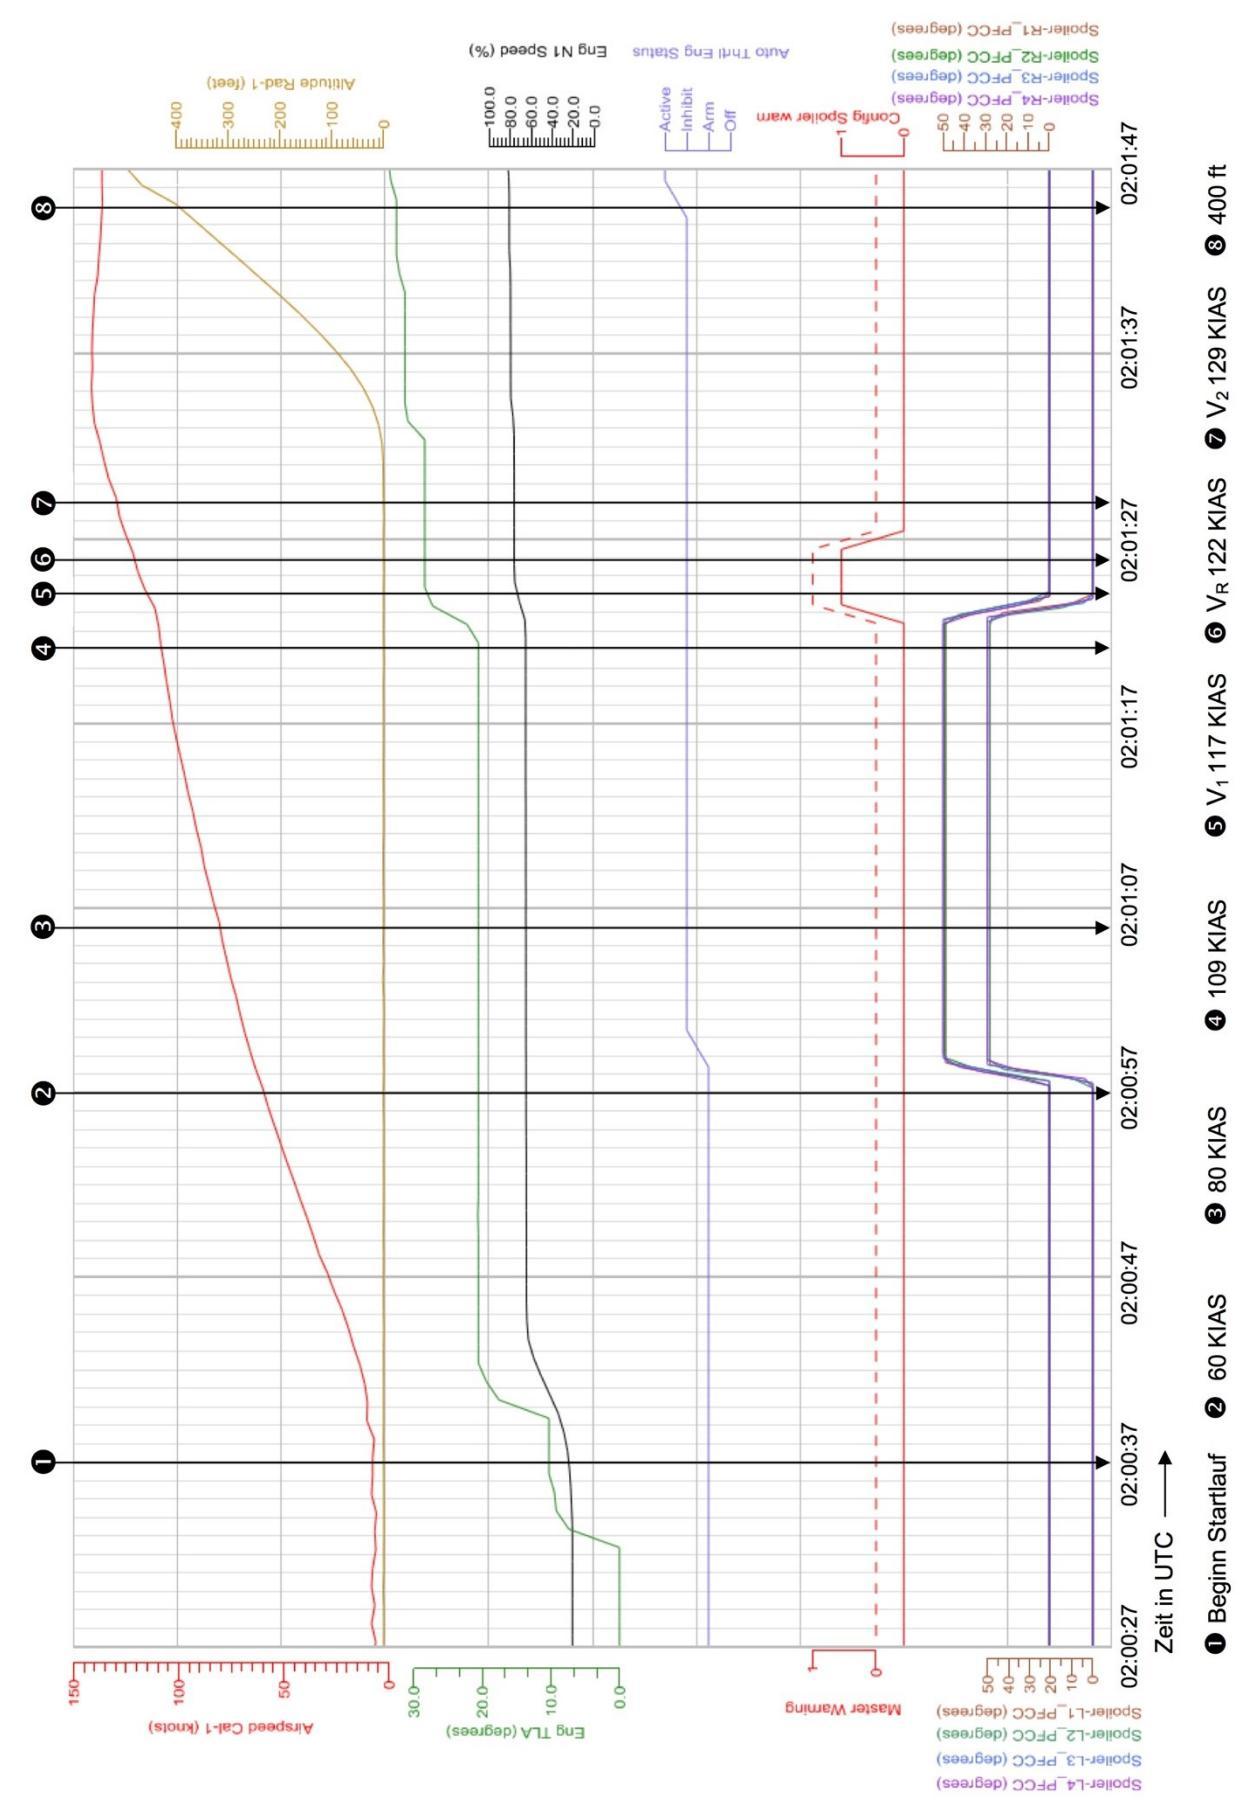
Annex 1: Records during takeoff roll of HB-JCC

Only once the CMD had pushed the throttles forward at a later time did the TLA change to above 23° and the spoilers retracted within 2 seconds, 23 seconds after having extended (see annex 1). As observed by the flight crew, the SPOILER CONFIG warning displayed on the EICAS for 4 seconds whilst the spoilers were retracting.
