Swiss Confederation

Summary report

Aircraft type	Beech B200 Super K	ing Air	N7779V			
Operator	Private					
Owner	Aerospace Trust Management LLC Trustee, 1013 Centre Rd Ste 403A, Wilmington, DE 19805-1270, USA					
Pilot	Dutch citizen, born 1	962				
Licence	Commercial Pilot Lic Aviation Administration	ence Aeroplane on (FAA)	(CPL(A)) issued	by the Federal		
Flying hours	Total On type	13 200 hours 549 hours	Last 90 Last 90	days62 hoursdays22 hours		
Second pilot	Dutch citizen, born 1	981				
Licence	CPL(A) issued by the	e Civil Aviation A	uthority Netherla	inds		
Flying hours	Total	427 hours	Last 90	days 3 hours		
	On type	239 hours	Last 90	days 0 hours		
Location	12.2 NM north-east of	of Lausanne Airp	ort (LSGL)			
Coordinates	553 337/171 312 (Sv N 46° 41' 29"/E 006°	viss Grid 1903) 49' 43'' (WGS ¹	Altitude 84)	Flight level 155		
Date and time	23 February 2019, 14	4:54:18 UTC (LT	= UTC + 1 hour)		
Nature of flight	Private					
Flight rules	Instrument Flight Rul	es (IFR)

Departure airport	Saanen (LSGK)					
Destination airport	Amsterdam (EHAM)					
Flight phase	Climb					
Nature of the serious incident	Total electrical failure)				
Injuries	Crew members	Pass	engers ⁻	Third parti

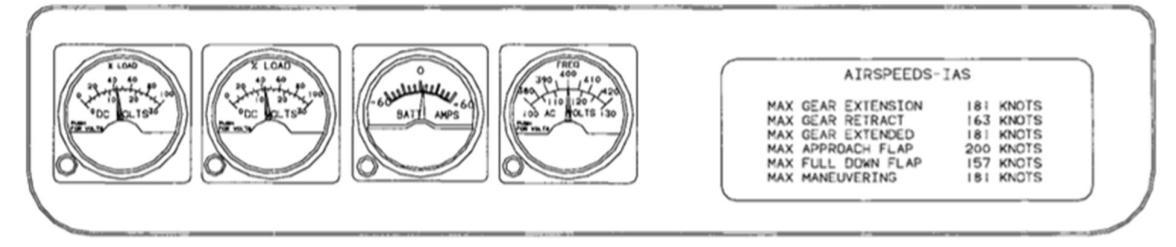
Figure 1: The two instruments on the left-hand side show the loads of the left and right generators (0 to 100%) on their upper scales and, when the button is pressed, the voltage (0 to 30 V) on their lower scales. The third instrument indicates the load on the battery (-60 to +60 A) and the fourth instrument shows the AC frequency (380 to 420 Hz) on its upper scale and the voltage (100 to 130 V) on its lower scale.

Before taxiing the aircraft, the flight crew must work through the corresponding checklist (before taxi) (see Fig. 4). The first item in both the procedure issued by the manufacturer and the one issued by Flight Safety International explicitly requires checking the power supply to the generators. This is done via the displays of the electrical instruments (see Fig. 1).

- (7) It is recommended to rephrase the Normal Checklist, section Before Taxi checklist, item "Electrical System ... CHECKED" into "DC Volts and Load ... CHECKED". This will require both crew members to check the actual output of the generators and the correct functioning of the electrical system. Refer to Appendix B for an example.

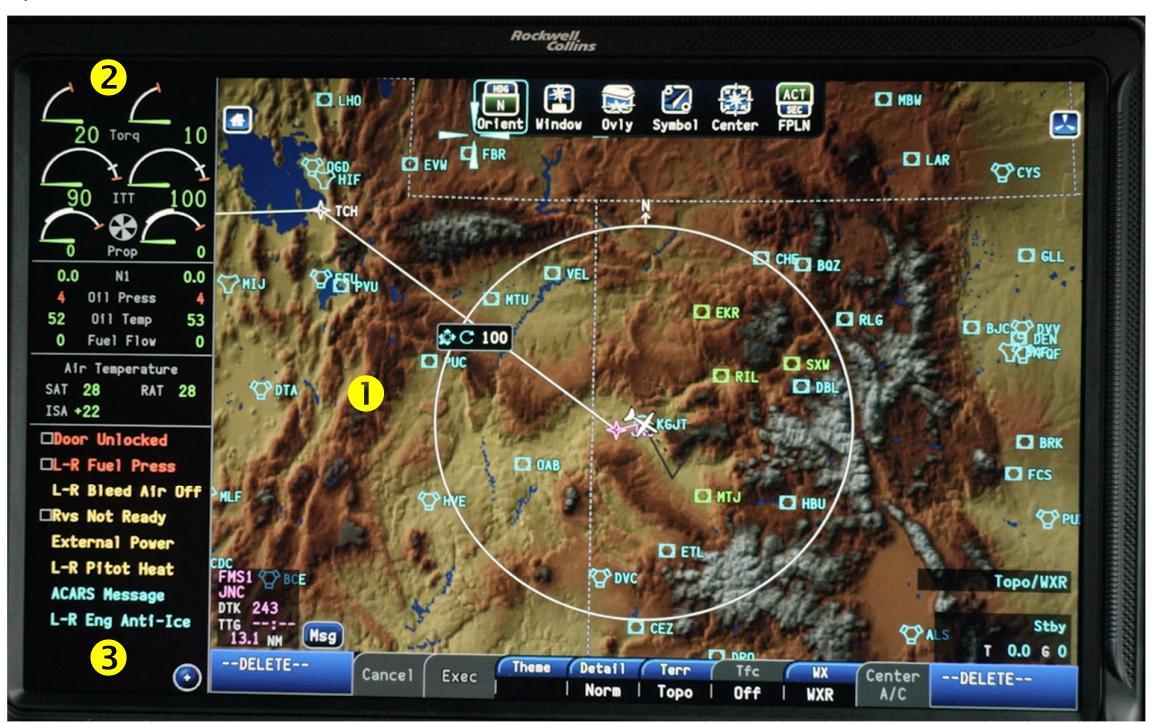
Figure 2: Left of the map display ($\mathbf{0}$) and below the displays to monitor the engines ($\mathbf{0}$), optional messages and warnings will be displayed ($\mathbf{0}$). This option had not been activated on the N7779V. (Picture edited by the SUST).

It is also possible that the annunciator panel displays were dimmed and therefore difficult to see in the prevailing lighting conditions. The optional displays of notifications and warnings on the centre screen of the Pro Line Fusion avionics system (see Fig. 2) overcome these problems.

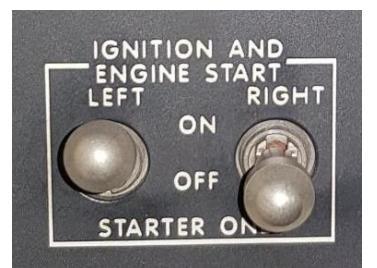
After switching off the two engines, the pilot noticed that the left-hand IGNITION AND ENGINE START switch, that can be set in the three positions ON, OFF and STARTER ONLY, was still in the ON position (see Fig. 3), although it has to be returned to the OFF position after the engine has been started (see Appendix 4). He attributed the total electrical failure to this incorrect switch position and decided to recharge the battery with a ground power unit. Once the battery was charged, the flight crew started the left-hand engine. It started successfully and no anomalies were found. The right-hand engine was then started and again no anomalies were found and all systems and displays were functioning normally.

Figure 3: Three-position IGNITION AND ENGINE START switch; left switch in ON position, right switch in OFF position

The left three-position IGNITION AND ENGINE START switch was left in the ON position (see Fig. 3). This meant that the left engine's starter generator² was still being powered, incurring a high consumption of electricity, and that the electrical system was only being supplied by the right generator and the battery. The high-power consumption of this combination of circumstances exceeded the capacity of the right generator, which is why the battery was discharged. Ten minutes into the flight, the battery voltage dropped below 16 V, which caused the avionics system to fail.

After starting the left motor, the three-position IGNITION AND ENGINE START switch was incorrectly left in the ON position. Since the start procedure was not performed as per the checklist, this error went unnoticed by both pilots. The flight crew again failed to spot the error by not following the next step of the «before taxi» procedure, whose very first item is the check-ing of the electrical system (see Fig. 4).

- (6) As the engine start is done by memory, it is recommended to add the following item to the Normal Checklist, section Before Taxi checklist: "Ignition/start switches ... OFF". Some operators include an "Engine Start" checklist in their Normal Checklist. An example of such a checklist is depicted in Appendix B.
