# Swiss Transportation Safety Investigation Board STSB Annual Report 2021

Swiss Transportation Safety Investigation Board STSB

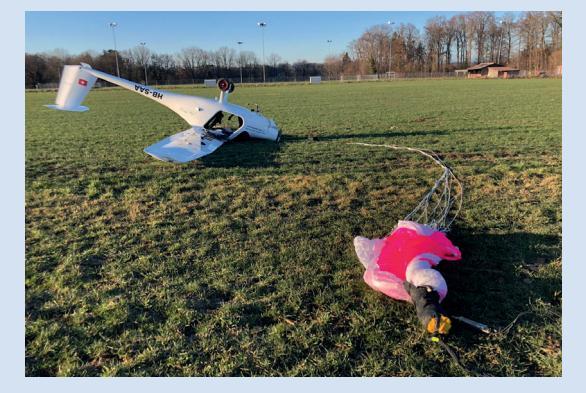
### Emergency landing of an electrically powered motorised aircraft approximately 2 km east of Ecuvillens aerodrome, 03.01.2019

During an emergency landing outside the aerodrome area, which was due to a loss of motor power, the Pipistrel Alpha Electro 167 made a hard impact with the ground and then flipped over.

Due to a faulty electrical connection, the cooling system's circulating pump failed, causing the propulsion unit's power controller to over-heat within a short time. As a result, the available motor power was automatically reduced to less than 15% of the maximum take-off power. As a result, the pilot was forced to make an emergency landing outside the aerodrome area during which the aircraft was severely damaged. The fact that a single pump was installed in the cooling system was recognised by the STSB as a lack of redundancy and a high safety risk.

The European Union Aviation Safety Agency (EASA) should ensure that the aircraft manufacturer adapts the propulsion units cooling system in such a way that the failure of a single system component, such as the circulating pump, does not significantly affect cooling and consequently motor power.

The FOCA should, in cooperation with aerodrome operators and the emergency services which are usually involved in accidents involving aircraft, take measures to raise awareness of the hazards posed by electrically powered aircraft and how these can be countered.

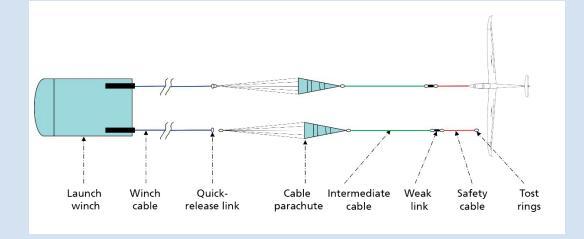
### Incident during a winch launch at the Fricktal-Schupfart airfield, 10.05.2019

In the course of a winch launch a glider collided with the cable parachute and winch safety cable (strop) after the crew released the winch cable, the cable parachute opened and the winch driver retracted the winch cable.

The investigation found that, depending on the arrangement of the winch launch cable, having aborted a winch launch neither the crew nor the winch driver is able to prevent a collision between the glider and the inflated cable parachute and safety cable. To reduce precisely this risk, airworthiness directive (AD) 73-16 issued by the German federal aviation authority (LBA), in February 1973 (now AD 1973-016) contains requirements for cable parachutes and cable arrangements. It emerged that few people in Switzerland are aware of this information.

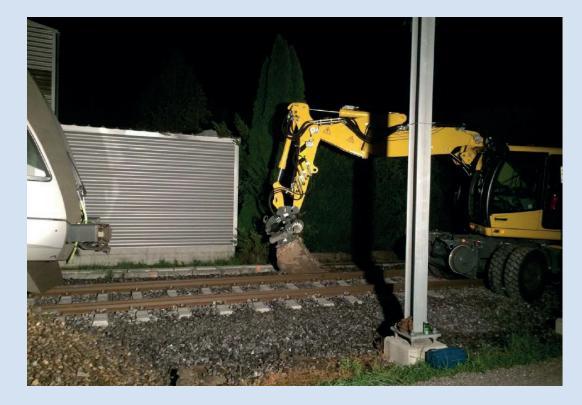
### Collision of a multiple unit with a road/rail vehicle in Burgistein (BE), 10.09.2015

On 10 September 2015 at 22:13 hrs, a 'Lötschberger' RABe 535 multiple unit collided with a road/rail excavator in Burgistein (BE). Both vehicles were damaged, and one person suffered minor injuries. The roof of the building on the adjacent property was also damaged, but the railway infrastructure was not affected.

The collision was caused by the road/rail vehicle having joined the rails on an unsecured track. This occurred because communication (observance of speech and radio rules) between the controller and safety warden via mobile telephone did not follow the official regulations, leading to misunderstandings and contradictions that were not picked up. Additionally, the relevant documents did not specify the location at which the excavator was to join and leave the tracks, or this was not stated correctly.

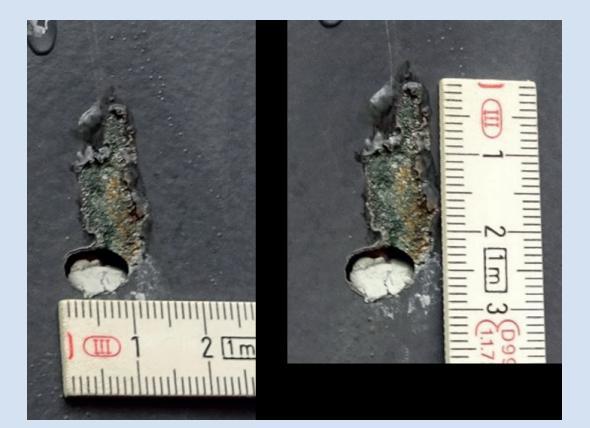
# Dangerous goods incident in Basel SBB shunting yard, 19.10.2020 (interim report)

On 19 October 2020, a technical inspector at Basel SBB RB marshalling yard heard a hissing sound from a tank wagon and noticed steam escaping from an almost imperceptible hole. He complained of feeling unwell and was taken to hospital for a check-up. On 6 July 2021 in Lüsslingen, a driver noticed some blue smoke during a shunting movement. Upon inspection, he found that smoke and liquid were escaping from a small hole near the access opening of a tank wagon filled with hydrochloric acid.

Within the space of nine months, two identical Zacns tank wagons in Switzerland experienced a leakage of hydrochloric acid, one at Basel SBB freight station and the other at Lüsslingen.

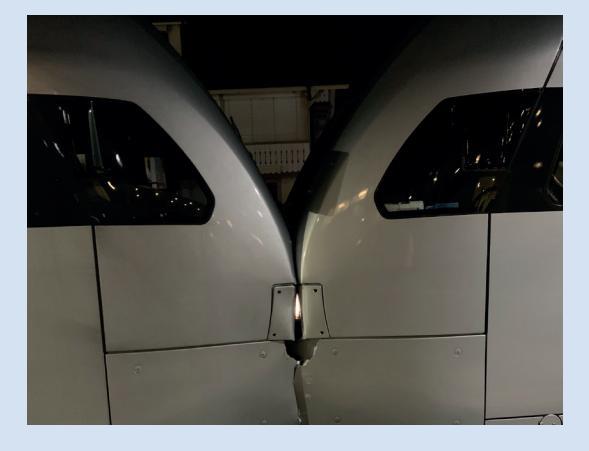
#### Train collision in Belp, 31.12.2020 (interim report)

On the afternoon of 31 December 2020 at 16:43, a passenger train stopped at Belp Steinbach station. The passenger train was due to couple with a multiple unit waiting on track 2 in Belp. Leaving Belp Steinbach, the driver of the passenger train accelerated to 40 km/h. Around 230 m before the waiting multiple unit he started braking using the electrodynamic brake. As the braking effect was inadequate, the driver pulled the emergency brake about 160 m before the stationary multiple unit. However, the braking effect was still inadequate and the passenger train collided with the stationary train at a speed of 23 km/h.

The preliminary results of the investigations suggest that the RABe 515 trainsets do not always achieve the braking performance that was determined when type approval was granted. For example, when the emergency brakes are triggered by the train protection system, the train may not always stop before the danger point.

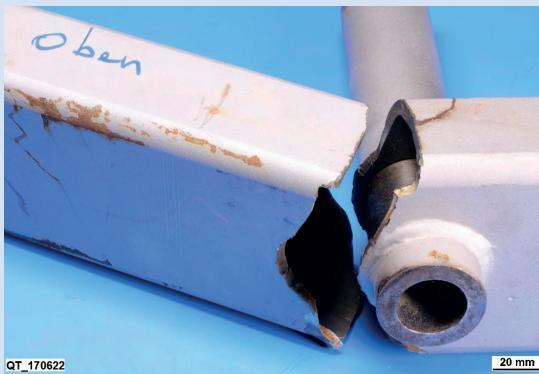
On 13 February 2021, during operating hours at approximately 11:45, on the three-seat detachable chairlift (TSD 3) linking Morgins to La Foilleuse, the maintenance bridge on tower No 14 broke off and fell to the bottom of the tower. A passenger noticed that a piece of the system was on the ground and reported it to a member of the operating staff when he arrived at the upper terminal. A technical expert went immediately to the site and ordered the evacuation of the lift system. The installation was temporarily shut down while the technical staff secured the tower. There were no injuries.

The collapse of part of the maintenance bridge of tower 14 resulted from fatigue caused by cyclic vibrations.

Similar vibrations also occur in the welded and bolted joints. Non-destructive testing to date has also revealed cracks in the other towers of the system. Tower components which are repeatedly exposed to vibration can lead to the formation of cracks, and a component with a hairline crack can break at any time.

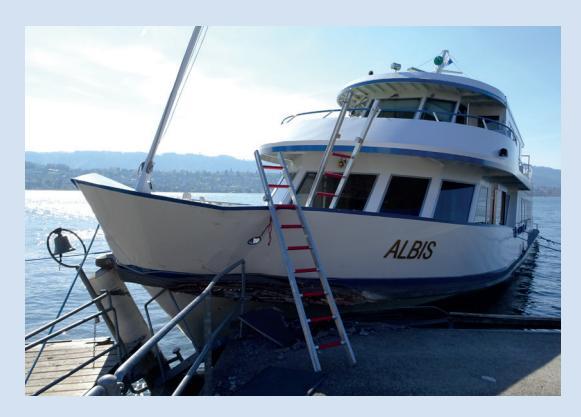
# Collision between MS Albis and the jetty in Küsnacht (ZH), 20.04.2016

On 20 April 2016 at approx. 13:09, the motorvessel Albis (MS Albis) belonging to the Zürichsee-Schifffahrtsgesellschaft (ZSG) collided with the jetty while mooring in Küsnacht (ZH). Several people were injured in the collision. Extensive damage was caused to the ship and the jetty.

The collision between MV Albis and the jetty in Küsnacht on 20 April 2016 can be attributed to the fact that it was not possible to take over driving control on the port bridge-wing control stand. As the records for some important parameters for the accident investigation are lacking, it cannot be said conclusively whether purely technical or purely human factors were the cause.

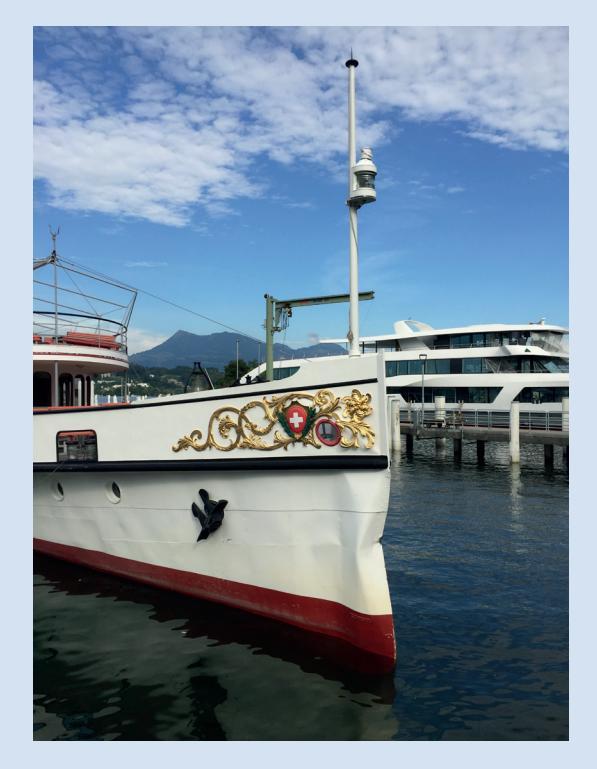
# Collision between two steamships in Lucerne, 19.08.2016

In an encounter involving two steamships in the Lucerne lake basin on Lake Lucerne on 19 August 2016 at approximately 13:35, the steamship Unterwalden (DS Unterwalden) suddenly veered to the left and so collided side-on with the steamship Schiller (DS Schiller).

The collision between the DS Unterwalden and the DS Schiller in the Lucerne lake basin was due to the fact that the rudder deflection to port could not be corrected in time when two steering commands were given almost simultaneously at two control stands. The rudder steering software was programmed to continue carrying out the first command received even after further commands had been given by another control signal transmitter.
