**Final Report
of the Aircraft Accident
Investigation Bureau**

to the Piper Aztec PA-23-250 aircraft, registration C-FBQS
on 5 July 2000
12 km south of the town of Bulle (FR)
near the Pointe de Cray (FR)

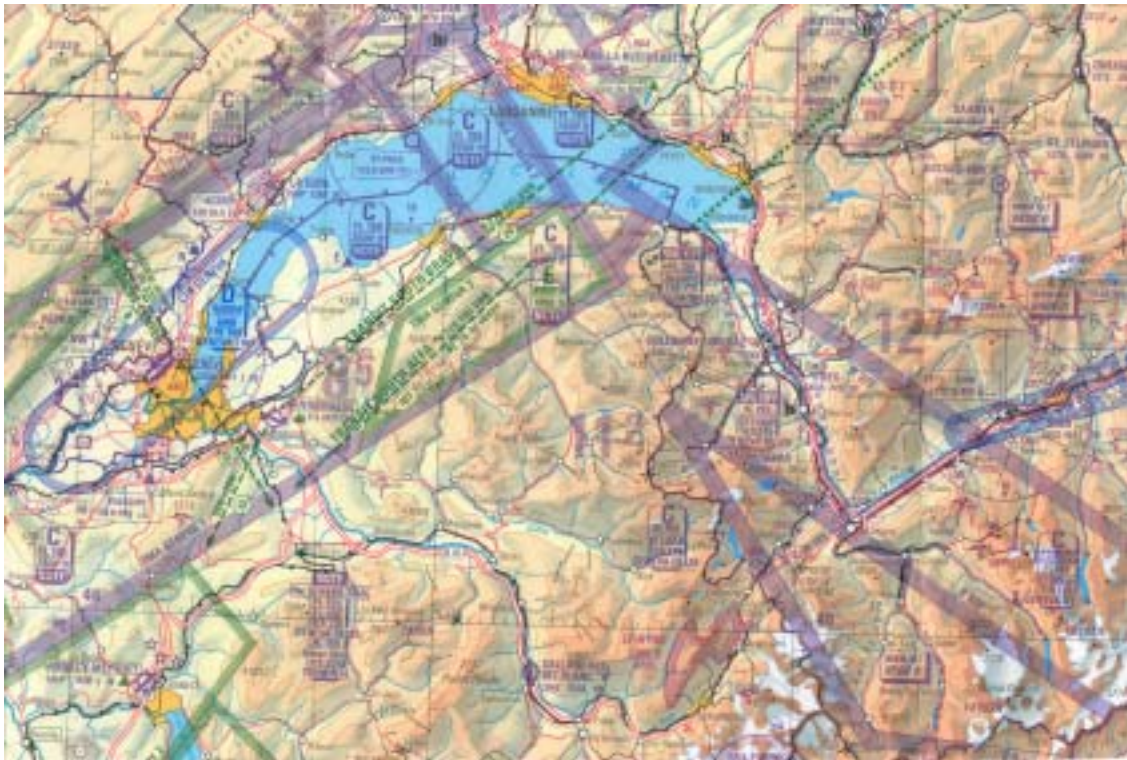
Excerpt from ICAO chart 1:500'000

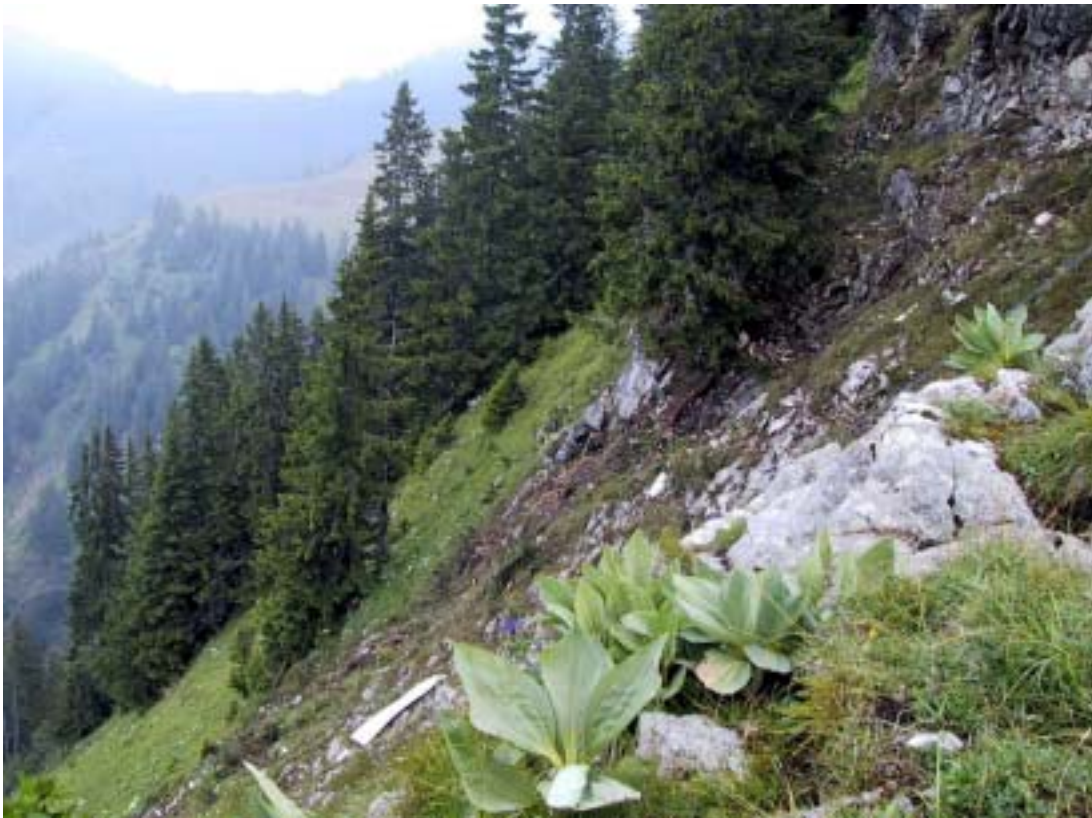
Place of impact

The aircraft was in head-on collision with a slope of approximately 45 degrees, approximately 15 metres below the summit. The wreck then slid downwards approximately 80 metres.

This slope, which is very difficult to access, consists of rocks and a few trees.

The impact was so forceful that a large part of one of the tanks was propelled over the summit and fell onto the other slope.

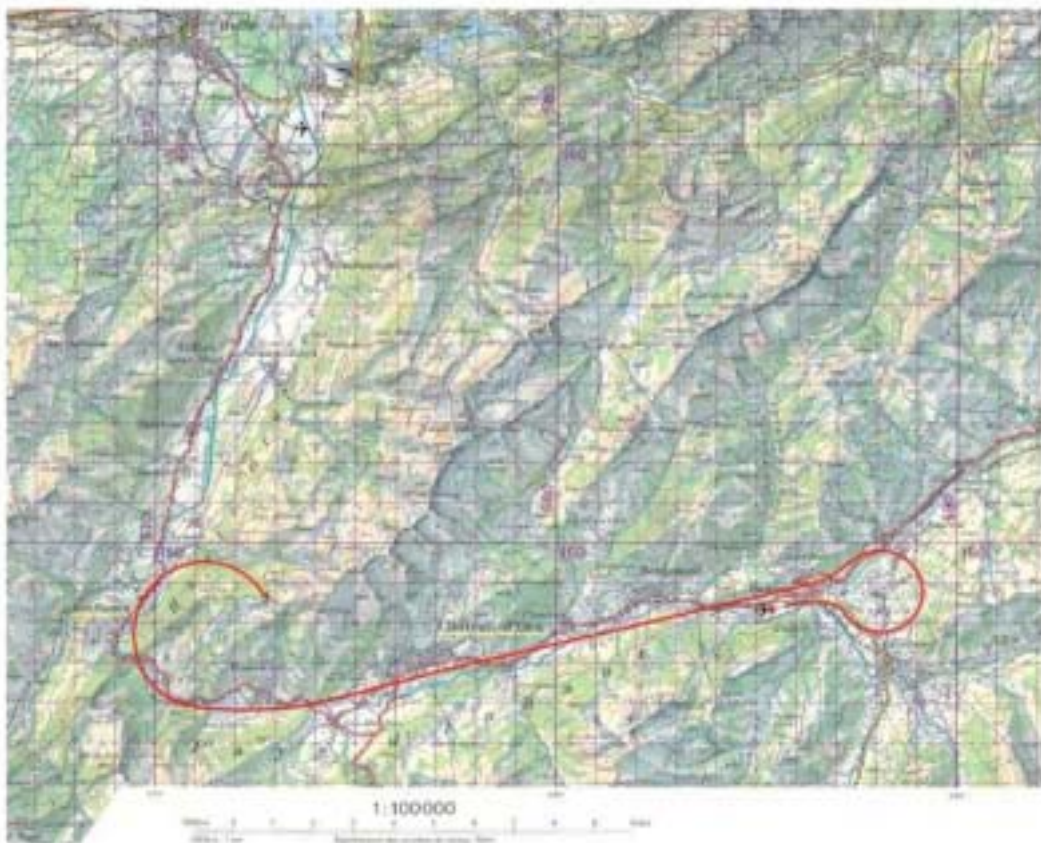
Presumed flightpath of C-FBQS

Arrivals and departures at Saanen airfield in bad weather conditions require excellent knowledge of the local topography. When the sides of the mountains close to the airfield are in the clouds, the width of the airspace below the clouds becomes narrow, especially at the bend in the valley, at the village of La Tine.

One can deduce from these testimonies that the pilot encountered a compact cloud barrier, the base of which was clearly below the peaks. He then decided to make a 360° right turn, enabling him either to gain sufficient altitude to fly over the summits safely or to turn back to Saanen airfield. With a ceiling between 2500 – 3000 ft MSL at Montbovon, the width of the valley available to make a turn back is less than 1000 metres and at the narrowest point of the valley is close to 500 metres! Furthermore, again according to the testimonies, the aircraft was in a steeply descending trajectory, and therefore probably at high speed.
