Final Report No. 1918 by the Aircraft Accident Investigation Bureau

concerning the serious incident (airprox)

between ECA 923, 5B-DBW

and SPW 35A, HB-VNA

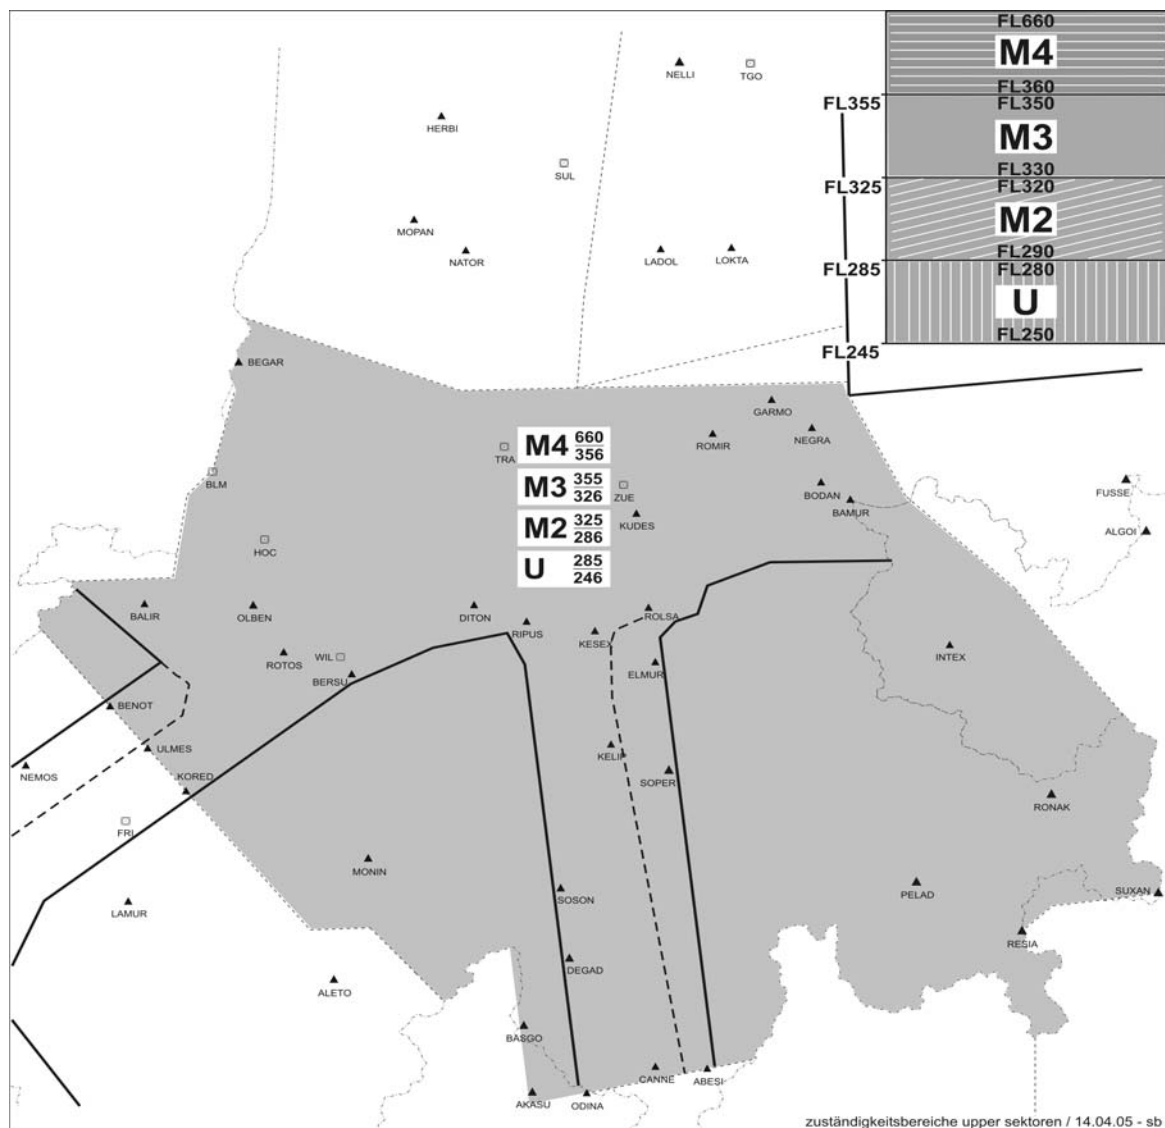
Map showing Areas of Responsibility – ACC Upper Sectors

Area control centre (ACC) Zurich is responsible for the airspace of air traffic control Zurich above FL245.

The airspace is subdivided into four vertically defined sectors.

Sectors	upper	(U)	upper M2	(M2)
	upper M3	(M3)	upper M4	(M4)

After making contact with Zurich, the crew received clearance from radar Lower Sector West to fly from BERSU on a track of 110° direct to RESIA. The crew had requested a cruising altitude of FL 370 in their flight plan. Since the upper limit of sectors West and South (see Annex 1) is limited to FL 245, after coordination with Sector South, who cleared his airspace for transit, the Sector West air traffic controller (ATCO), allowed ECA 923 to climb to FL 240 and handed over the aircraft for its continued climb directly to the radar executive Upper Sector U (RE-U), who was responsible for the next airspace up, from FL 246 – FL 285 (see Annex 2).

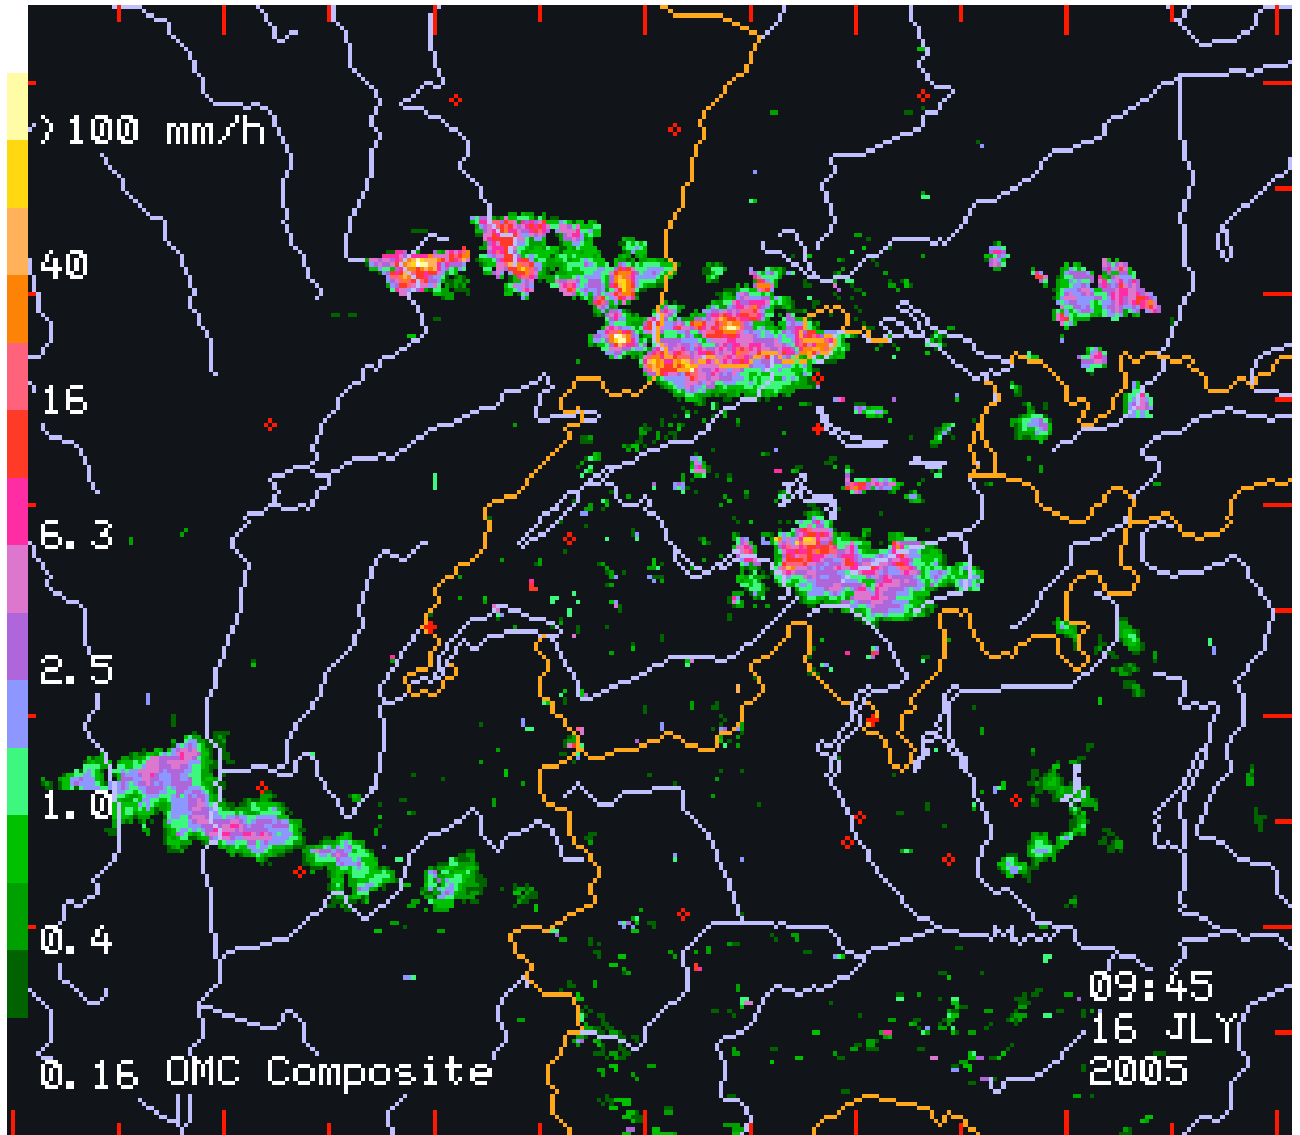
Radar picture on 16.07.2005, 0945 UTC

On the radar display, a line of thunderstorm is visible extending from the Vosges via Basel as far as the Black Forest. In the area of the Alps, the display shows an isolated thunderstorm cell centred in the area of Engelberg (see Annex 3).

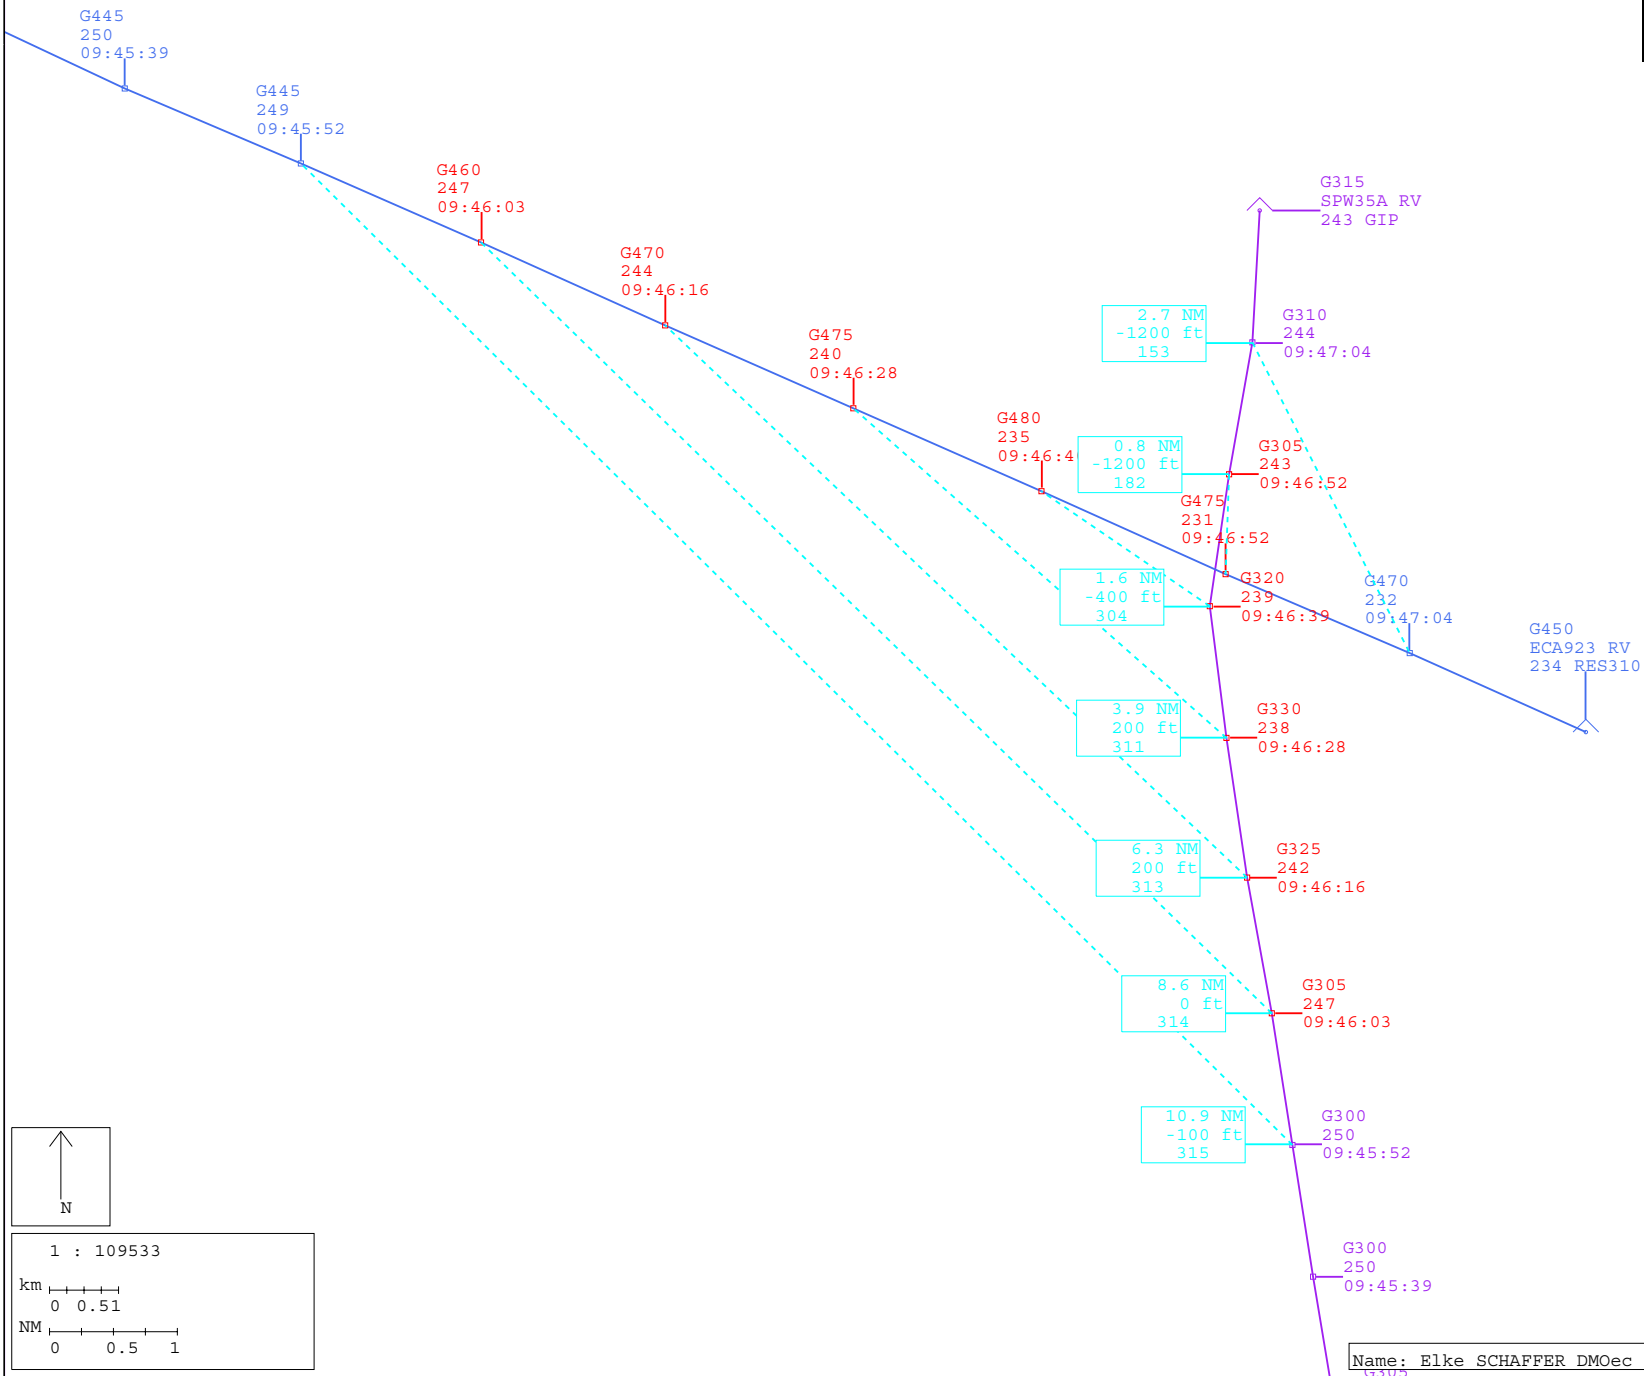
Analysis: SPW35A / ECA923 Time: 16.07.2005 09:47:20

At 09:46:43, SPW 35A crossed the flight path of ECA 923 1 NM in front of it; because of the TCAS manoeuvre, the altitude difference was now 700 ft.
