# **Final Report No. 2229 of the Swiss Accident Investigation Board SAIB**

concerning the serious incident (Airprox)

between the Piaggio P180 Avanti II aircraft, registration  
D-IKSI

and the Cessna C525 aircraft, registration N600HS

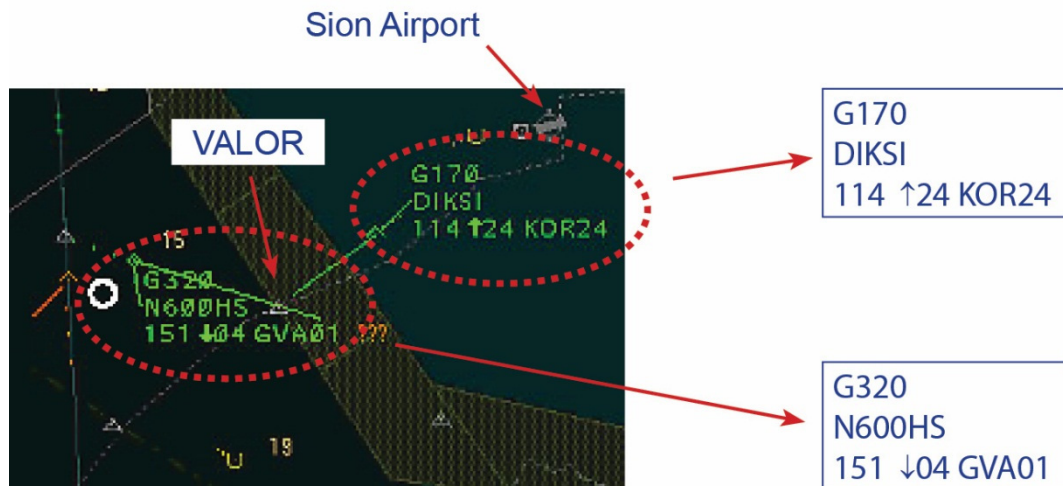
At 10:22:24 UTC, when N600HS was reaching FL 150, the pilot received the following traffic information from the RE controller: « [...] *november six hundred hotel sierra, your traffic take-off Sion, is at your eleven o'clock, twelve nautical, climbing to level one hundred and twenty [...]* ». The pilot replied: « [...] *not in sight yet, we can descend lower if you want, in very good conditions... below 120 [...]* ». The RE controller then asked him if he was ready to cancel his IFR flight plan, to which the pilot replied in the affirmative.

**Figure 3:** Radar image of sector INI SE at the time of the first traffic information transmitted to the pilot of N600HS.

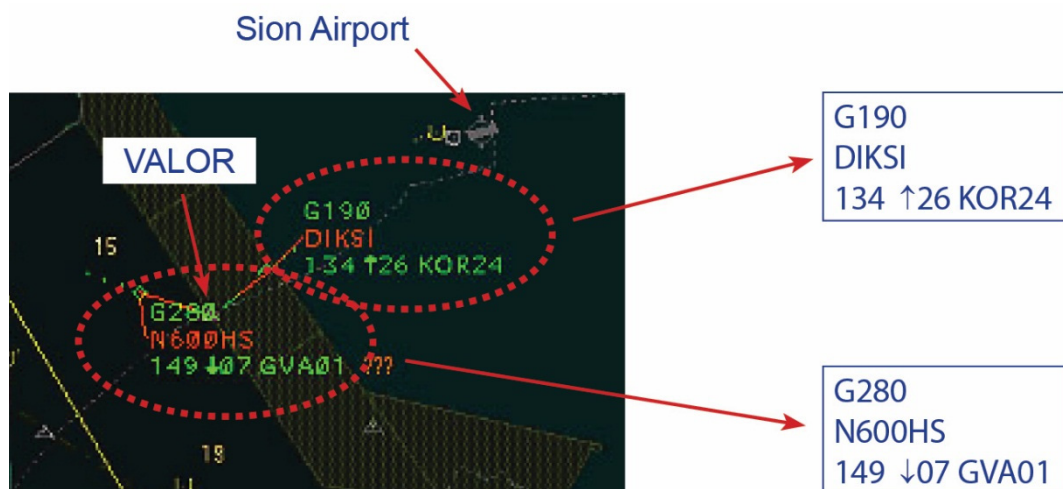
At 10:23:16 UTC, the STCA was triggered on the screens of sector INI SE. The radio callsigns and speed vectors are displayed in red (fig. 4) and a conflict alert window appears (fig. 5). It contains information relevant to the traffic involved. At this moment, N600HS was passing FL 149 in descent and D-IKSI was passing FL 134 in a climb. The distance between the two aircraft was 6.9 NM.

**Figure 4:** Radar image of sector INI SE at the moment the STCA was triggered.

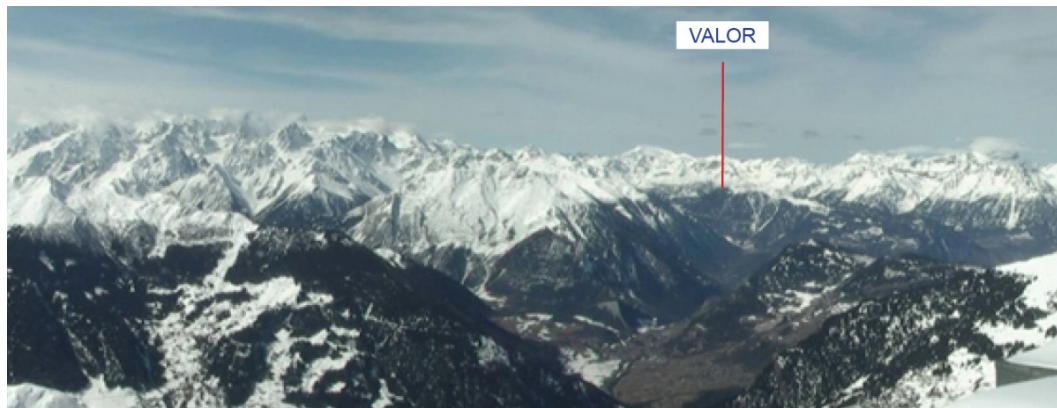
**Figure 6:** Les Attelas (Verbier) webcam, 2700 m AMSL, 22 March 2013, 10:30 UTC, looking west.

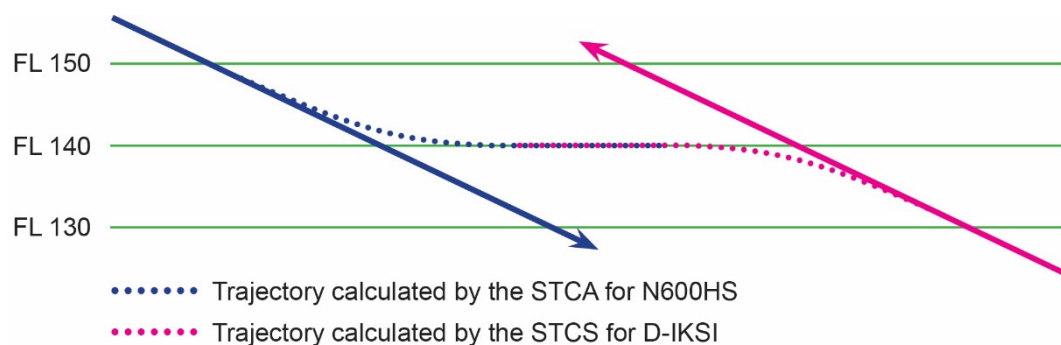
In the airspace in which the serious incident took place, the STCA is set to generate an alert in the event of a predicted convergence at distances less than 4.9 NM in the lateral plane or below 750 ft in the vertical plane. The earliest the alert is generated is 60 seconds before loss of separation. Moreover, if two aircraft are evolving vertically (one climbing and one descending) to the same flight level, the system assumes they will acquire this level (fig. 7). An alert is generated when the aircraft are at a vertical distance less than or equal to 1900 ft and when there is a risk of loss of lateral separation.

**Figure 7:** Operation of the STCA with traffic evolving vertically.
