# **Final Report No 2417**

## **by the Swiss Transportation Safety Investigation Board STSB**

concerning the accident of the helicopter  
Guimbal Cabri G2, HB-ZVK,

on 30 September 2021

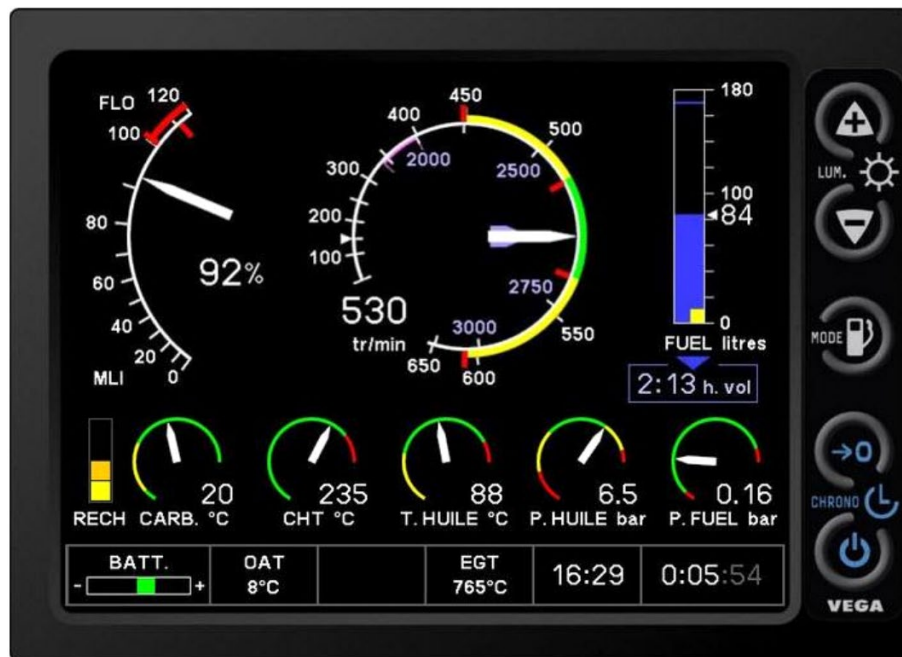
**Figure 3:** Image of the EPM. Source: Hélicoptères Guimbal

HB-ZVK with serial number 1279 was equipped with a data recorder. However, this had stopped recording any parameters around two months before the accident. The helicopter manufacturer is aware of the issue of the data recorder's unreliable performance and is looking for a solution, considering installing a video recording device in the cockpit in the foreseeable future that records various parameters and images of the cockpit and instruments. This kind of system is already being used by other helicopter manufacturers.

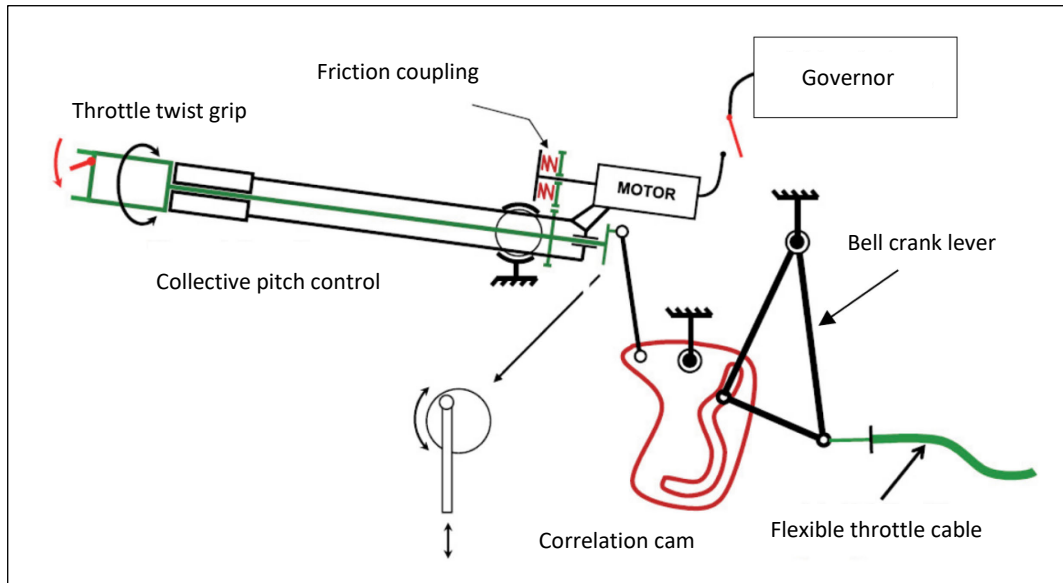
**Figure 4:** Schematic diagram of the throttle control: The electronic engine speed governor is switched on or off by means of a toggle switch at the end of the collective (red switch with arrow, red contact on the speed governor motor). Source: Hélicoptères Guimbal.
