**Final Report
of the Aircraft Accident
Investigation Bureau**

with the helicopter Robinson R 44, F-GPHS

of 2 July 1996

in Chancy/GE

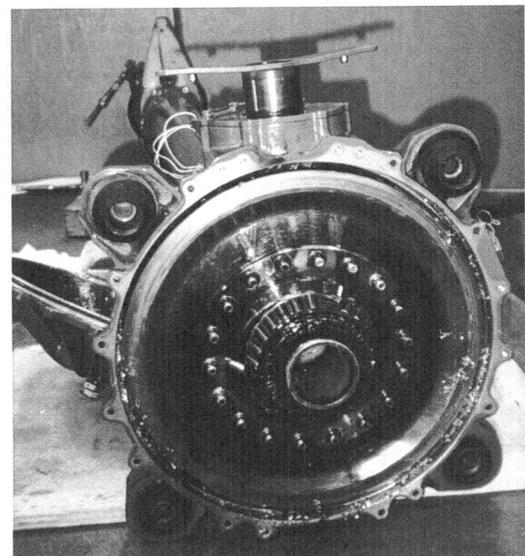
- Removal and partial disassembly of the main gearbox showed metal chips in the sump and a big crack in the gear carrier;

Disassembly showed the 18 NAS6606-2 bolt clamping the C146-3 ring gear and C268-1 gear carrier had loosened in service. Bolt torque in most cases had dropped to 25 to 50 inch lbs. This torque is equivalent to normal self locking nut drag, indicating no clamping between the ring gear carrier. Surface finish measurements of ring gear clamping surface showed 108 to 120 micro inch finish and a distinct phonograph groove appearance 63 micro inch finish is required.

Severe fretting developed around most bolts holes due to the loss of clamping. A fatigue crack progressed from a severely fretted bolt hole, across the flange, and circumferentially around the gear carrier, separating the gear mounting flange from the center section of the gear carrier. This resulted in a loss of positive drive to the main rotor:

The insufficient surface finish of the ring gear clamping caused the 18 bolts (NAS6606-2) to become loose in normal service. The problems continued with severe fretting around the bolt holes and the growth of a fatigue crack on the gear carrier, until it broke off.

Rubbing of the separated ring gear against the inner walls of the aluminium transmission case created the large quantity of chips found in the sump.

Damaged main gearbox
