# Rapport final No. 1806 de la Commission fédérale sur les accidents d'aviation

de l'hélicoptère MD 500N, HB-ZBI

survenu le 27 octobre 1999

à Sion / VS

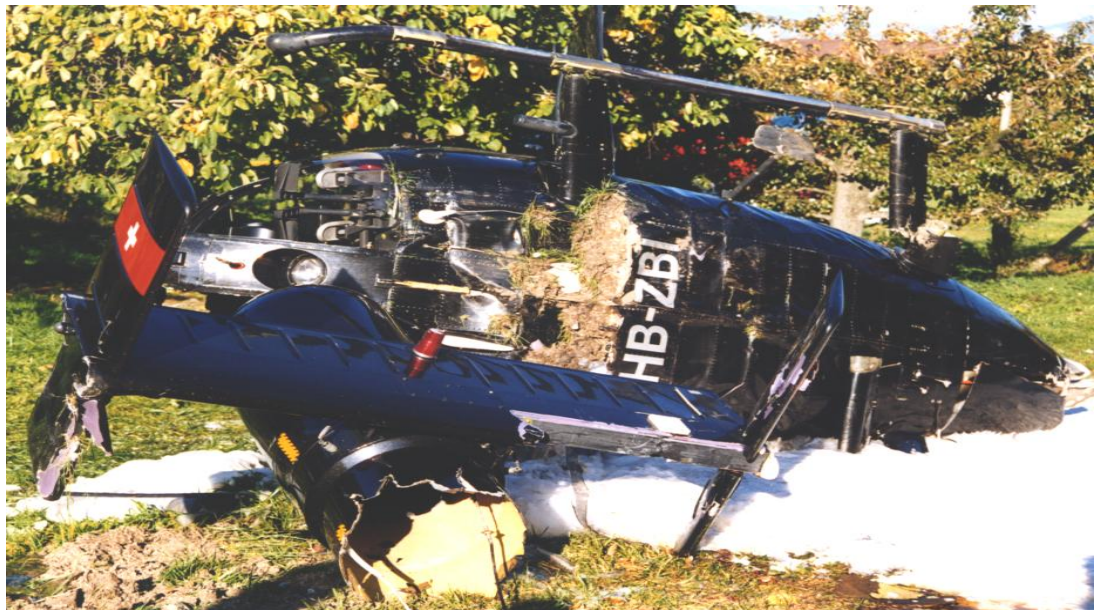
Lors du choc, le train d'atterrissage s'est plié et l'hélicoptère a basculé sur le côté, par-dessus le patin droit. En heurtant le sol, la poutre de queue s'est détachée de la cellule.

Le train d'atterrissage a absorbé une grande partie de l'énergie.

La construction compacte de la cellule a protégé les passagers.
