# Final Report No. 1882 by the Aircraft Accident Investigation Bureau

to the aircraft Piper Cheyenne PA-42, D-IFSH

Cirrus scheduled flight RUS 1050

on 28 October 2003

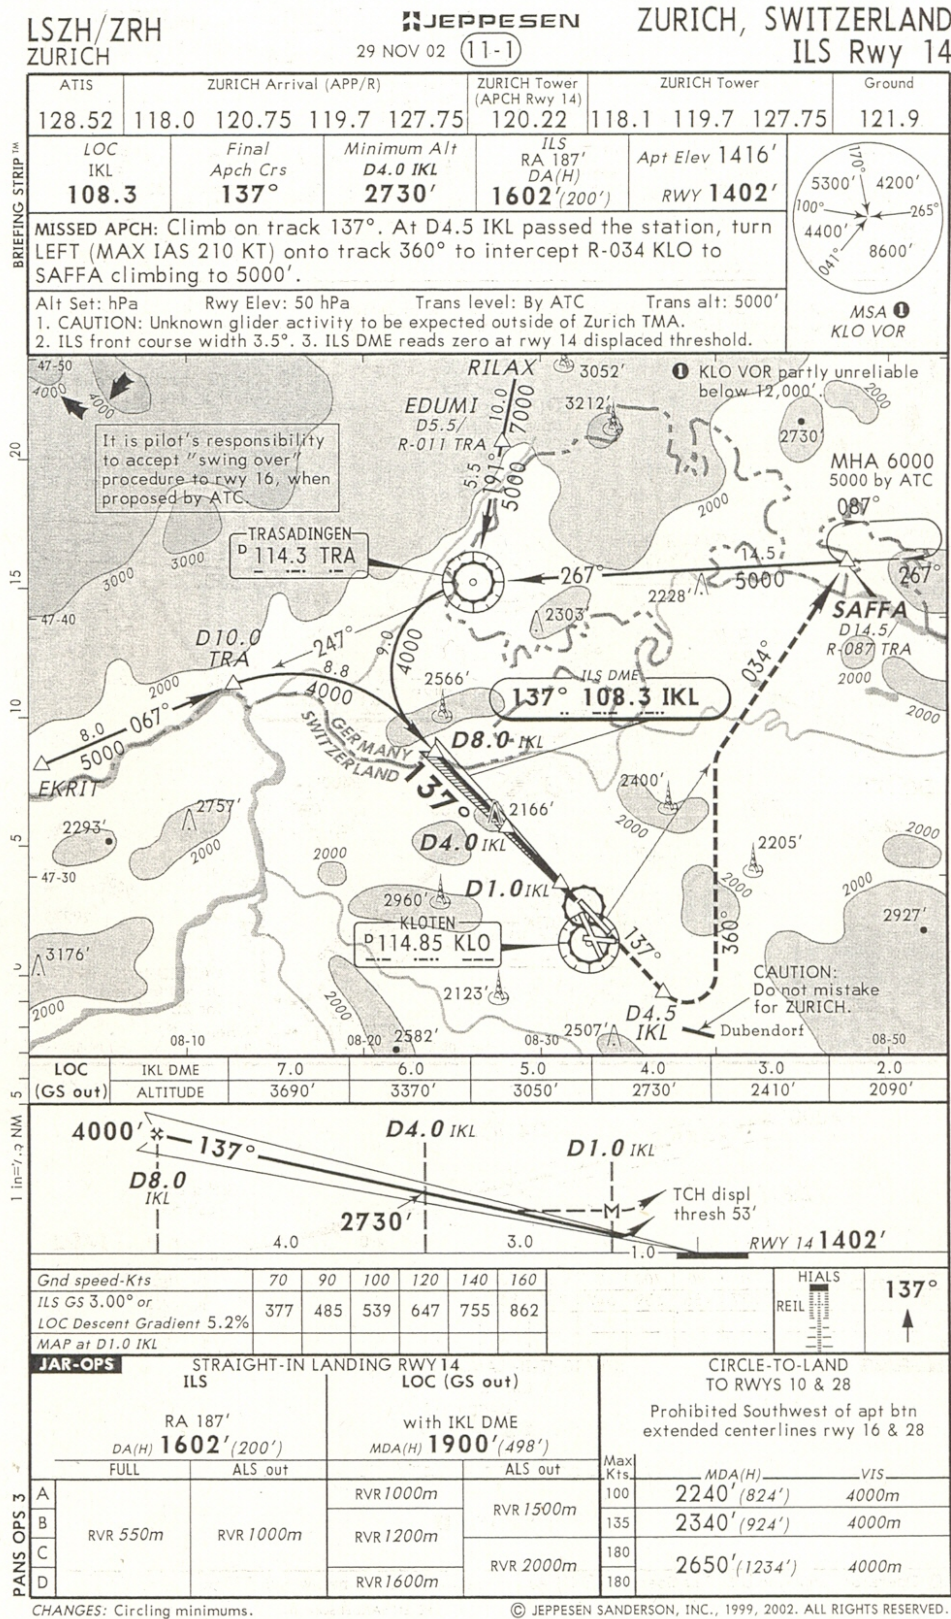
Appendix 4: Approach chart LSZH, Runway 14

- The crew passed below the minimum height for the approach (decision height – DH) of standard ILS approach 14 and continued the approach.
- No attempt was made to prevent continuation of the flight below the decision height.
- The PF also took over radio communications in the final phase of the approach.
- The flight ended at 06:42 UTC next to runway 14 whereupon the aircraft was heavily damaged.
- It was only by chance that the accident was survivable.
