# **Final Report No. 1909**

**concerning the accident**

of the aircraft Pilatus PC-21, HB-HZB, Prototype P02

on 13 January 2005

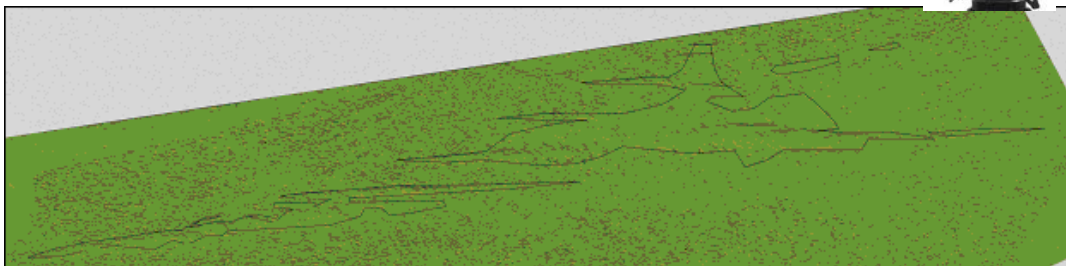
The primary trace of the impact was recorded in three dimensions with a high resolution **3D laser scanner**. The points measured by the scanner were polygonised and converted into a 3D surface, in which the smallest gouges caused by the impact are precisely recognisable.

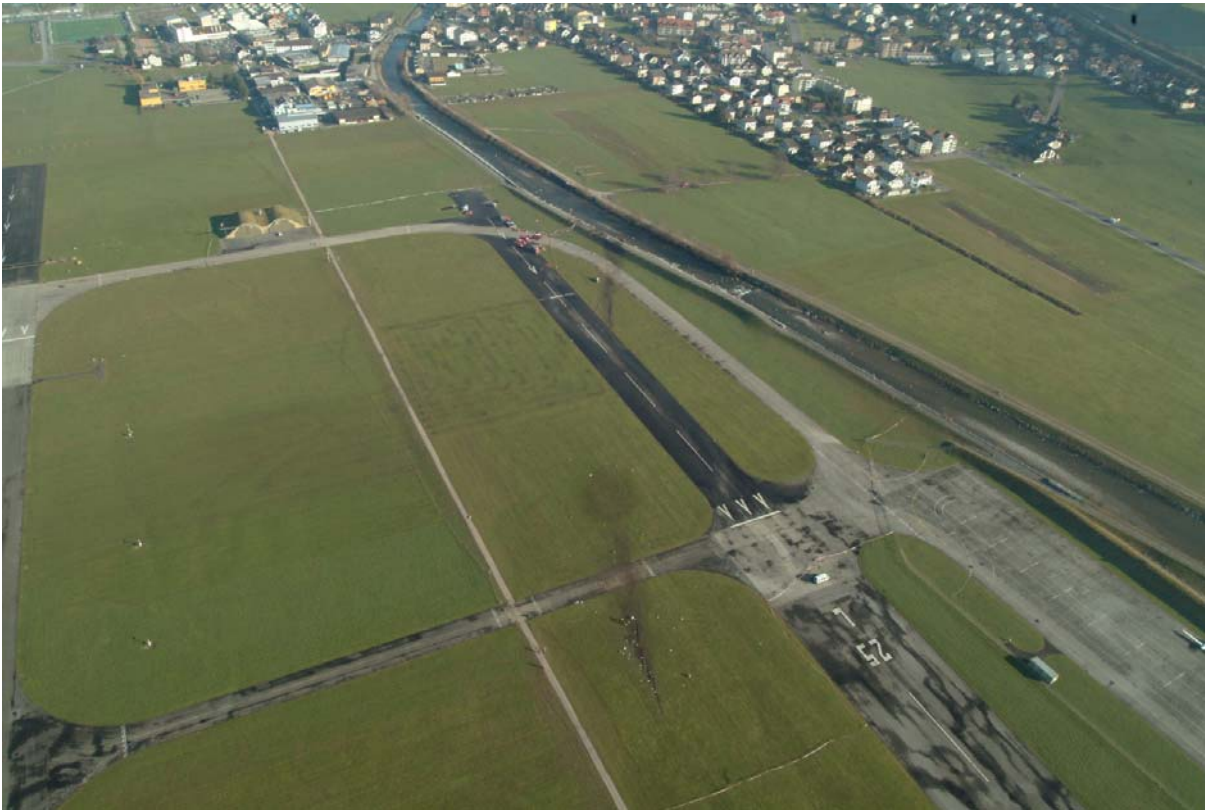
Overview in direction east

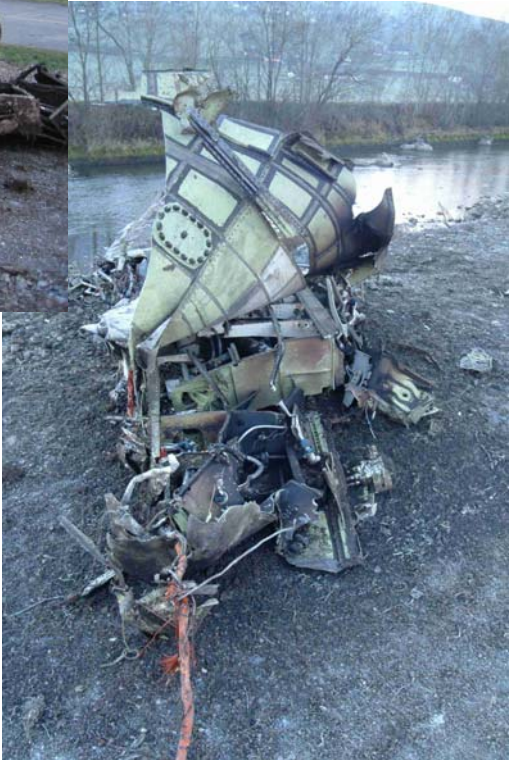
Skin of left wing on the board of the *Engelberger Aa*

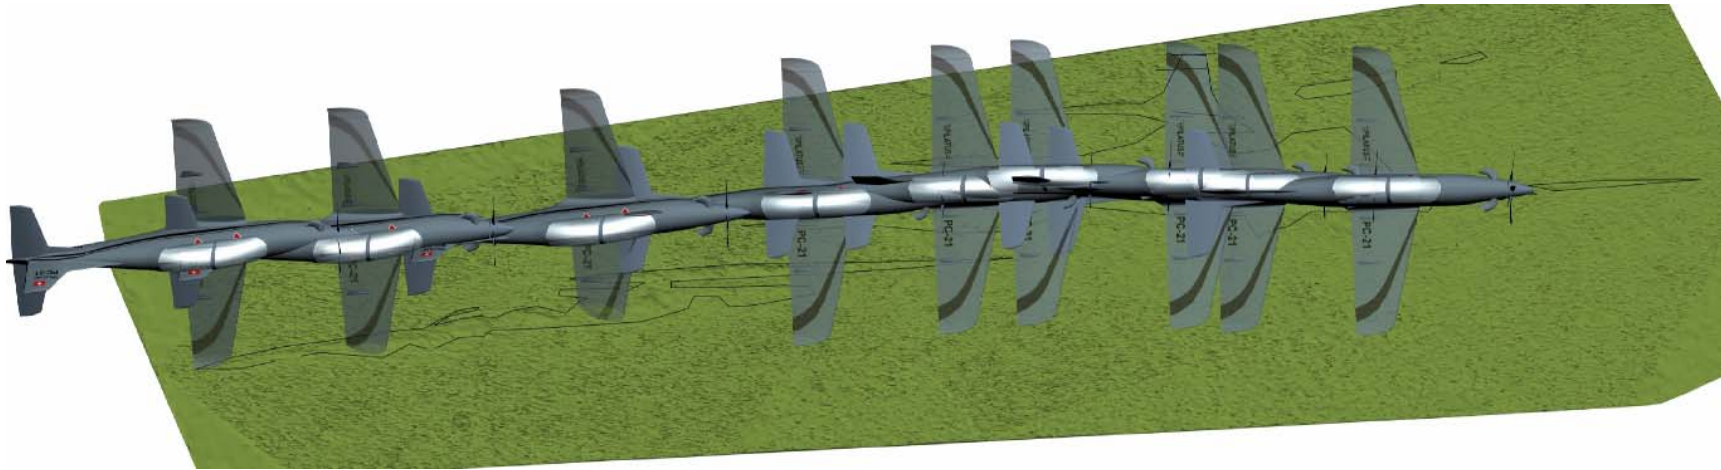
The reproductions below show a plan view and a lateral view of the positions of aircraft P02 from the point of initial impact until leaving the ground anew in the area of the first point of impact.
