Final Report No. 1925 by the Aircraft Accident Investigation Bureau

concerning the serious incident
to the aircraft AVRO 146-RJ100, HB-IXQ,
operated by Swiss European Air Lines
under flight number LX 778
on 5 December 2005
at Zurich-Kloten Airport

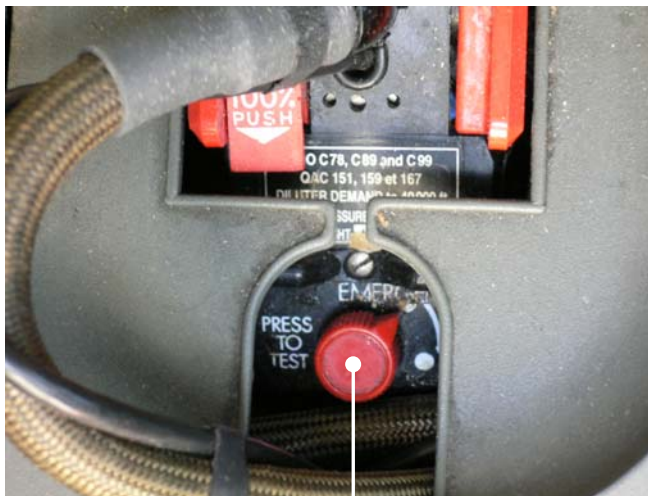
View A

If the Mask EMERGENCY pressure knob is in the emergency position, there is a continuous flow of oxygen as soon as the mask is taken out of its box. The same effect occurs if, with the mask donned, the Mask EMERGENCY pressure knob is rotated to the emergency position. On the one hand, the continuous oxygen flow means that the available oxygen is used up more quickly. On the other hand, the continuous oxygen flow has the advantage that in extreme smoke conditions penetration of smoke to the inside of the mask through points which are not air-tight is prevented.

Individual pilots stated that in the oxygen mask test they had detected a continuous oxygen flow immediately after pressing the PRESS TO TEST AND RESET slide, without having operated the Mask EMERGENCY pressure knob. One possible explanation is that according to their statements some pilots rotate the Mask EMERGENCY pressure knob to the emergency position before a flight. They justify this by saying that in simulator exercises with smoke in the cockpit they had to clear the mask of smoke and they found the necessary manipulation of the Mask EMERGENCY pressure knob to be very awkward.

Mask EMERGENCY pressure knob
