Final Report No. 1928 by the Aircraft Accident Investigation Bureau

to the Bell 407 Helicopter, HB-ZBA

on 2 September 2004

Steinweid-Gross Band, Bisistal, municipality of Muotathal/SZ

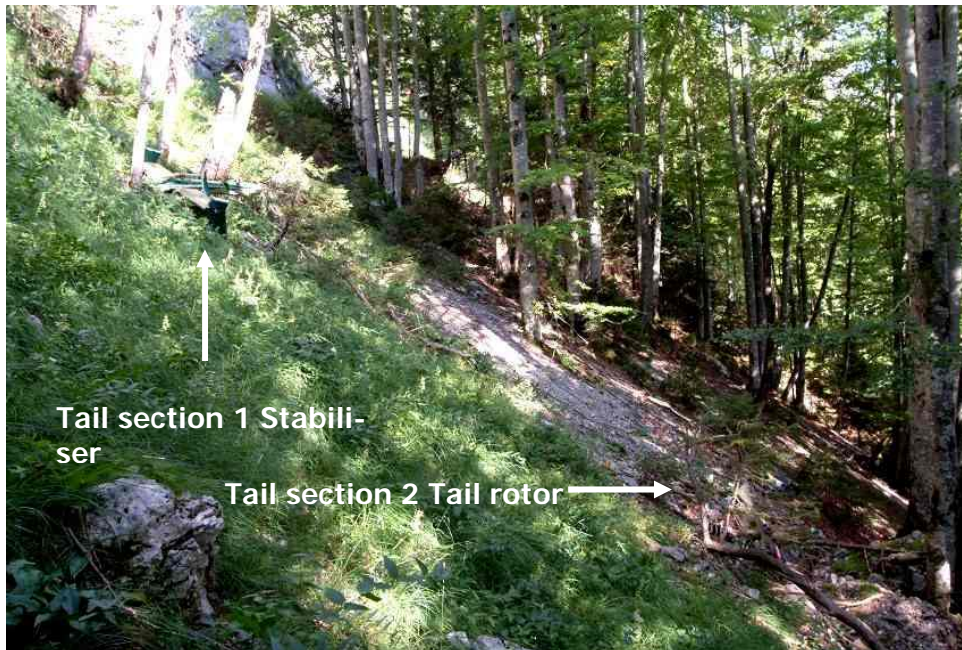
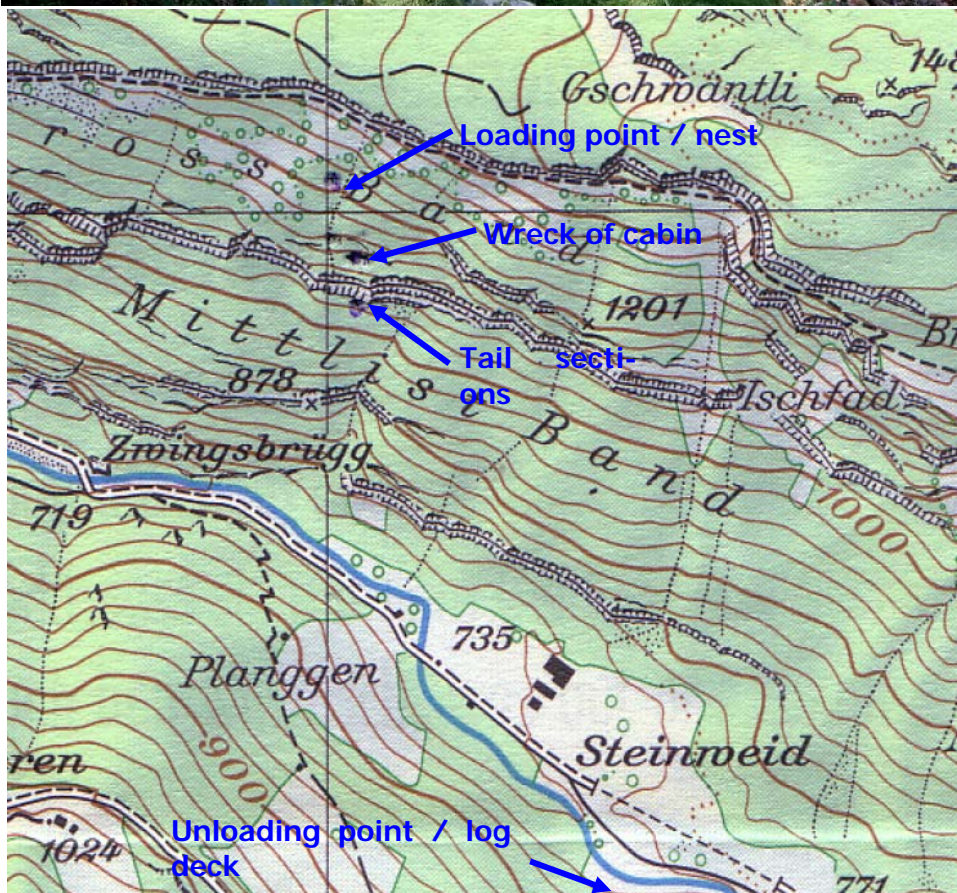
The terrain was searched for parts of the wreckage in the downward direction from the loading area to the final position of the helicopter over a width of about 120 m and, in the area of the large parts of the tail, over a circumference of 150 m. The first small parts, approximately 1 cm² in size, could be found at a distance of about 100 m from the final position of the helicopter and some 60 m above it. These were located above a band of rock about 20 m high. Other small parts were in the band of rock and also underneath it. All parts were lying in the downward direction over a width of about 40 m. The small parts which were found all came from the area of the tail panels and the auxiliary vertical fins.

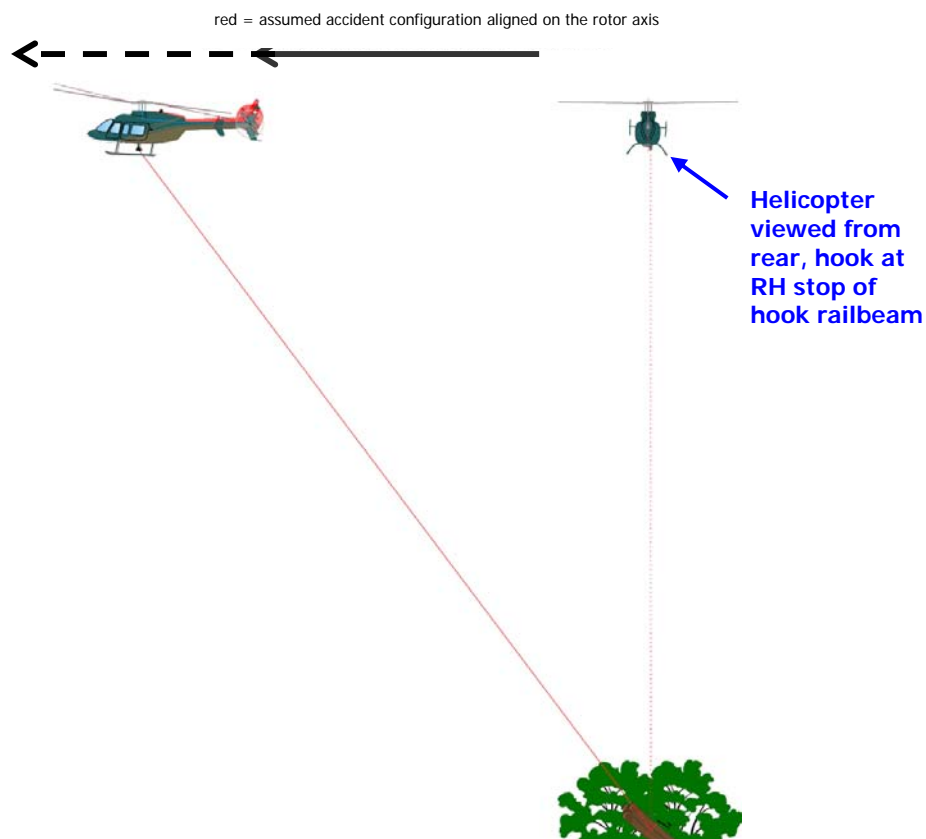
As in the case of this underslung cargo flight under investigation, the force of an entangled longline would act through the cargo hook in the direction of flight and offset to the centre of the rotor, resulting in a nose-down pitching moment. In the absence of corrective control inputs the resulting flight path of the helicopter would be an accelerated motion towards a vertical trajectory to the ground, along an arc with the length of the long line as the radius. The magnitude of this moment depends on the horizontal speed. The pilot reacted to this pitching moment by instinctively attempting to maintain the horizontal attitude of the helicopter by applying the necessary control inputs. Consequently the rotor disk tilted aft. In addition he manoeuvred the helicopter backwards. According to the pilot's statements, he was under the impression that he had freed the load and wanted to quickly initiate the descent. However, as the airframe movement was most likely still restricted by the load, the distance between the main rotor and the tail decreased below minimum separation.

From the ground, abrupt load changes were observed and these were clearly perceived by the pilot in the cockpit as hard shocks. The healthy and strong beech branches which were found, broken off by the suspended load, indicate instantaneous large forces as described above. In addition, when the break-away occurred, there was a brief and extreme load change with effects, among other things, on the individual rotor blades, the ends of which underwent major vertical oscillatory deflections.

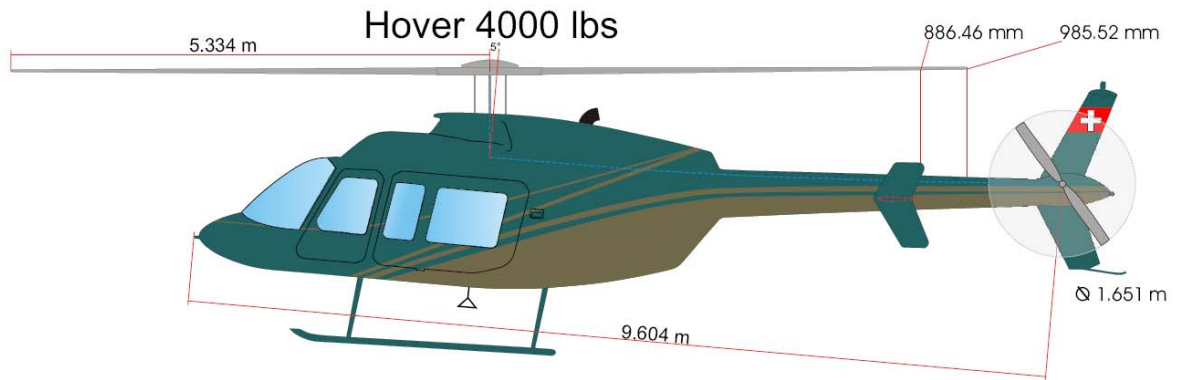
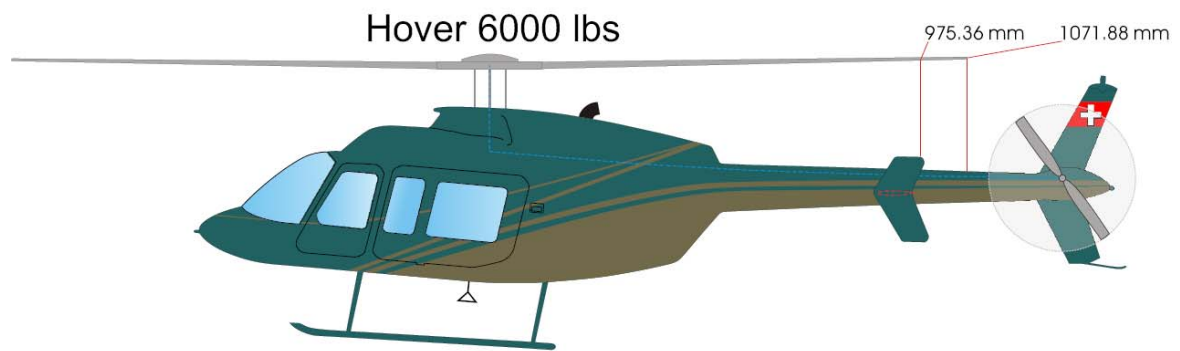
Blade clearance over tailboom

The "blade clearance over tailboom" in the annex, for two weights particularly relevant for cargo flights, indicates the small residual clearance between the main rotor plane and the area of the tailboom concerned as long as the centre of gravity is within the permissible limits.
