Final Report No. 1950 by the Federal Aircraft Accident Board

to the Boeing 737-33V aircraft, registration HB-III

of the EasyJet company, flight EZS 903

on 15 August 2003

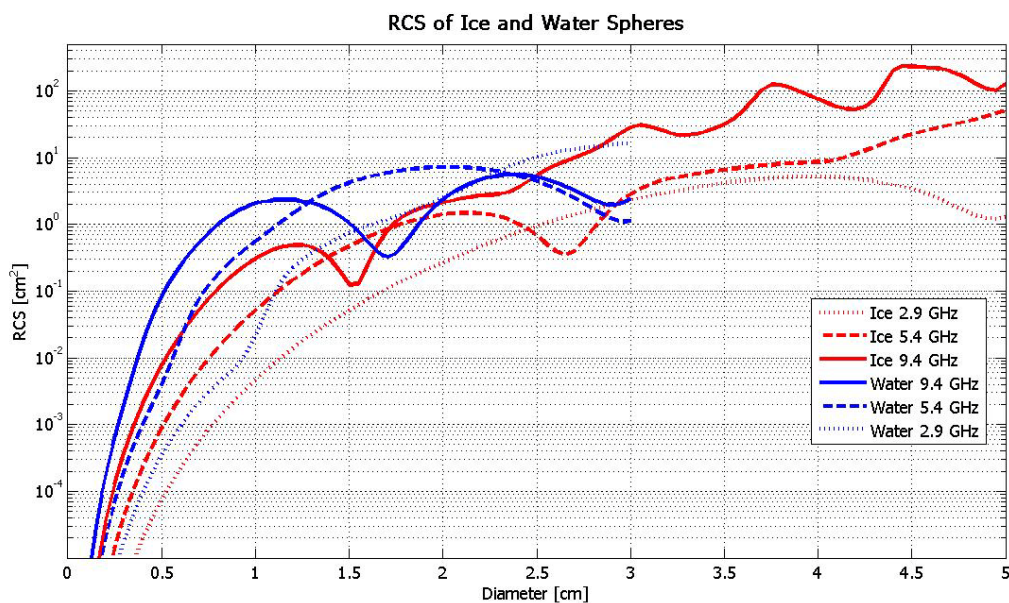
Fig. 3 RCS of water droplets and hailstones as a function of diameter, calculated using the Mie formulae for different radar frequencies

For the special case of diameters smaller than 1 cm, the RCS increases with frequency: reflection is greatest for an onboard radar (9.4 GHz); it reduces for ground-based weather radar (5.4 GHz) and is lowest for ATC radar (2.8 GHz).

The table also reveals that the RCS is higher for raindrops than for hailstones of the same size. However, hailstones may attain greater dimensions than raindrops and their reflectivity is therefore also increased.

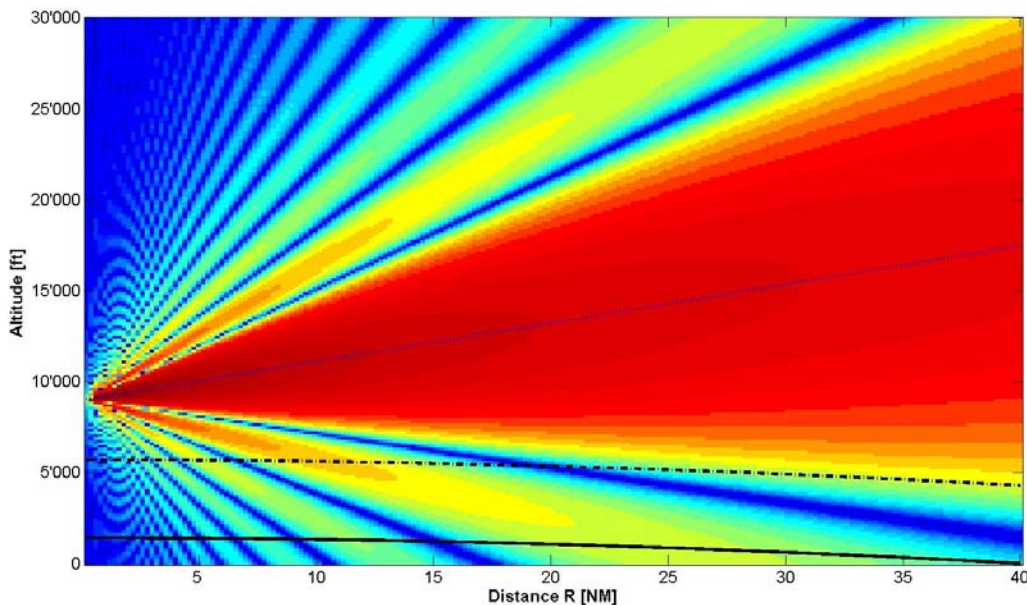
Fig. 5 Sensitivity diagram of the onboard radar for an aircraft flying at 9000 ft and a *tilt* setting of +2°

Outside this part of the beam, the energy decreases rapidly and reaches a minimum at just over twice the -3 dB angle, which corresponds to the sensitive angle of the pencil beam of 6.6°. This is why it is essential to ensure that the angle of the sweep plane in relation to the horizon is correctly adjusted using the *tilt* control, in order to avoid the detection of clutter.

The radar equation applied to a weather target which is completely within the beam emitted by the antenna shows that the sensitivity of the radar is proportional to the square of the antenna gain and inversely proportional to the square of the distance to the object (G^2/R^2). In figure 5, showing the sensitivity diagram of the onboard radar for an aircraft flying at 9000 ft and a *tilt* setting of +2°, this sensitivity is represented using a logarithmic scale of colour intensities, in which red is assigned to the highest value and blue to the lowest. The dotted line is the
