Final Report No. 1973 by the Aircraft Accident Investigation Bureau

concerning the serious incident
to the Embraer 145LR aircraft, HB-JAD
operated by Crossair under flight number LX 500
on 24 December 2001
at Basle Airport

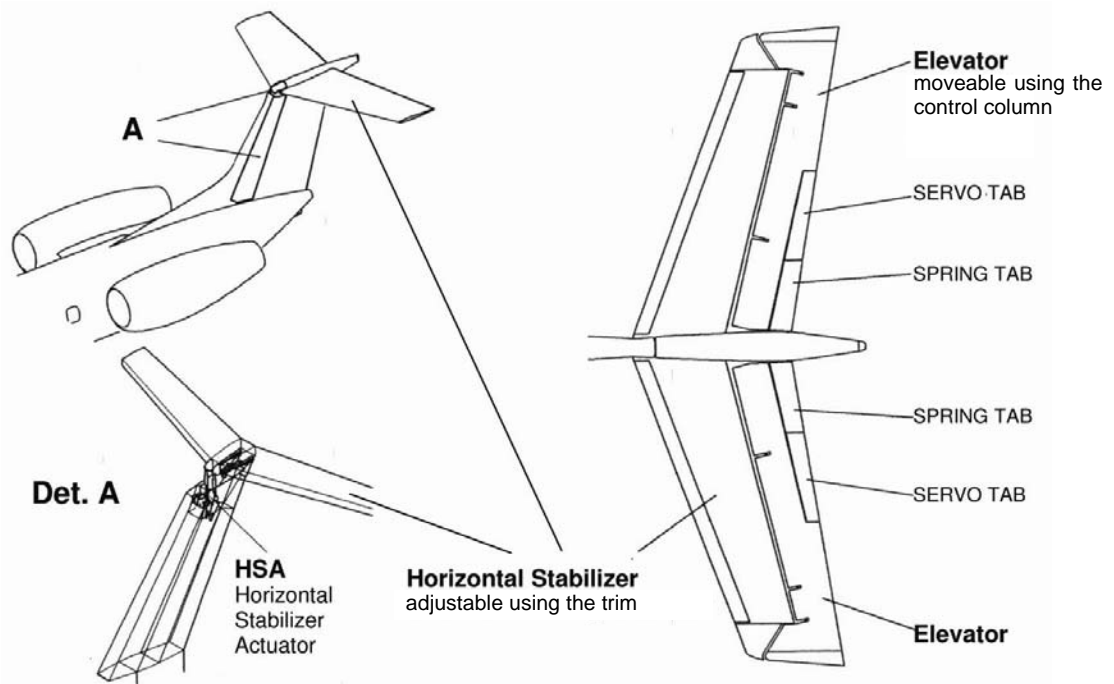
1.6.2 Horizontal stabilizer

Movement of the horizontal stabilizer is performed by means of the Horizontal Stabilizer Actuator – HSA. This in turn is controlled by the Horizontal Stabilizer Control Unit – HSCU. The HSCU has two channels, in order to ensure the primary and backup operating modes (see Annex 1).

In primary operating mode, the HSCU controls HSA motor M1 and in back-up operating mode it controls HSA motor M2. Both are identical electric motors.

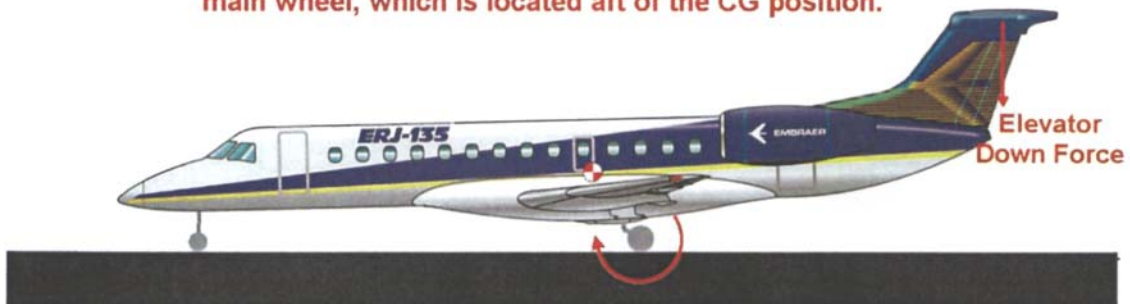
Rotation Technique

During rotation on ground the airplane rotates around the main wheel, which is located aft of the CG position.

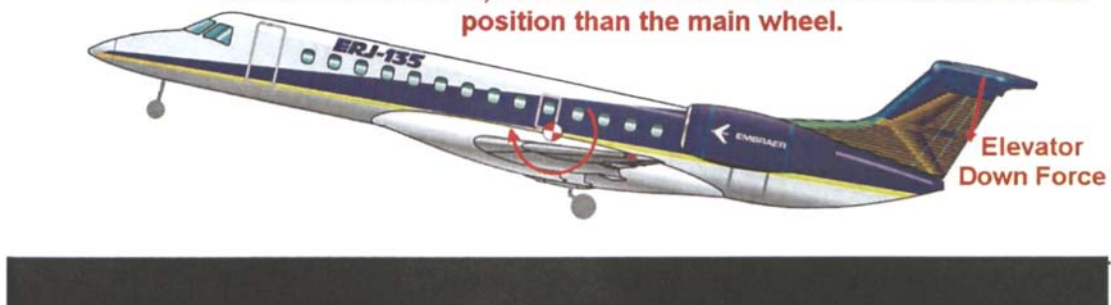
Once airborne the airplane rotates around the CG, which requires less elevator down force, as the CG is located in a much more forward position than the main wheel.
