Final Report No. 1987

Federal Aircraft Accident Board

to the aircraft model VAN'S RV-9, HB-YML

on 10 October 2007

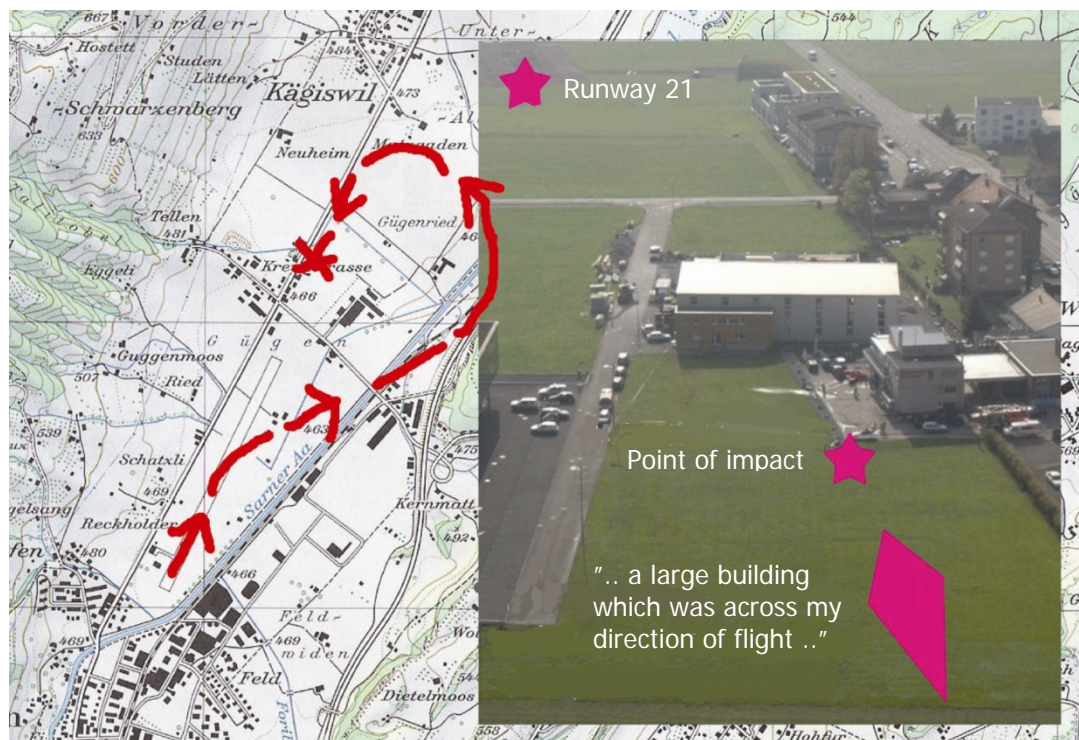
The aircraft collided with the terrain approximately 75 m in front of the large building. At a speed which was still considerably above landing speed, the aircraft crashed into several parked cars and a garage building; in the process the landing gear, wingtips and tail were torn off. Fire did not break out, even though a large quantity of fuel leaked out.

Fig. 1: Approximate flight path, view of runway 21 and point of impact

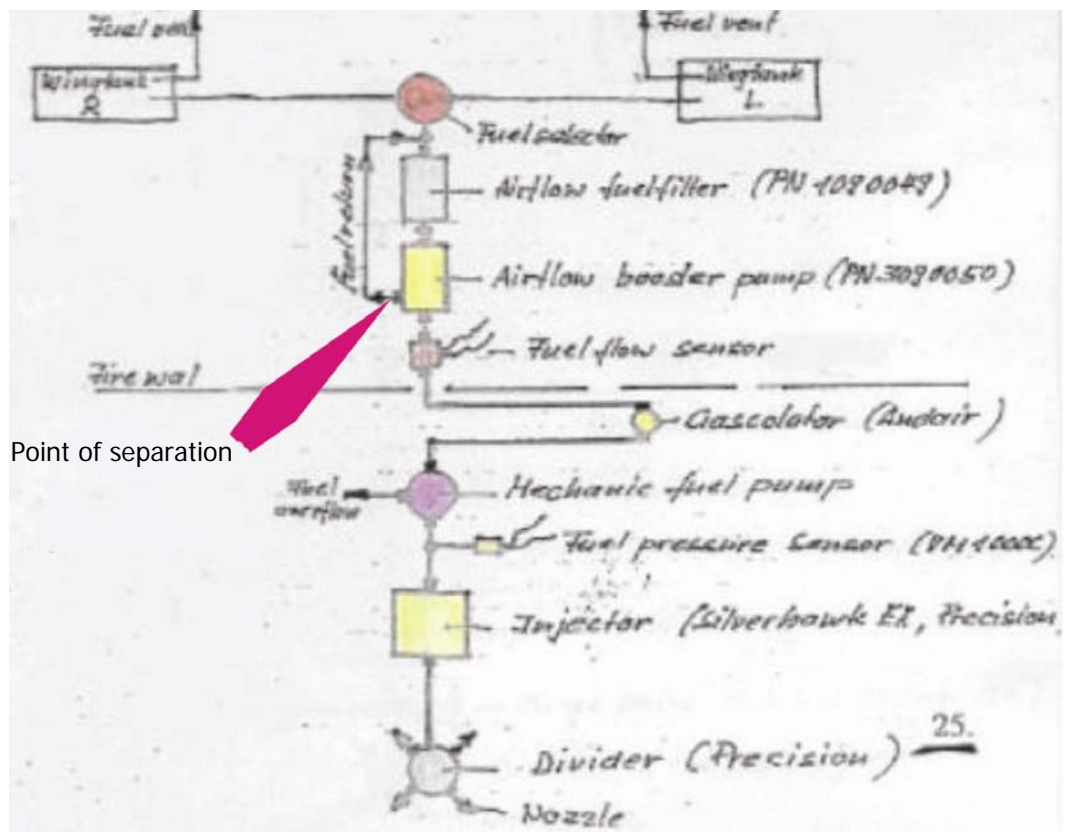
Once the only slightly damaged casing had been opened, it was found that the booster pump return line to the fuel selector was separated.

Fig. 4: Diagram of fuel system according to AFM HB-YML

No traces of an external violent force could be found either on the fuel selector casing or on the separated line.

The results of a leak in the return line from the booster pump to the fuel selector were investigated by performing static test runs on a comparison engine with the booster pump switched on. Depending on the magnitude of the simulated leak, the engine shut down after 10 seconds to 3 minutes. The engine stoppage was in each case preceded by a reduction in rpm, with pronounced fluctuations in speed. The test during which the engine shut down after 3 minutes was one with a small simulated leak. At full power, the reduction in speed before shutting down was approximately 600 rpm, accompanied by heavy vibrations. The time from the reduction in speed to the engine shut down was about 15 seconds.
