Final Report No. 1995 by the Aircraft Accident Investigation Bureau

to the Kamov KA-32A12 helicopter, registration HB-XKE

on 26 March 2002

“Ufem Schoren” municipality of Neuenegg/BE

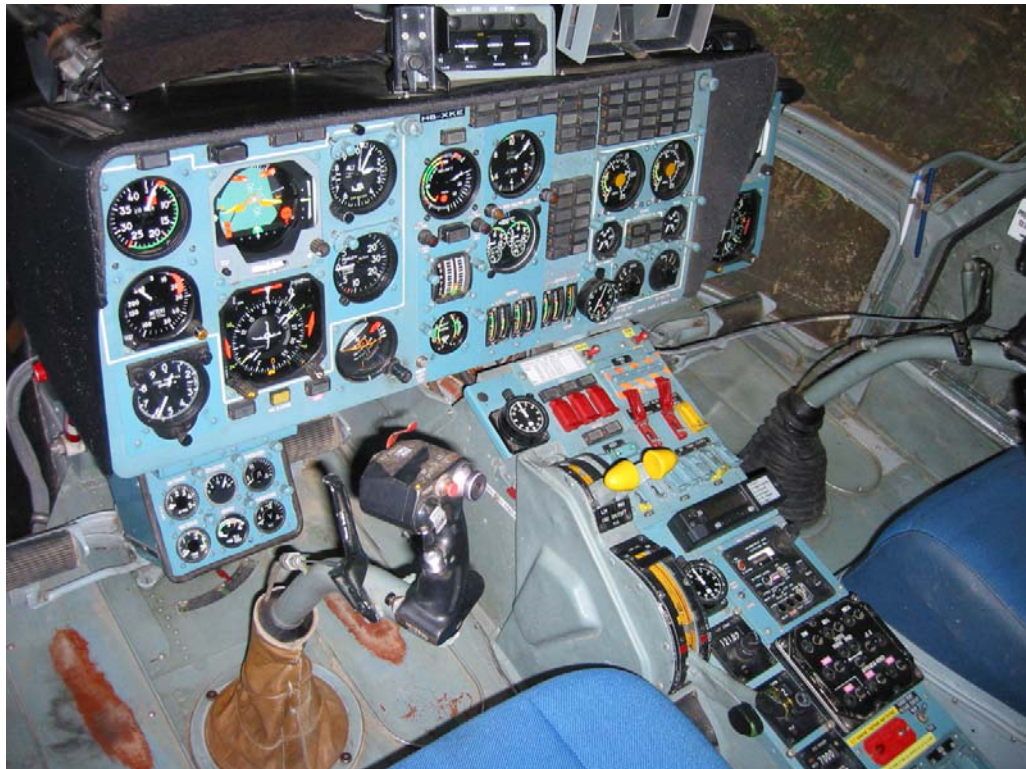
Helicopter HB-XKE has conventional cockpit equipment. The instruments display metric scales. On the right-hand side of the instrument panel there is a panel of warning lamps (annunciator panel), which is coupled with an audio warning system. The light blue colour of the panels is distinctive. The left seat is for the pilot flying. The dual controls were installed on the right-hand side.

Fig. 1: Cockpit Layout – Instrument panel and upper part of the centre console

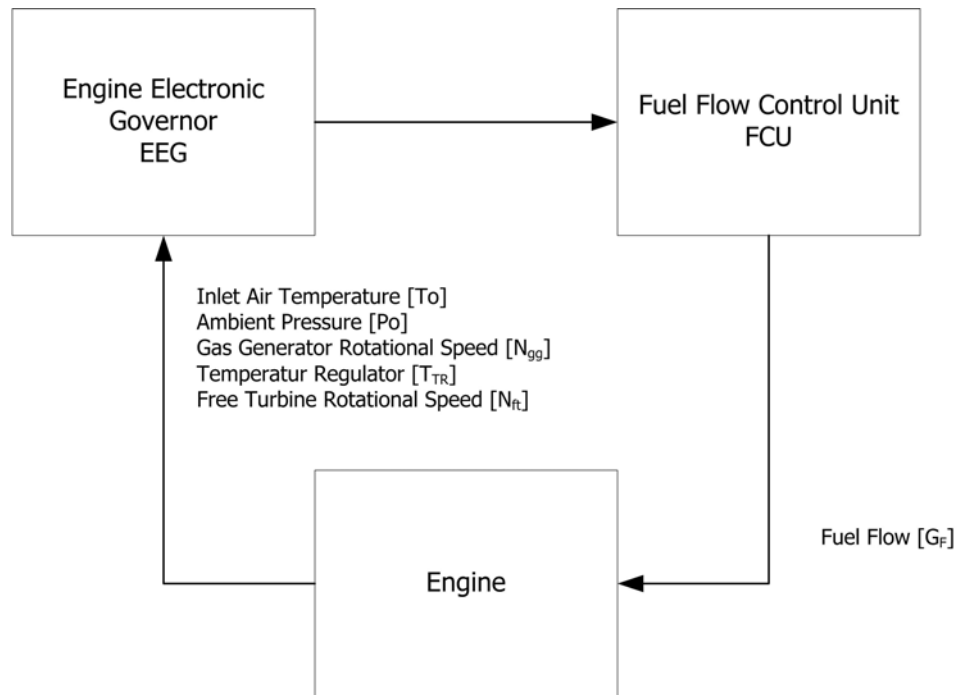
The two engines are each fitted with a speed regulation system. This system consists of a hydromechanical controller (fuel flow control unit – FCU) and an electronic regulator (engine electronic governor – EEG). This unit is designated the engine power conditioning limiting system. Its function is described as follows in the engine maintenance manual:

Fig. 2: Block diagram of an engine conditioning limiting system

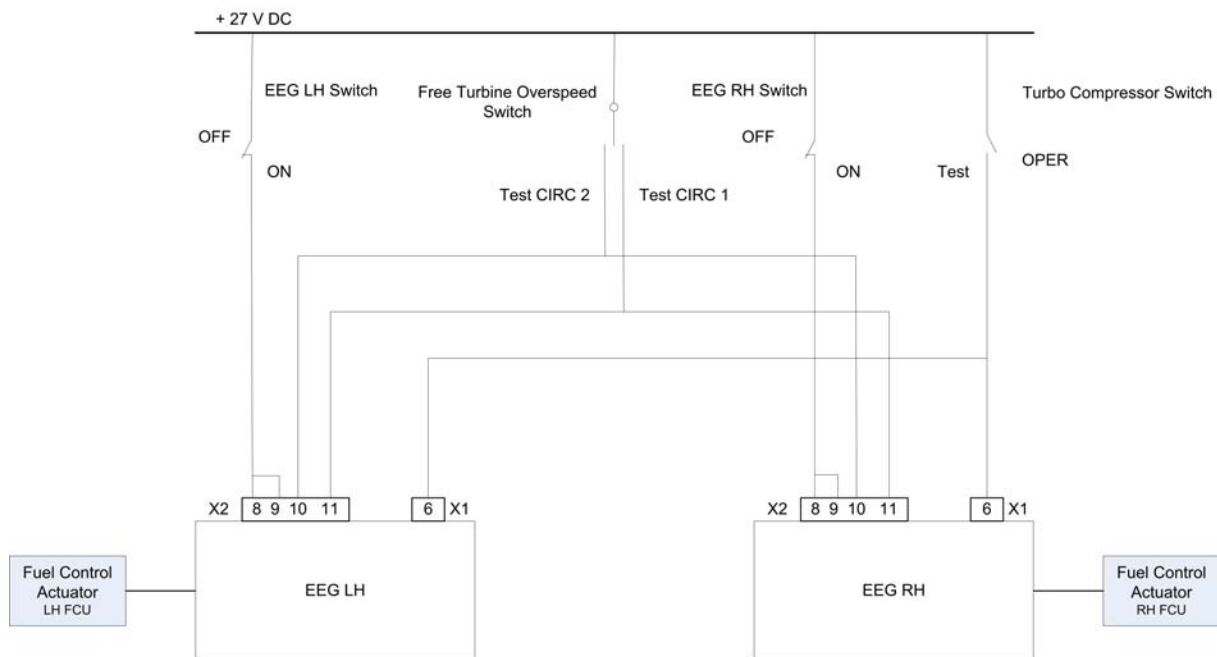
The two engines each have an FCU and an EEG. The free turbine overspeed test switch acts simultaneously on both EEGs.

A simplified electrical schematic of installation of the two EEGs in helicopter HB-XKE is given below:
