# **Final Report No. 2072**

concerning the accident  
to the Kaman K-1200 helicopter K-MAX, registration HB-XQA  
on 11 October 2004  
"Petit Truyo", Grandvillard/FR  
approx. 30 km south of Fribourg

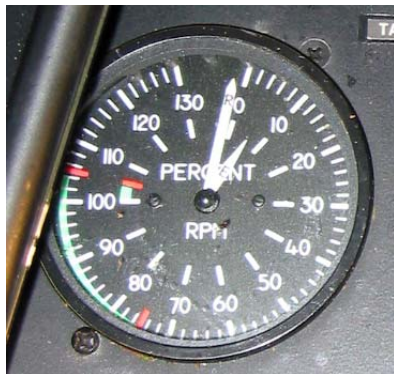
Figure 7: The large pointer with the "R" marking indicates rotor speed and the one with the "E" marking indicates engine speed. The indication is in percent of nominal speeds.

He heard the low RPM horn warning, which signals a rotor speed which is too low.

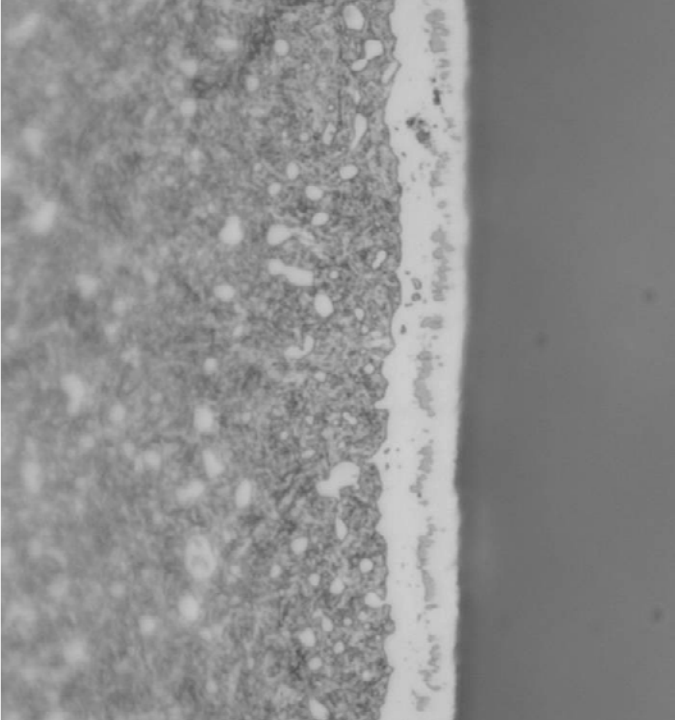
<p>Figure H</p> <p>Component K974110-003, S/N 093</p> <p>Event HB-XQA</p> <p>Peripheral zone of chromium carbides (white)</p> <p>Etching: 1.5% alcoholic nitric acid</p>

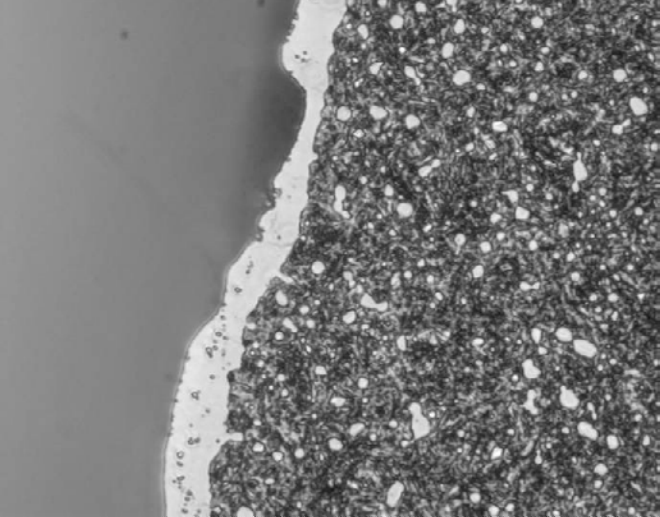
<p>Figure I</p> <p>Component K974110-003, S/N 227</p> <p>Reference part, new</p> <p>Peripheral zone of chromium carbide (white)</p> <p>Etching: 1.5% alcoholic nitric acid</p>

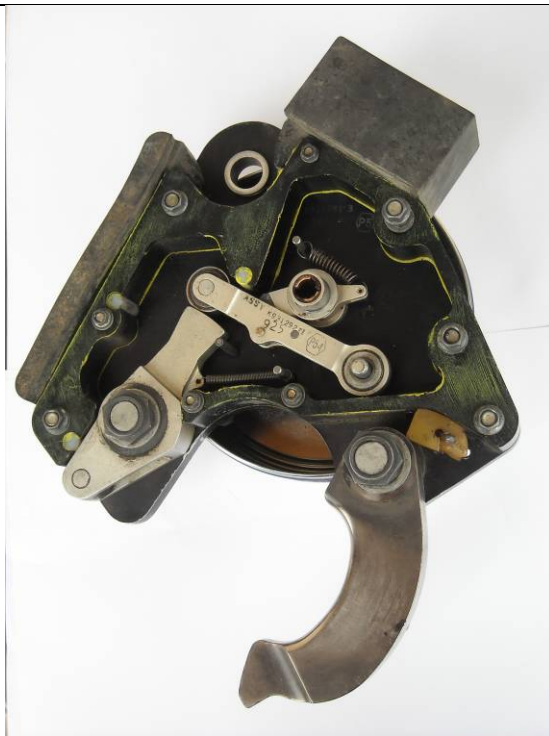
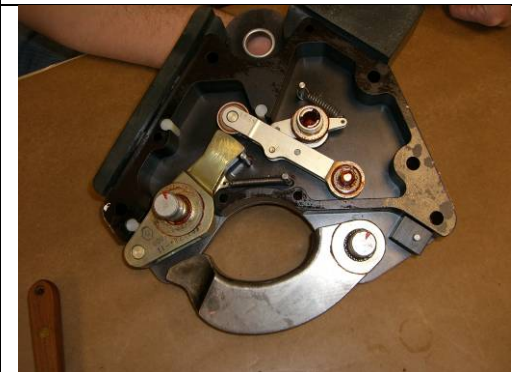
Figure P top

Indications of friction and wear

Event HB-XQA

Undamaged cargo hook from the manufacturer
