Final Report No. 2090

by the German Federal Bureau of Aircraft Accident Investigation

involving the Saab Aircraft AB/Saab 2000, registration HB-IZY

on 10 July 2002

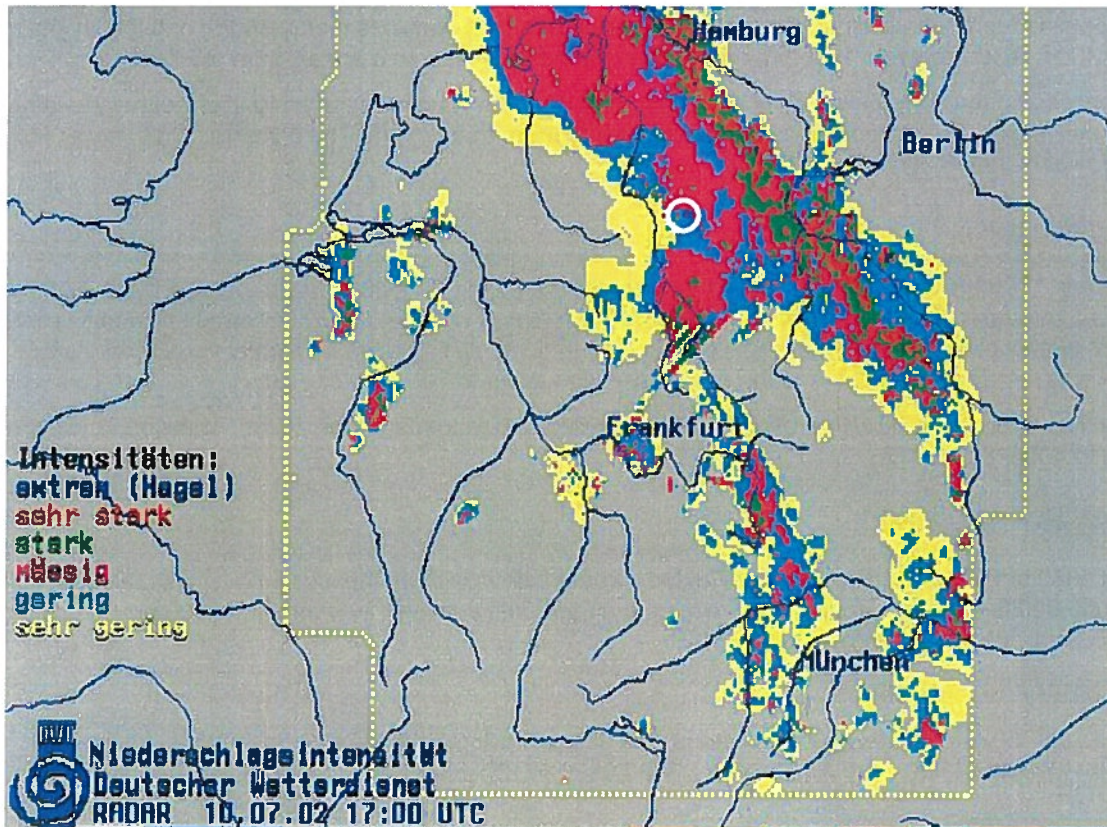
The radar image from 1900 hrs shows the position of the thunderstorm frontal system when the aircraft was radar vectored to a heading of 060° and the aircraft's position at this time.

Radar image showing intensity of precipitation and the aircraft position at 17:00 UTC (1900 hrs local)

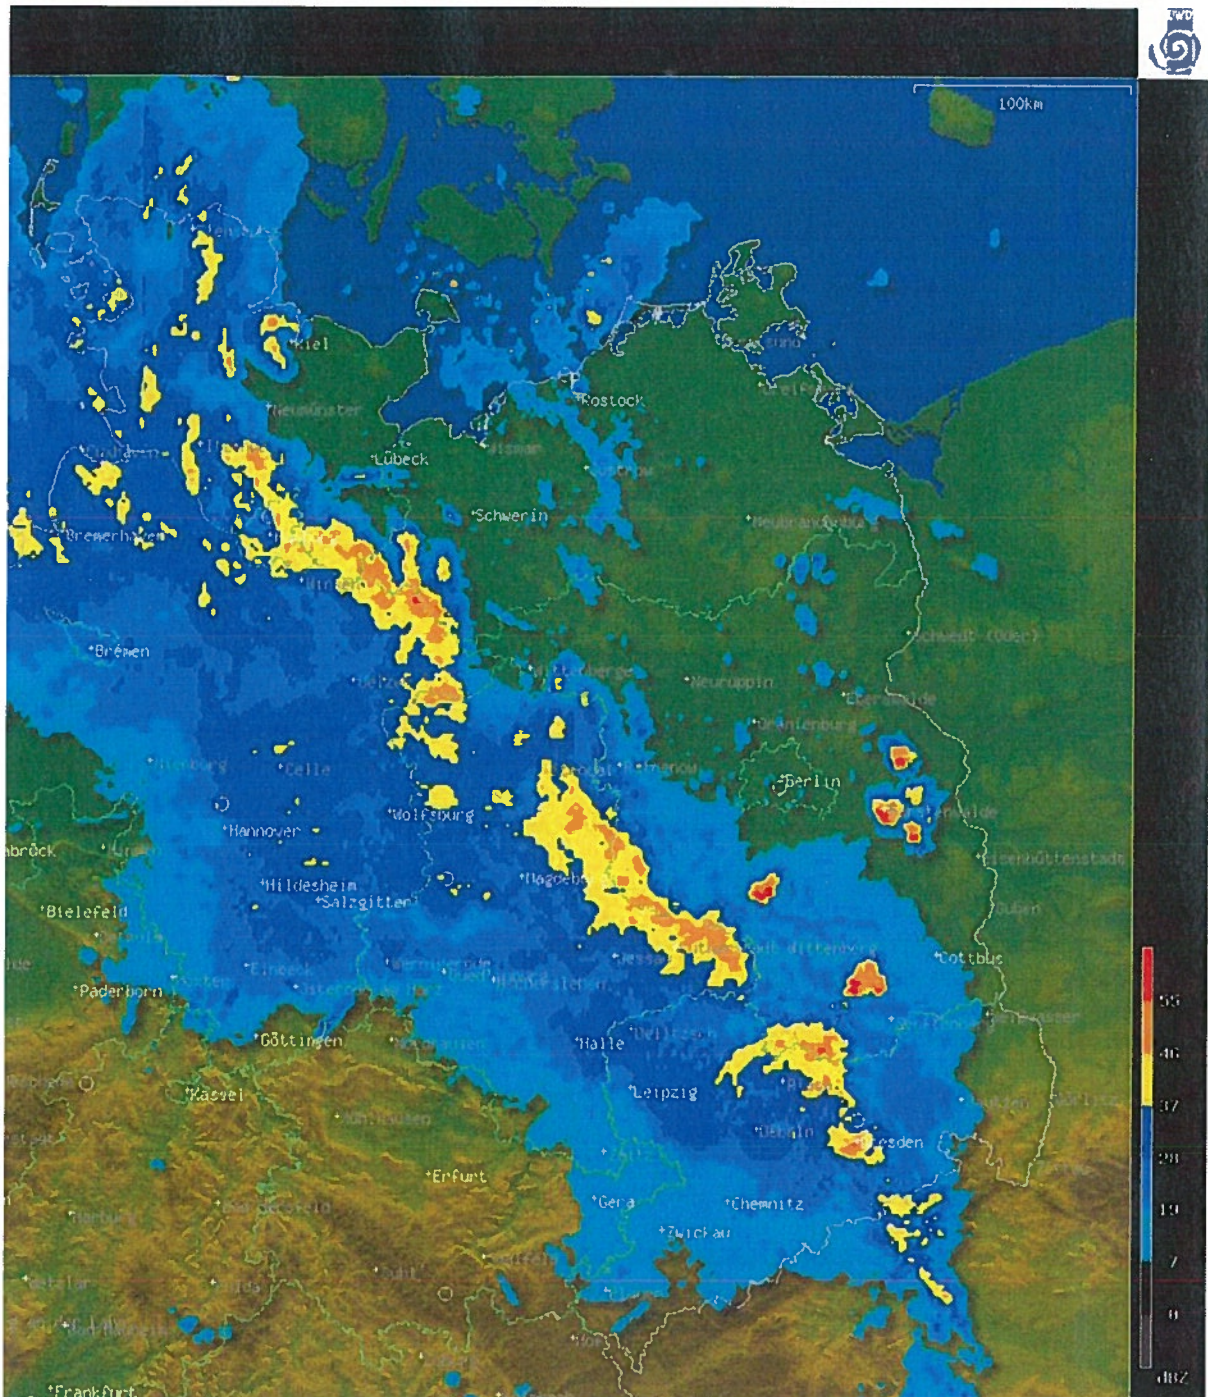
Extract from the weather radar picture taken at 17:43 UTC (1943 hrs local), precipitation intensity (dBZ)

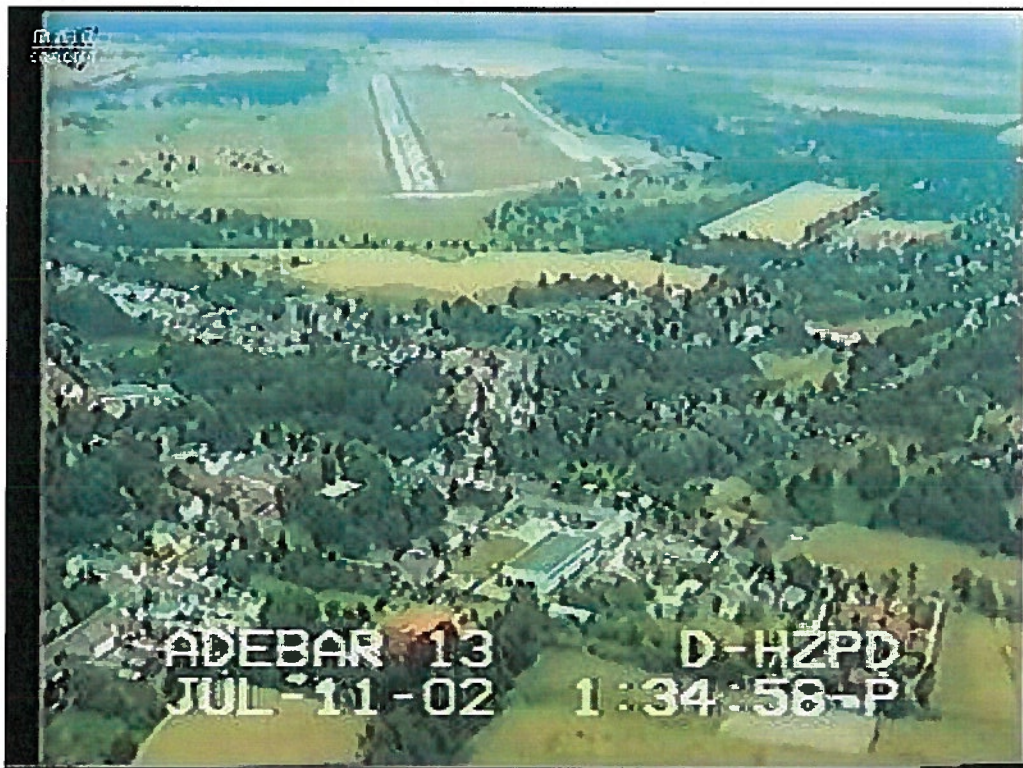
As part of the investigation, a day later a video film was made of the accident site from a police helicopter; an approach was flown to runway 08 to document to what degree the runway markings and earth walls could be discerned from the air.

View of the airfield at a distance of about 2.6 km from the runway threshold.

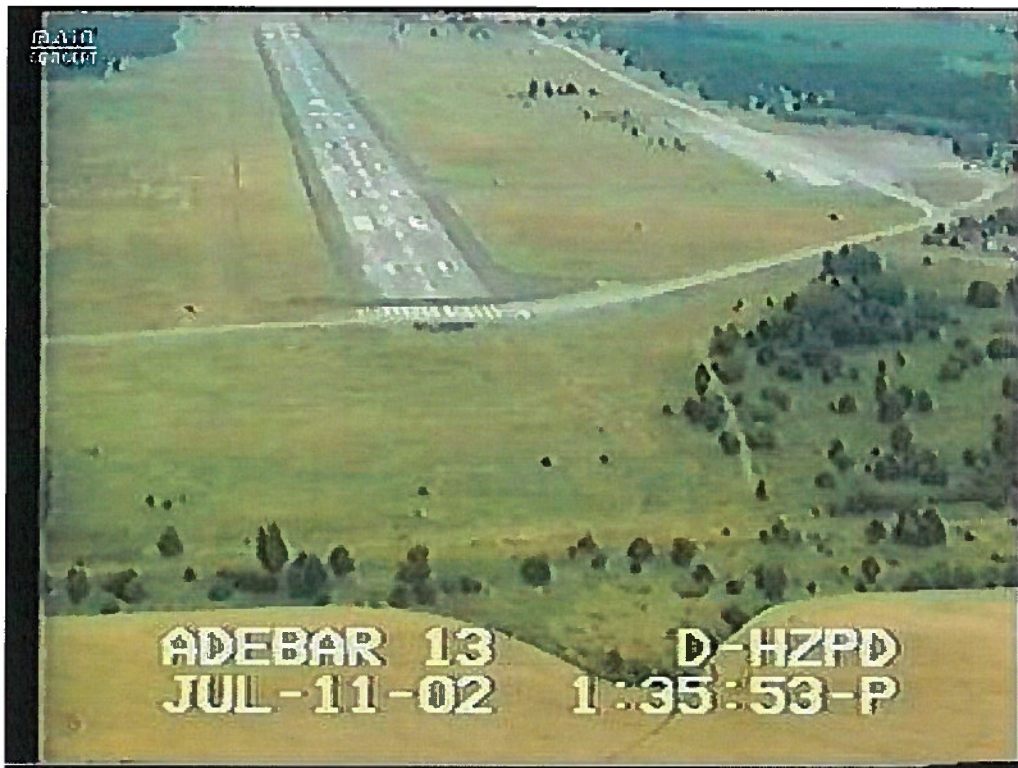
View of the airfield at a distance of about 1.8 km from the runway threshold.
