# **Final Report No. 2103**

## **by the Aircraft Accident Investigation Bureau**

concerning the accident involving  
the Diamond DA 42 aircraft, registration HB-LUO  
on 19 April 2010  
Zurich Airport

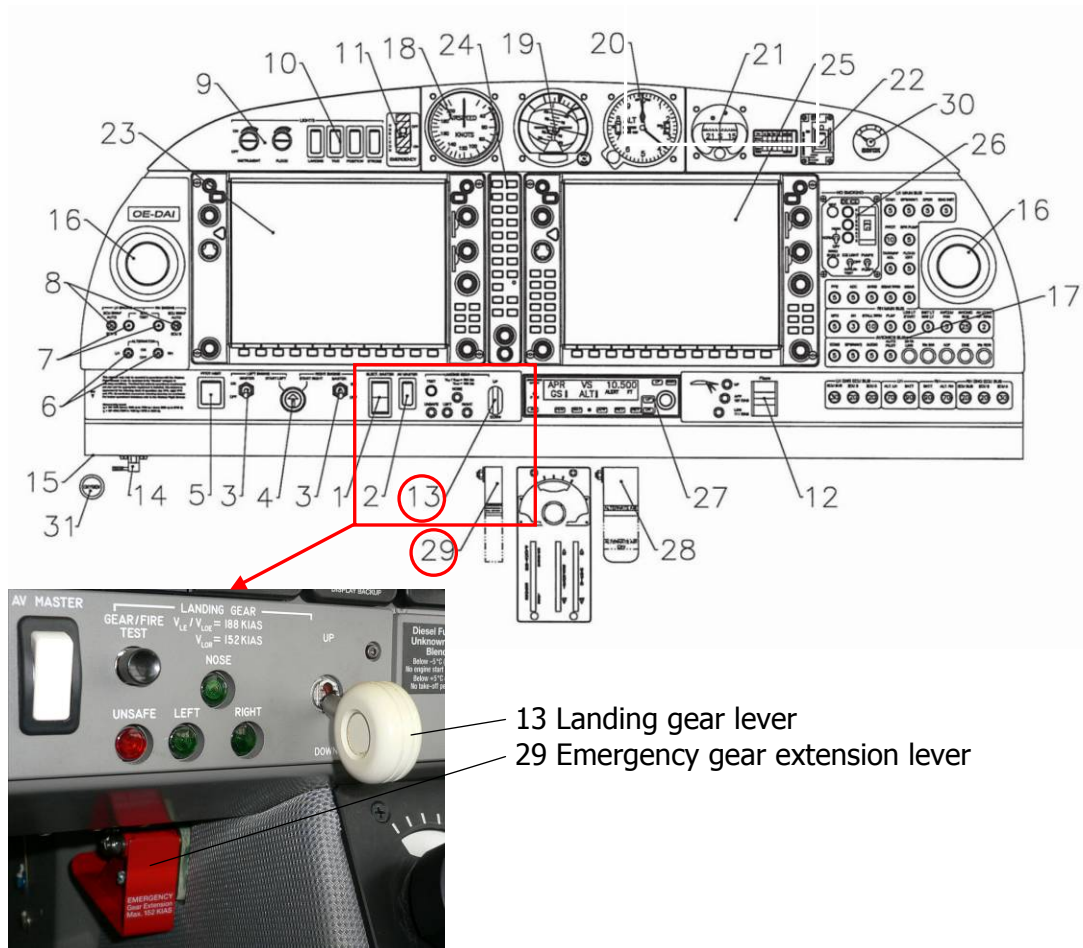
### 1.3.2.3 Cockpit indications and controls

Three green lights (left, nose and right) directly adjacent to the landing gear lever indicate when the landing gear is extended and secure. If the gear is neither fully extended nor retracted, the red (unsafe) warning light illuminates; it is located directly adjacent to the green lights (cf. chapter 1.3.2.3).
