Final Report No. 2122 by the Swiss Accident Investigation Board SAIB

concerning the accident involving the
Agusta A109K2 helicopter,
registration HB-XWJ

on 23 June 2008

Helicopter landing pad on the roof of
Samedan Hospital/GR

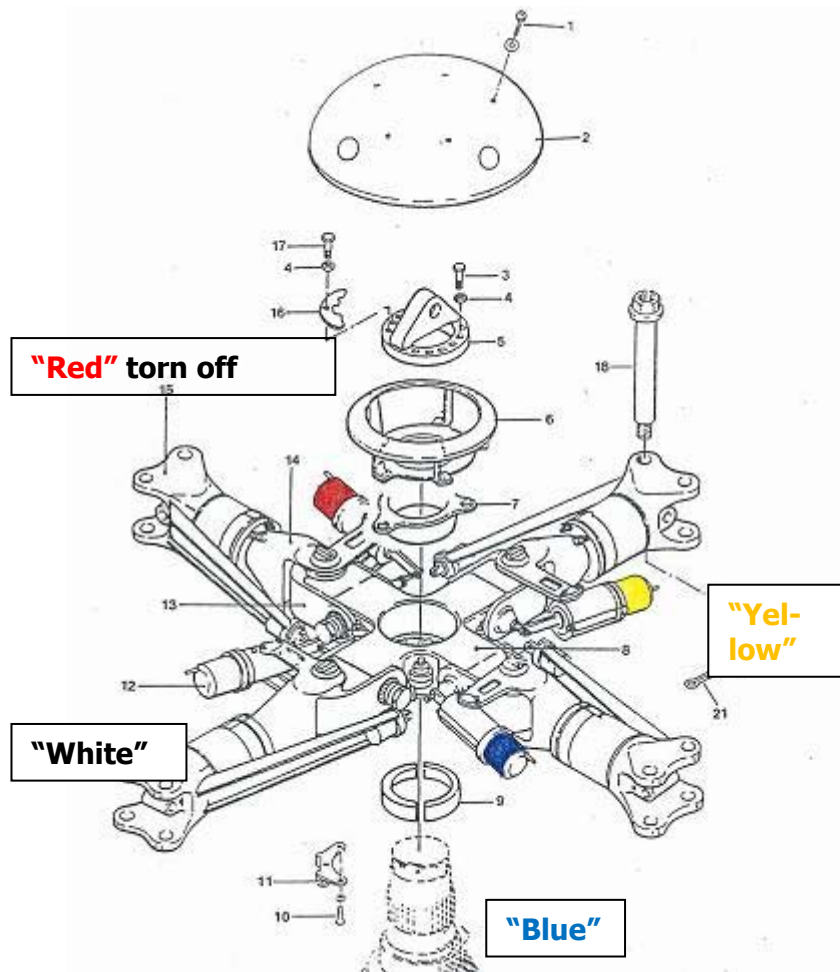
Figure 7: Exploded view of the rotor head with the four drag dampers

The x-ray examination of the four drag dampers showed that the piston rod mounting nut was missing on each of the three shock absorbers – “Red”, “Yellow” and “Blue”. The absorber springs were accordingly expanded.

The condition and test results for the four drag dampers were as follows:
