# **Final Report No. 2134 by the Swiss Accident Investigation Board SAIB**

concerning the serious incident involving a  
B737-800 aircraft, registration D-AHLR

on 7 June 2009

65 NM on radial 135° of the GVA  
(Geneva) VOR

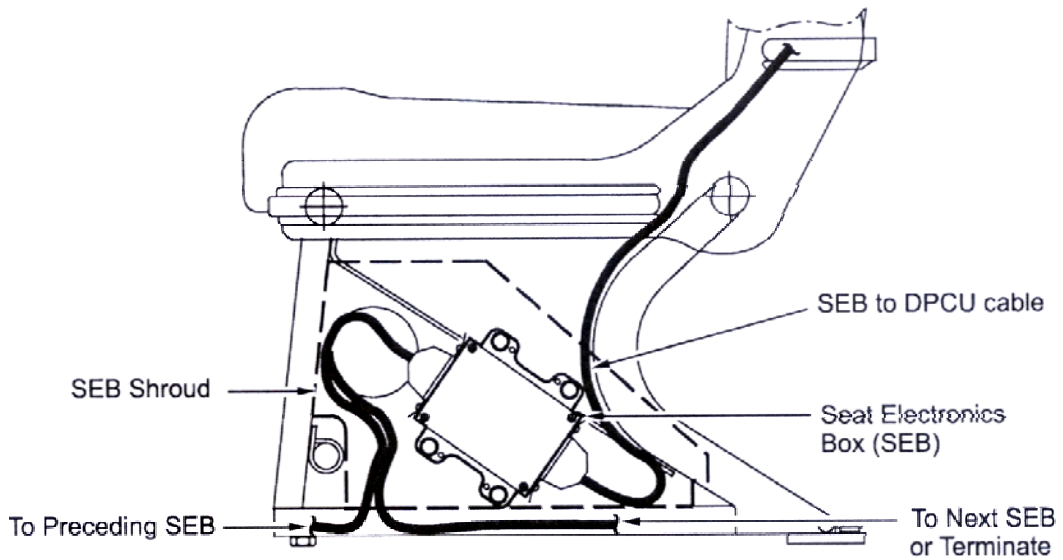
Fig. 1: Position of the Seat Electronic Box (SEB) under the seat

The electronic box of the defective audio system was manufactured by Rockwell Collins Inc. It bears part number 700-2218-001, serial number 34424 and manufacturing date 02/01. It was installed on the left, under seat E of row 5 (see fig. 1 and 2). The SEB supplied the audio output to the seats of passengers D, E and F of row 5. The examination of the SEB electronic box is covered in section 1.16.

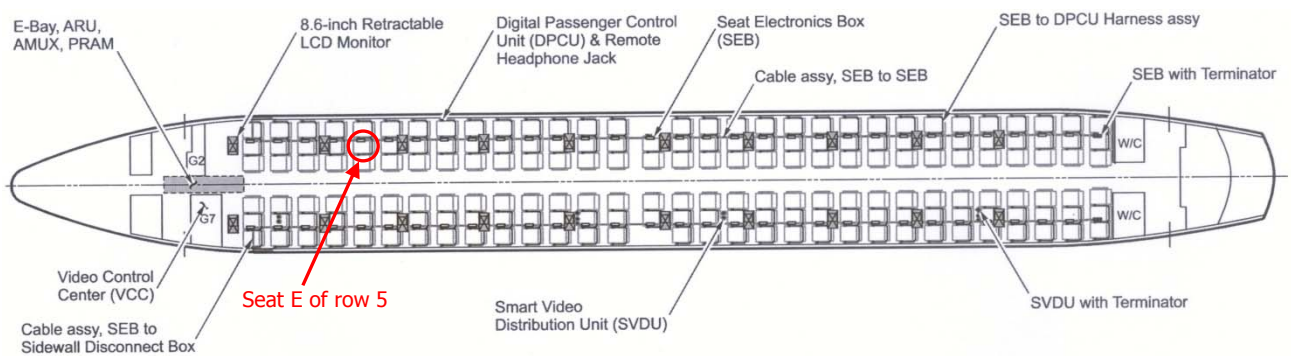
Fig. 3: Positioning of seat E in the 5<sup>th</sup> row in the cabin of the Boeing 737-800 and of the audio system distribution schematic

The cabin of the Boeing 737-800 is equipped with 62 SEB electronic boxes for its audio distribution system. The SEB box is the key element of the audio distribution system. The SEB decodes the digitised audio data of the Audio Multiplex (AMUX) system located in the front of the aircraft and distributes the analogue audio to the three passengers in the row.
