Final Report no. 2136 of the Swiss Accident Investigation Board SAIB

concerning the serious incident - airprox
involving the Airbus A320-214 aircraft, registration HB-IJH,
operated by Swiss International Airlines
under radio callsign SWR 1326
and the Airbus A320-214 aircraft, registration HB-IJW,
operated by Swiss International Airlines
under radio callsign SWR 202W
on 15 March 2011
at Zurich airport

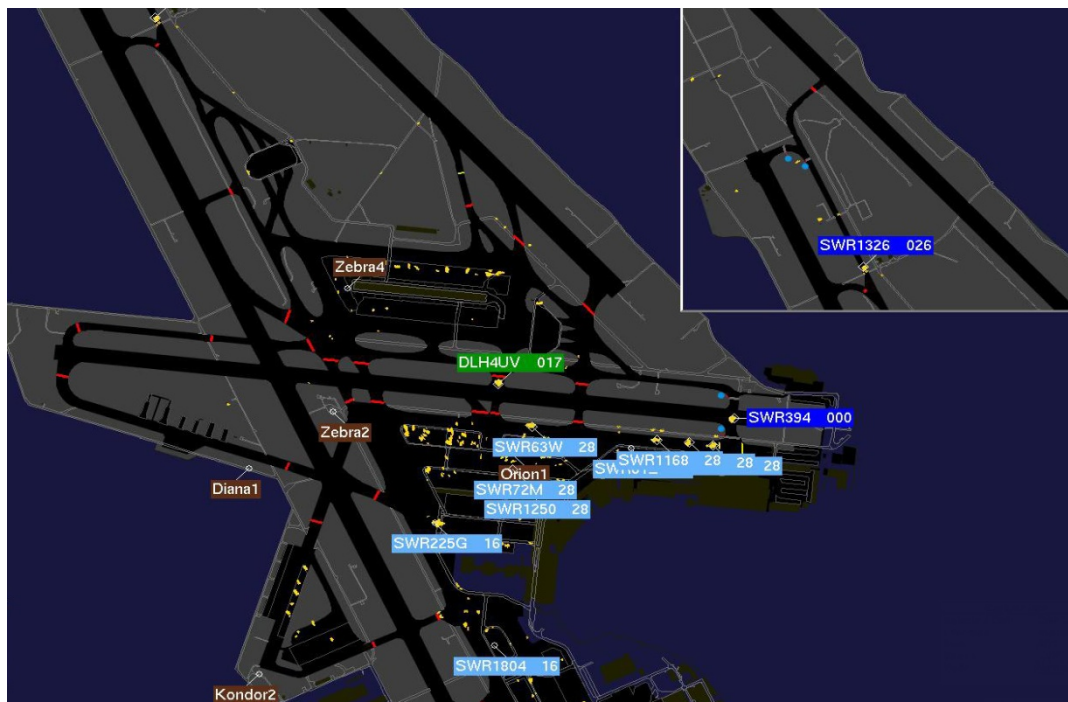
Figure 11: SAMAX ground radar screen. The northern part of the runway system is shown in a separate box (inset) on the screen.

Special mention should be made in this regard of the presentation of the runway system on the ground radar screen (SAMAX), as it was in operation at the time of the serious incident. This rectangular screen displayed the traffic situation on the ground and was positioned at an angle (cf. figure 11, section 1.11.2). In order to display the entire runway system coherently on this screen, a magnification ratio showing insufficient detail would have had to be chosen. Therefore, a setting was usually used in which the northern part of the runway system was shown in a separate window (inset). Such a display is ergonomically unfavourable, since it makes it more difficult for the air traffic control officer to take in the entire runway system at a glance. In the present case, this was especially significant at 11:43:05 UTC (cf. Annex 1), when both aircraft were at the beginning of runways 16 and 28, SWR 1326 had begun its take-off roll and SWR 202W received take-off clearance. Since at Zurich airport 73% of the departing traffic takes off from the intersecting runways which are in simultaneous operation, a comparable situation is common and the ergonomically poor display is therefore of particular importance.

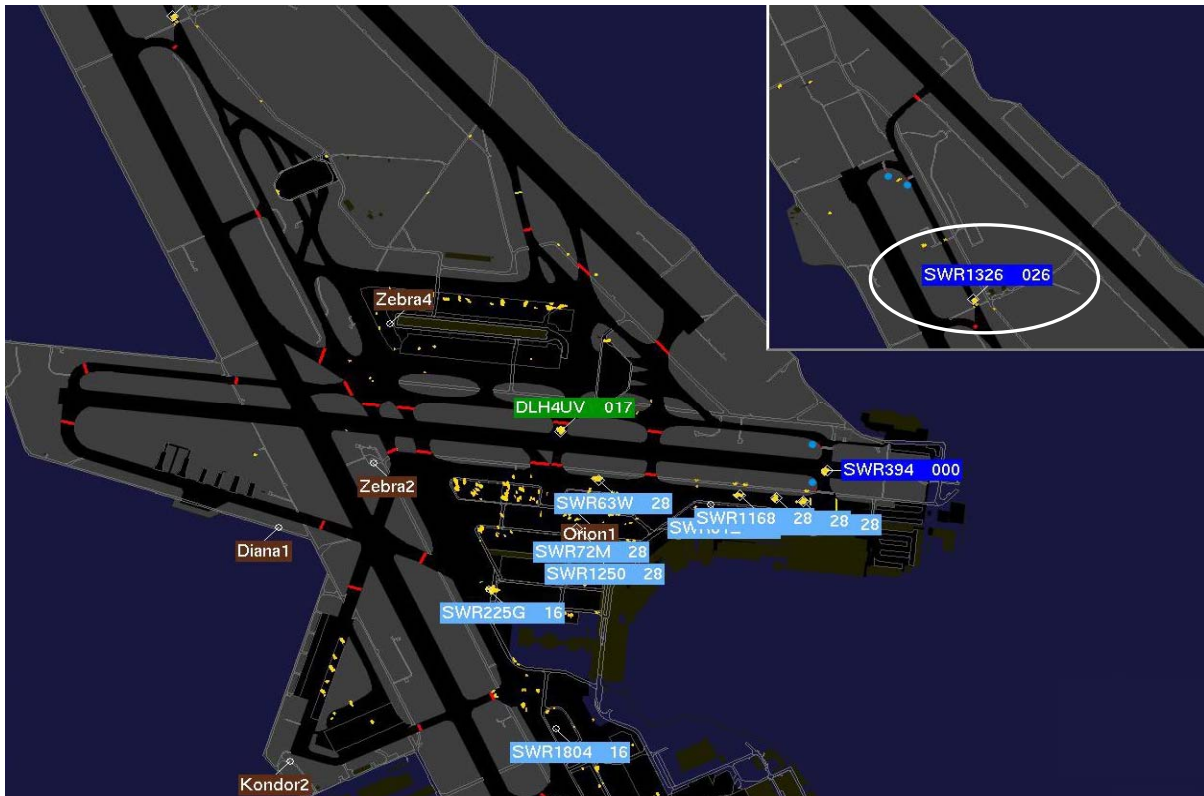
11:41:17 UTC: SWR 1326 receives clearance to taxi to the take-off position on runway 16

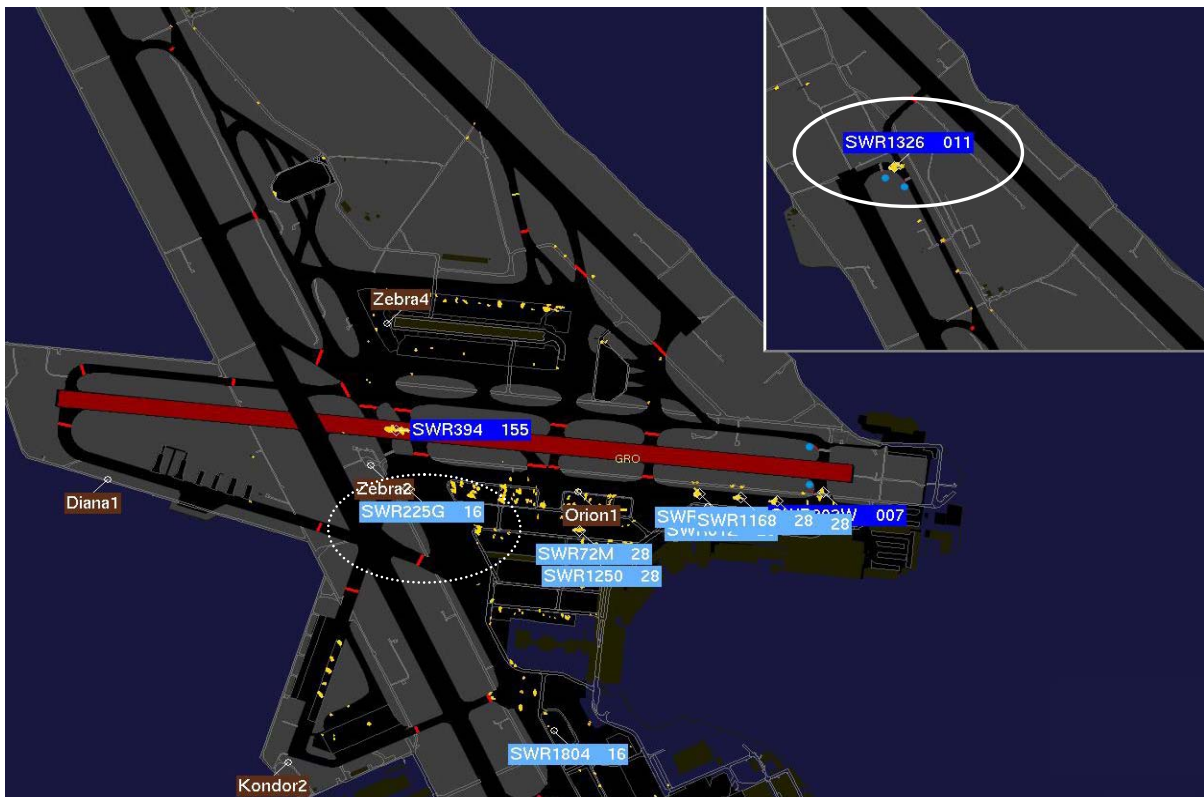
11:42:18 UTC: SWR 225G receives clearance to cross runway 28 (runway turns red).

11:42:19 UTC: SWR 1326 receives take-off clearance on runway 16

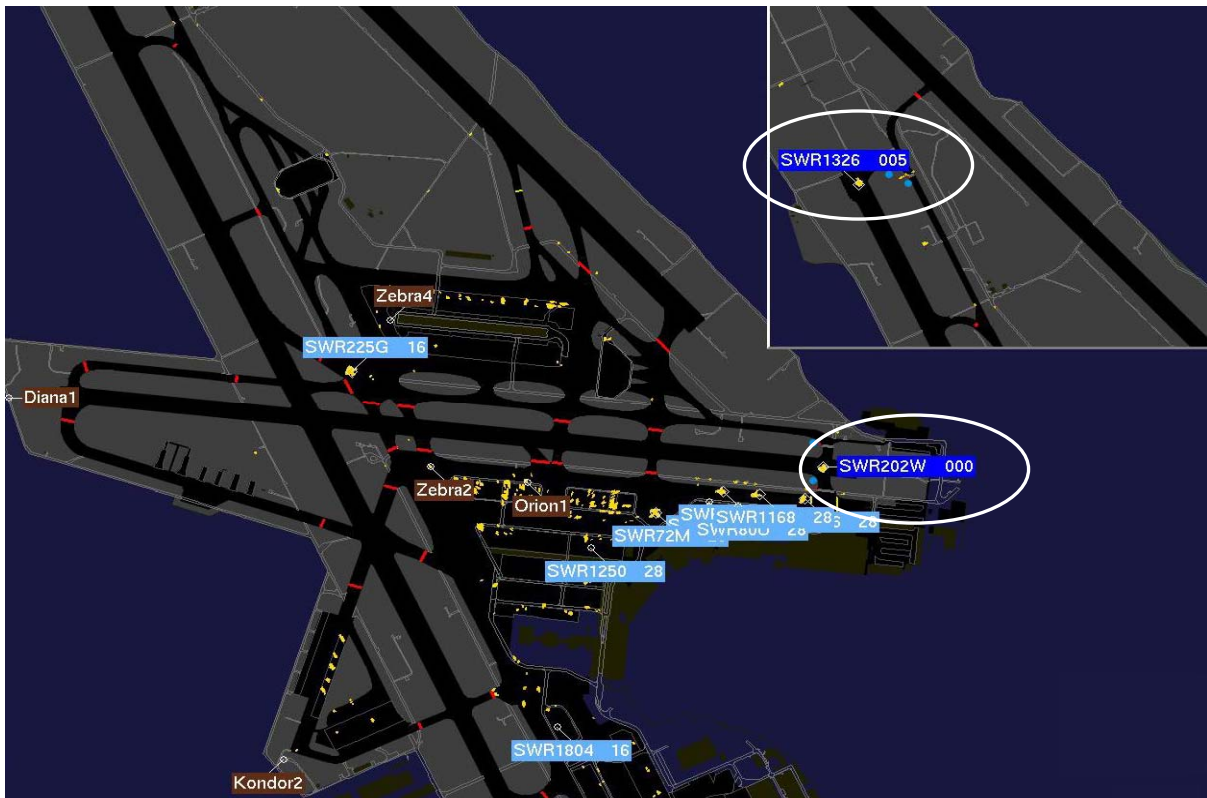
11:43:05 UTC: SWR 202W receives take-off clearance on runway 28, SWR 1326 starts its take-off roll
