Final Report No. 2142 by the Swiss Accident Investigation Board SAIB

concerning the accident involving the K-1200 K-MAX helicopter, registration HB-ZEH

on 2 October 2007

in Strit, municipality of Illgau/SZ

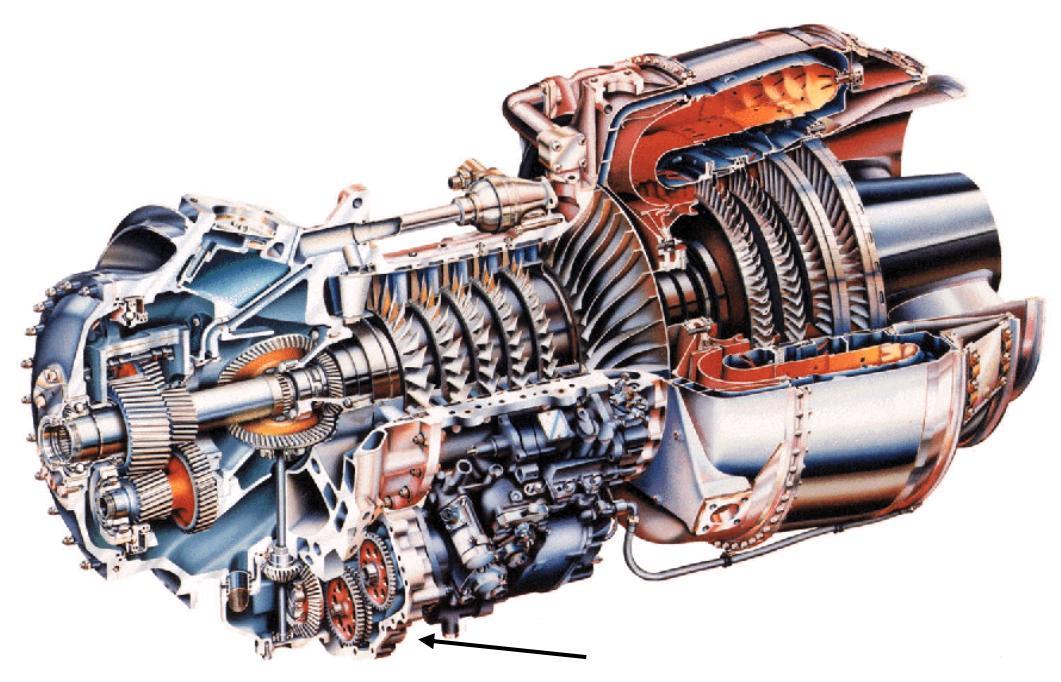
Figure 2 – Depiction of the T53 engine and the position of the N1 accessory drive gearbox(see arrow)

The N1 accessory drive gearbox is mounted at the six o'clock position of the air inlet housing. It is driven via the accessory drive shaft, which connects the N1 stage of the engine via the outer pinion gearshaft assembly to the accessory drive gear assembly (see Figures 1 and 2).

- The power turbine could be rotated freely by hand.
- The N1 accessory drive gearbox was removed. It was found that the accessory drives could not be driven by turning the accessory drive shaft. In particular, axial play in the accessory drive gear assembly was found.

Due to the large amount of metal chips found in the N1 accessory drive gearbox, the engine was disassembled for inspection and examined.
