Schlussbericht Nr. 2148 der Schweizerischen Unfalluntersuchungsstelle SUST

über die möglichen Gefährdungen von
Rettungs- und Untersuchungsorganen
durch ballistische Fallschirmrettungssys-
teme (*Ballistic Parachute Systems – BPS*)
in Flugzeugen

Thermal behavior of BRS 440 and BRS 601 rockets

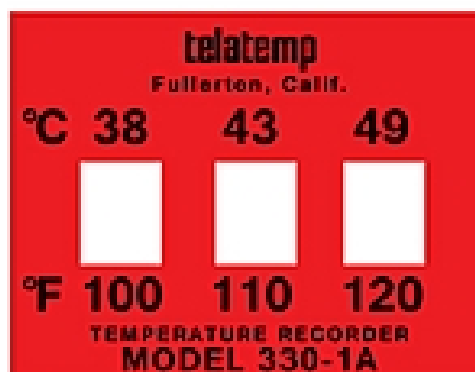
Abbildung 14: Telatemp Temperaturmessstreifen

Auf den Raketen von BPS müssen möglichst nahe am Raketenmotor Thermoindikatoren angebracht sein (z.B. Telatemp). Bei diesen Thermoindikatoren wechselt die Farbe, wenn eine gewisse Temperatur überschritten worden ist.

Die Kontrolle der Thermoindikatoren muss z.B. in die Checkliste der Grundkontrolle der Flugzeuge integriert werden.

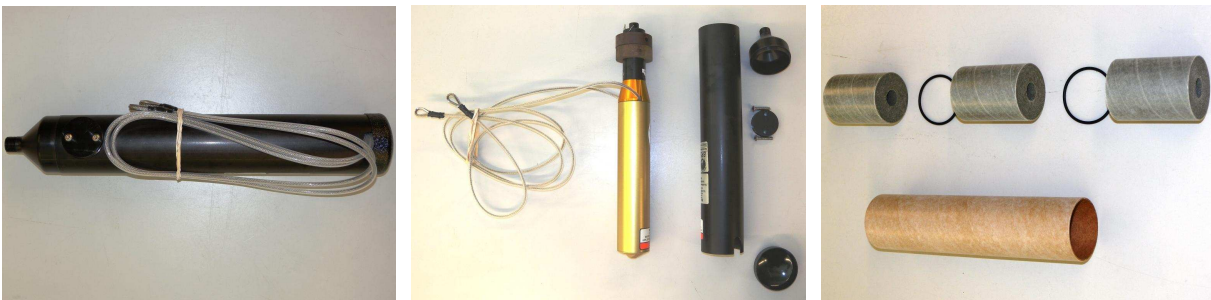
According to the producer, the energetic substances used in BRS 440 and BRS 601 are identical. To isolate these substances from the system, the BRS 440 rocket Nr. 1 was dismantled completely. From this rocket we got three different energetic materials:

- rocket motor (HTPB/AP/Mg) three cylinders, 71.3 g each
- primary booster (BP/Mg) 160mg
- primer mixture (composition unknown) 300mg

Fig. 1: Main components of the BRS 440 rocket; the 3 gray cylinders at the top of the rightmost picture compose the rocket motor.

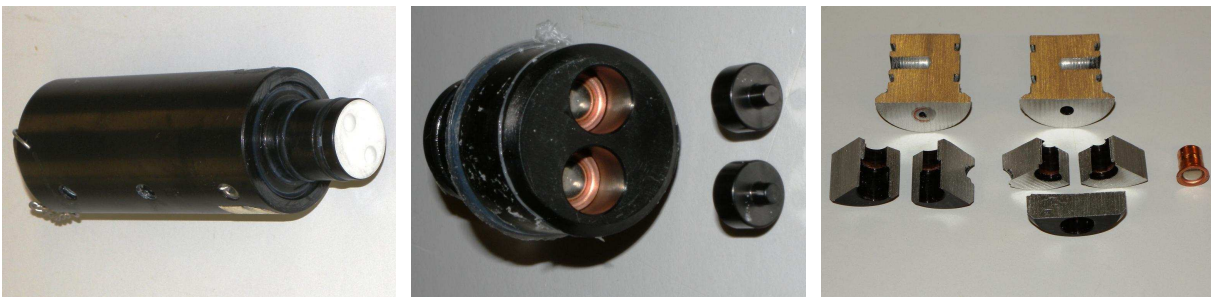
Fig. 2: Detail of the igniter of the BRS 440 rocket. The primary booster charge is contained in two firing channels under an aluminum foil (glued to the base of the igniter; left picture). The picture in the middle shows the two percussion cups in the igniter housing and the two firing pins beside. The rightmost picture shows one of the two percussion cups and the housing cut by a diamond wire saw.

The active parts in the BRS are mechanically well protected and sealed properly. This is of great importance as Magnesium (Mg) reacts with humidity by the time under production of hazardous hydrogen gas.

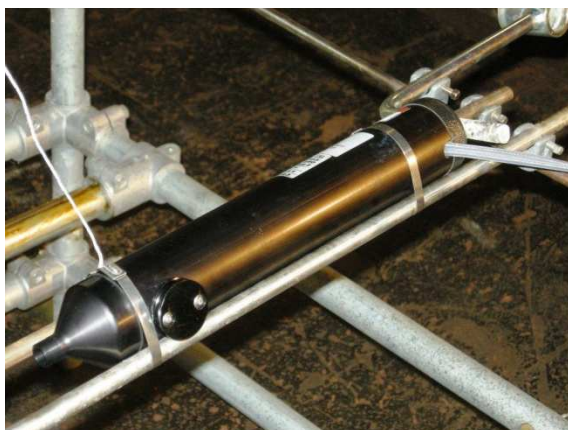
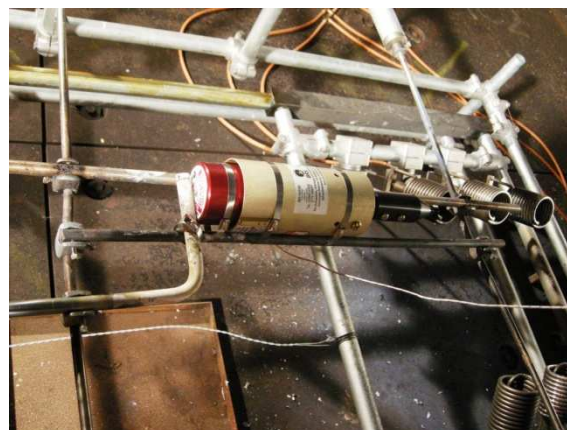
Test Nr. / Rocket	Mean Temp. [°C]	Time to Reaction [s]	Type of Reaction ¹	Remarks
V01/ BRS 440 Nr. 2	1045	145	Type V-IV Fast burning towards deflagration	End cap was axially ejected out of the rocket casing with high velocity. The main part of HTPB cylinder of the rocket motor did not react. Both percussion cups of the Igniter did not react.
V03/ BRS 440 Nr. 3	1085	129	Type V-IV Fast burning towards deflagration	The end cap was axially ejected out of the rocket casing with high velocity. One wire cut and the second wire almost cut. No unreacted rocket motor parts left. Igniter including primary booster remained unreacted.
V02/ BRS 601 Nr. 1	1050	43	Type V-IV Fast burning towards deflagration	The rocket was axially ejected apart from the fixation and penetrated the 2 mm thick aluminum witness plate (see Fig. 7). The outer casing of the rocket was ejected to the opposite witness plate which resulted in a crack into the plate. All parts of the rocket motor and igniter did react.

V04/ BRS 601 Nr. 2	1065	69	Type V-IV Fast burning towards deflagration	The rocket remained onto the support but shifted the whole test equipment about 1.5 m in the direction of the base of the rocket. All parts of the rocket motor and igniter did react.

Fig. 3: FCO set-up; respectively for the BRS 440 (left) and the BRS 601 (right).

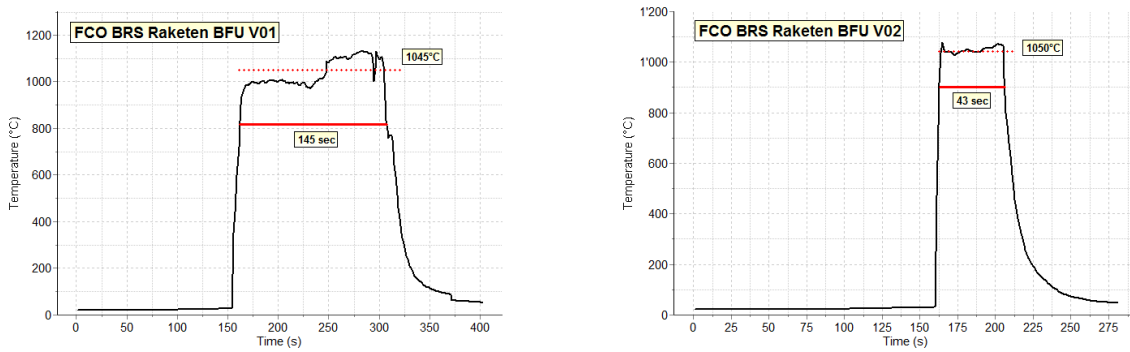
Fig. 5: FCO curves respectively for the BRS 440 (left) and the BRS 601 (right).

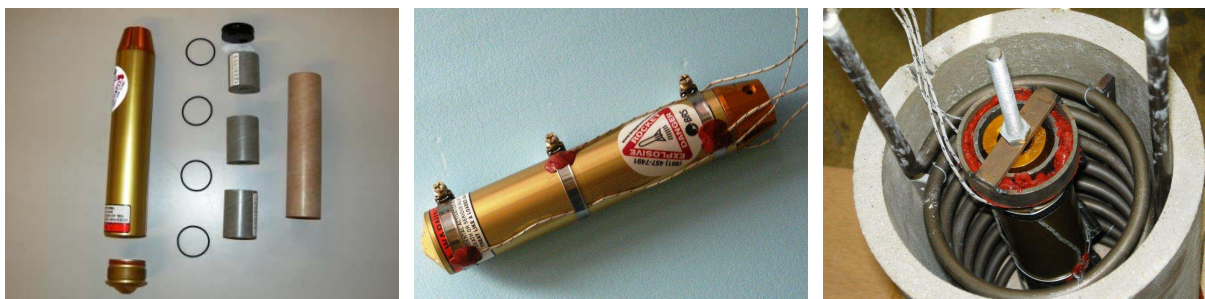
Only one type of BRS rocket was left to perform an indicative SCO experiment; BRS 440 Nr. 1 which was used for dismantling. The test was performed without Igniter (used for analytical tests) and with an aluminum disc of 1 cm thickness for confinement towards the rocket nozzle. The first HTPB cylinder of the rocket motor weighted 57.3 g instead of 71.3 g. We have chosen a heating rate of 15°C/h for this experiment which corresponds to a realistic heating rate for the thermal radiation of a fire in the vicinity.

Fig. 8: Arrangement of the BRS 440 rocket for the SCO test; respectively rocket with probes and in position in the brick cylinder.

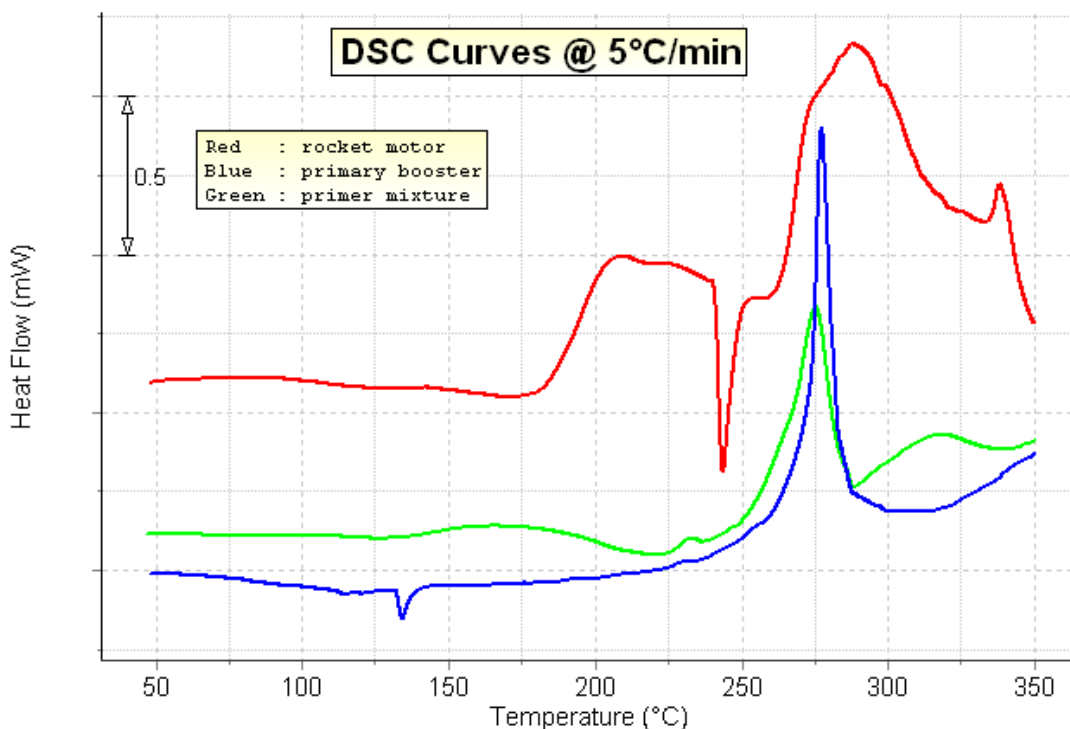
Fig. 11: DSC curves of the rocket motor, the primary booster and the primer mixture with a heating rate of 5°C per minute.

The DSC experiments have shown that for a heating rate of 5°C per minute, the rocket motor is the sample which shows first an exothermic reaction at 180°C (cf. fig. 11). In comparison the primary booster and the primer mixture seem to be thermodynamically more stable.

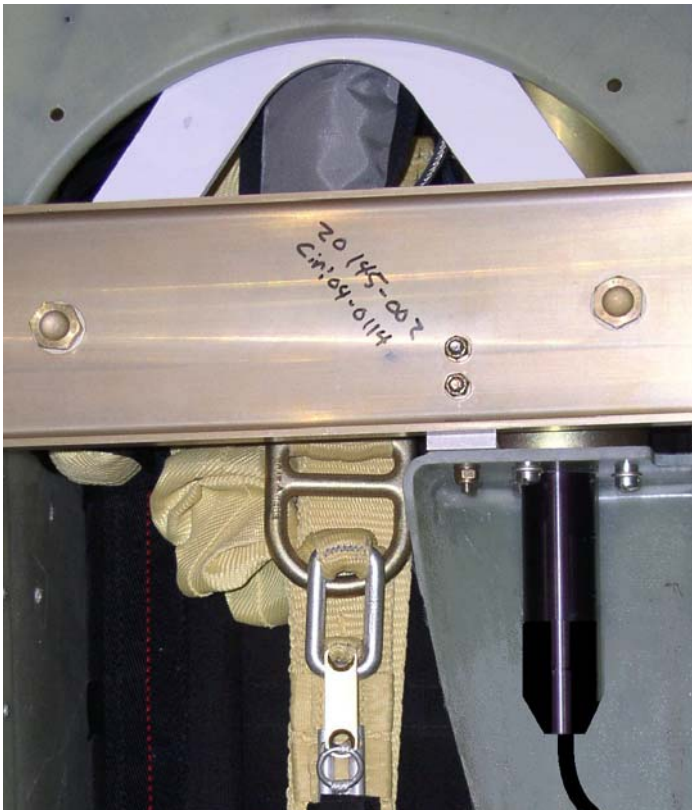
The photo at left shows the **Cirrus** parachute installed into its storage area, located just behind the baggage compartment. It is normally covered by a sheet metal panel and carpet, which is secured with Velcro. The rocket motor is mostly hidden behind the aluminum beam; the igniter is visible in the upper right center as a black cylinder. The Cirrus parachute is contained within a heavy nylon bag, so it is a *softpack* by definition.

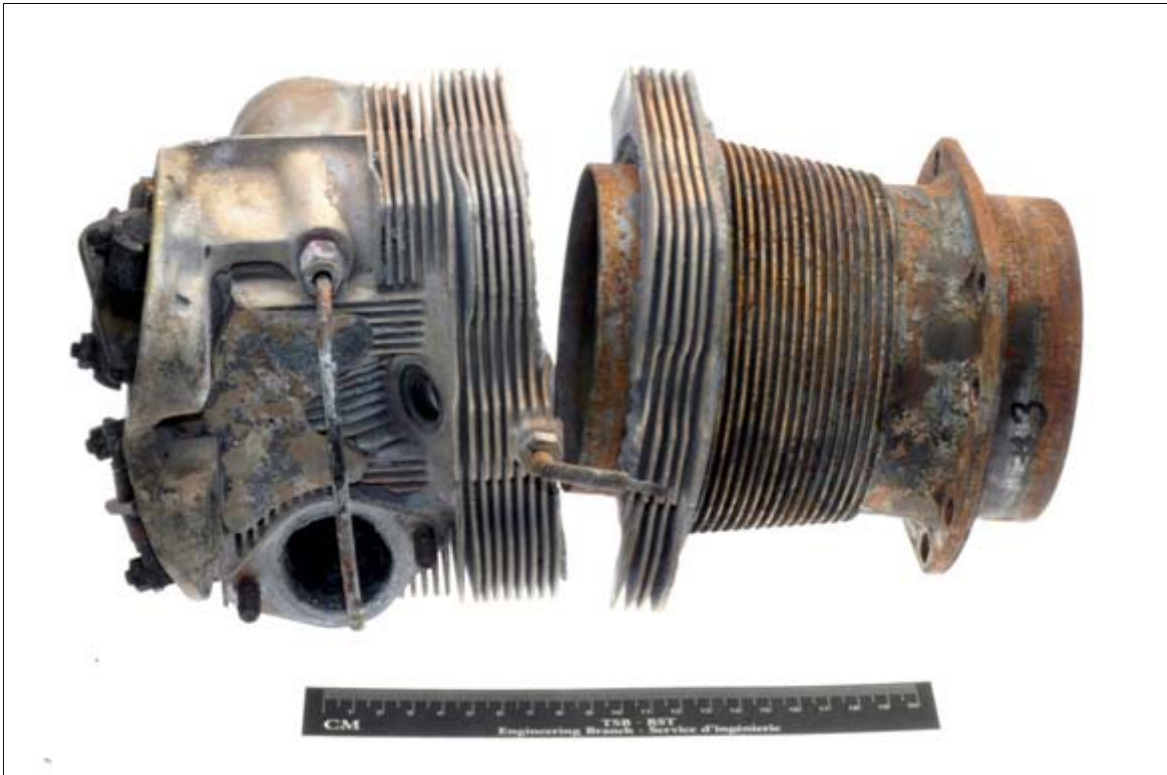
Figure 1. Le cylindre numéro 3 déposé du moteur

L'examen du moteur a révélé que la culasse du cylindre numéro 3 s'était détachée du barillet (voir la [figure 1](#)). La culasse est restée en place parce qu'elle était retenue par les circuits

d'admission et d'échappement. Aucune autre anomalie qui aurait pu empêcher le moteur de produire de la puissance n'a été découverte. L'examen de la culasse défectueuse du cylindre numéro 3 a révélé qu'elle s'était fracturée près des deuxième et troisième filets, et des criques de fatigue étaient visibles sur la surface de la fracture. Vue de l'extérieur, la fracture était située à la base des ailettes de refroidissement 4, 5 et 6³.
