Schweizerische Unfalluntersuchungsstelle SUST
Service d'enquête suisse sur les accidents SESA
Servizio d'inchiesta svizzero sugli infortuni SISI
Swiss Accident Investigation Board SAIB

Final report No. 2148

On potential risks of ballistic parachute systems (BPS) in aircraft to rescue and investigation crews

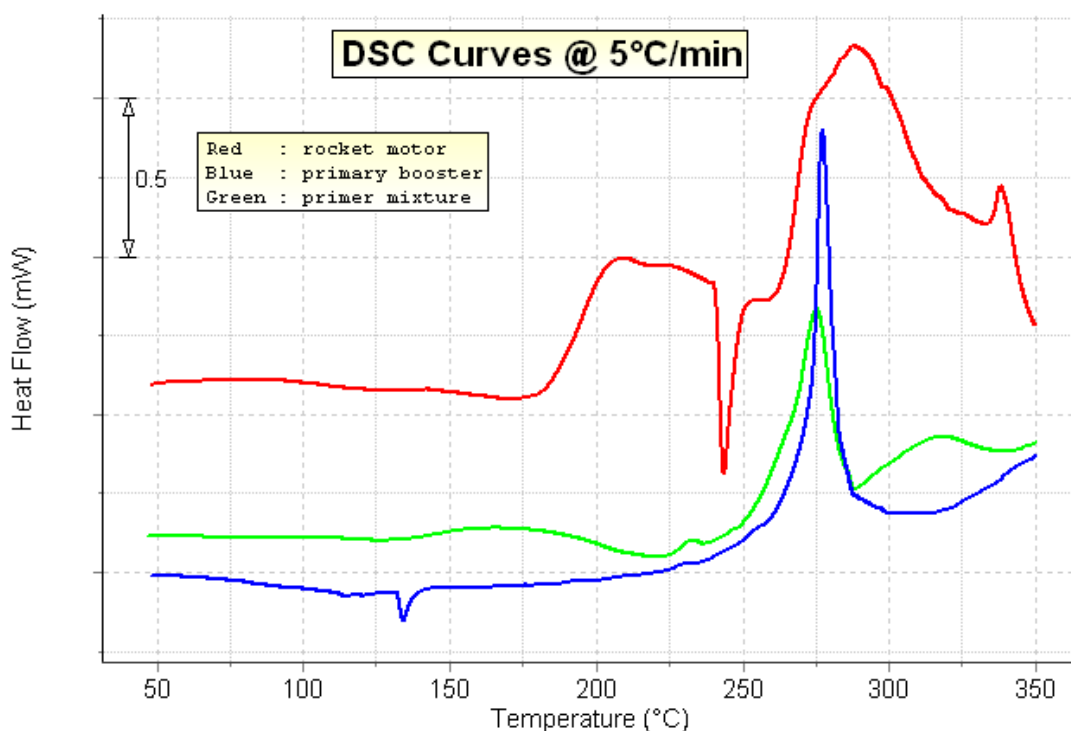
Fig. 11: DSC curves of the rocket motor, the primary booster and the primer mixture with a heating rate of 5°C per minute.

The DSC experiments have shown that for a heating rate of 5°C per minute, the rocket motor is the sample which shows first an exothermic reaction at 180°C (cf. fig. 11). In comparison the primary booster and the primer mixture seem to be thermodynamically more stable.

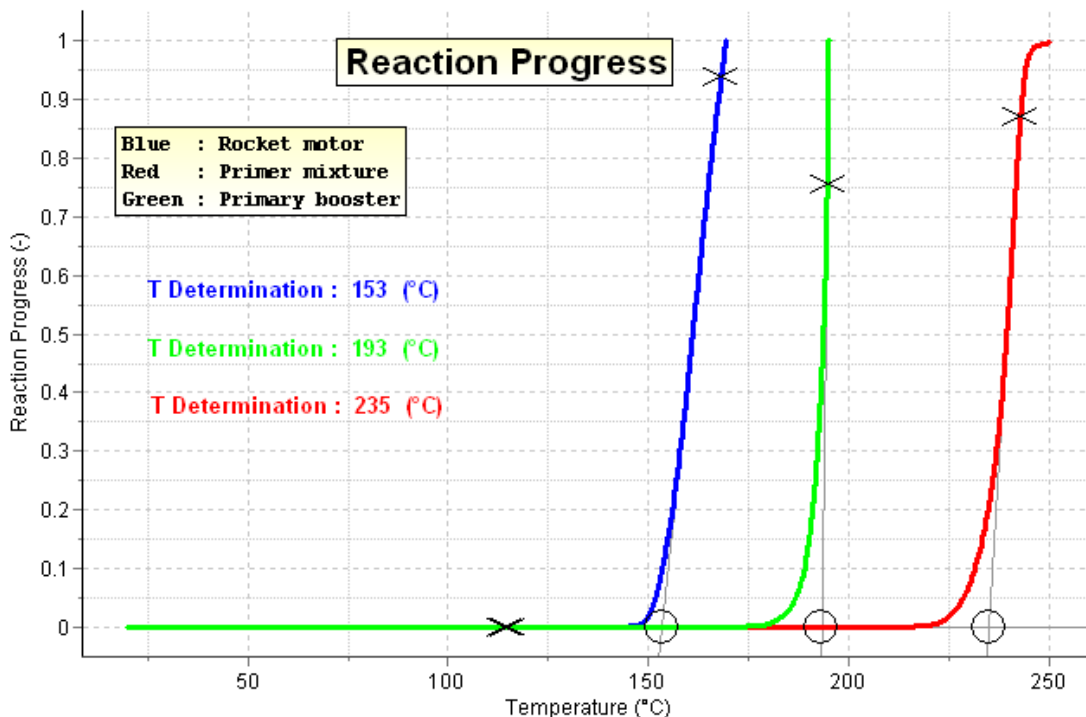
Fig. 15: Prediction of the reaction progress under adiabatical condition for a heating rate of 15°C per hour; the blue curve represents the rocket motor, the green curve the primary booster and the red curve the primer mixture.

For the thermodynamical simulations we had to make a compromise due to the high inhomogeneity of the sample in the milligram domain. This was especially the case for the HTPB rocket motor. For the simulation we could use only the first exothermic peak (up to 220°C) instead of the full spectrum as for the other two substances. Figure 15 shows the reaction progress of the three samples in an adiabatically configuration. Although that this condition does not totally fulfill to the SCO test set-up, it is reasonable to assume that with a heating rate of 15°C per hour, the rocket motor will probably react first.

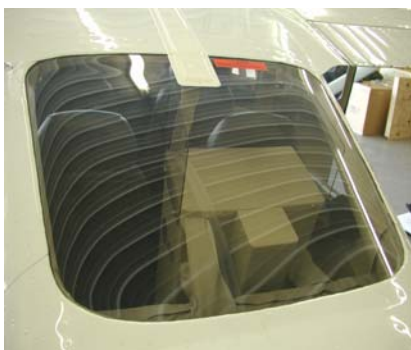
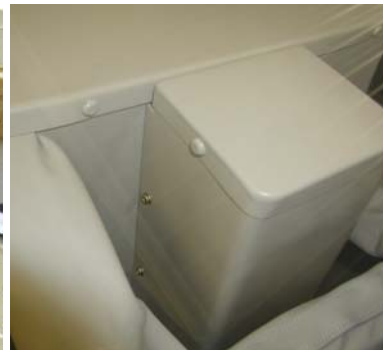
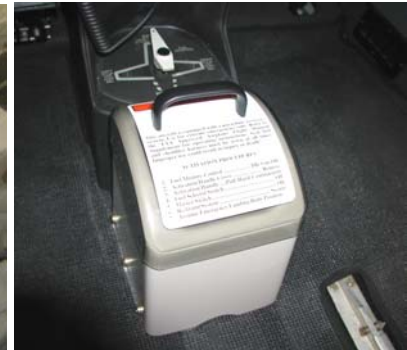
Cessna 182

Many of the design elements of the newer, C182 ballistic parachute system are similar to its predecessor, the C172. The canister is rotated 90 degrees and the rocket is located *aft* of the canister, however, the activation cable is still relatively accessible prior to being covered on the floorboard. The best way to reach the cable would be through the left side baggage door, if possible. As shown here, the rocket motor and igniter are covered by the upper and lower rocket shields, which are intended to protect the components from bumping. To gain access to the cable, perform the following steps:

1. Using a Phillips screwdriver, remove the two 8-32 screws securing the left side of the lower rocket shield
2. Place force on the shield in an effort to move it *away* from the parachute canister. Even though there are two more screws on the right side, it should fracture and may then be pushed out of the way.
3. You will then see the igniter and the activation cable, as at left.
4. Using the Felco cutter, or equivalent, proceed to cut the cable 1" - 2" from the end.
5. The rocket has now been rendered safe, and it may be removed for disposal or safe storage.
