Final Report No. 2153 by the Swiss Accident Investigation Board SAIB

concerning the accident involving the
Agusta helicopter A109K2,
registration HB-XWM

on 24 November 2009

at the former Airport
Interlaken / BE

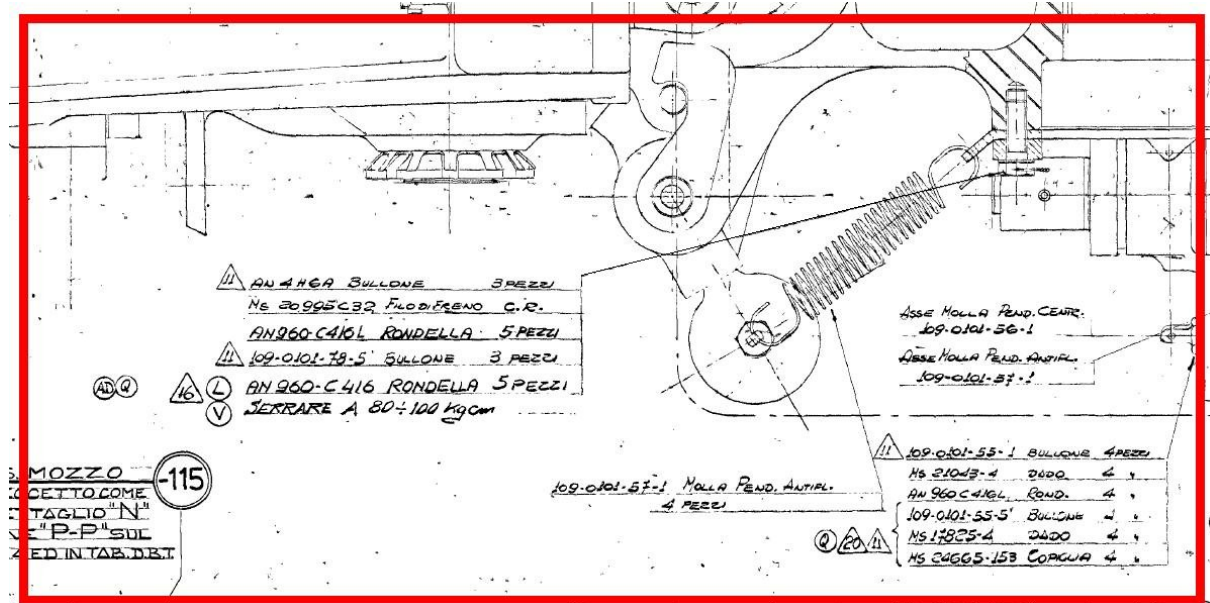
Annexe 1: Extract from the design drawing of the rotor hub 109-0101-01 and corresponding revision notes

Kausal für den Bruch der Bolzen war der Umstand, dass die vom Hersteller publizierte und vom Unterhaltsbetrieb verwendete Unterhaltsdokumentation fehlerhaft war.

Detail of the connection between swash plate driving scissor fitting and hub

Ⓛ 16 PER NUOVE COSTRUZIONI E PARTI DI RICAMBIO, IL PART. 109-0101-32-3 SOSTITUISCE IL PART. 109-0101-32-1 INOLTRE AGGIUNTE N° 5 RONDELLE AN. 960 C 416
