# **Final Report No. 2158** **by the Swiss Accident** **Investigation Board SAIB**

concerning the serious incident involving the  
AVRO 146-RJ100 aircraft, registration HB-IXP,  
under flight number LX 5187

on 20 July 2011

at Zurich-Kloten airport

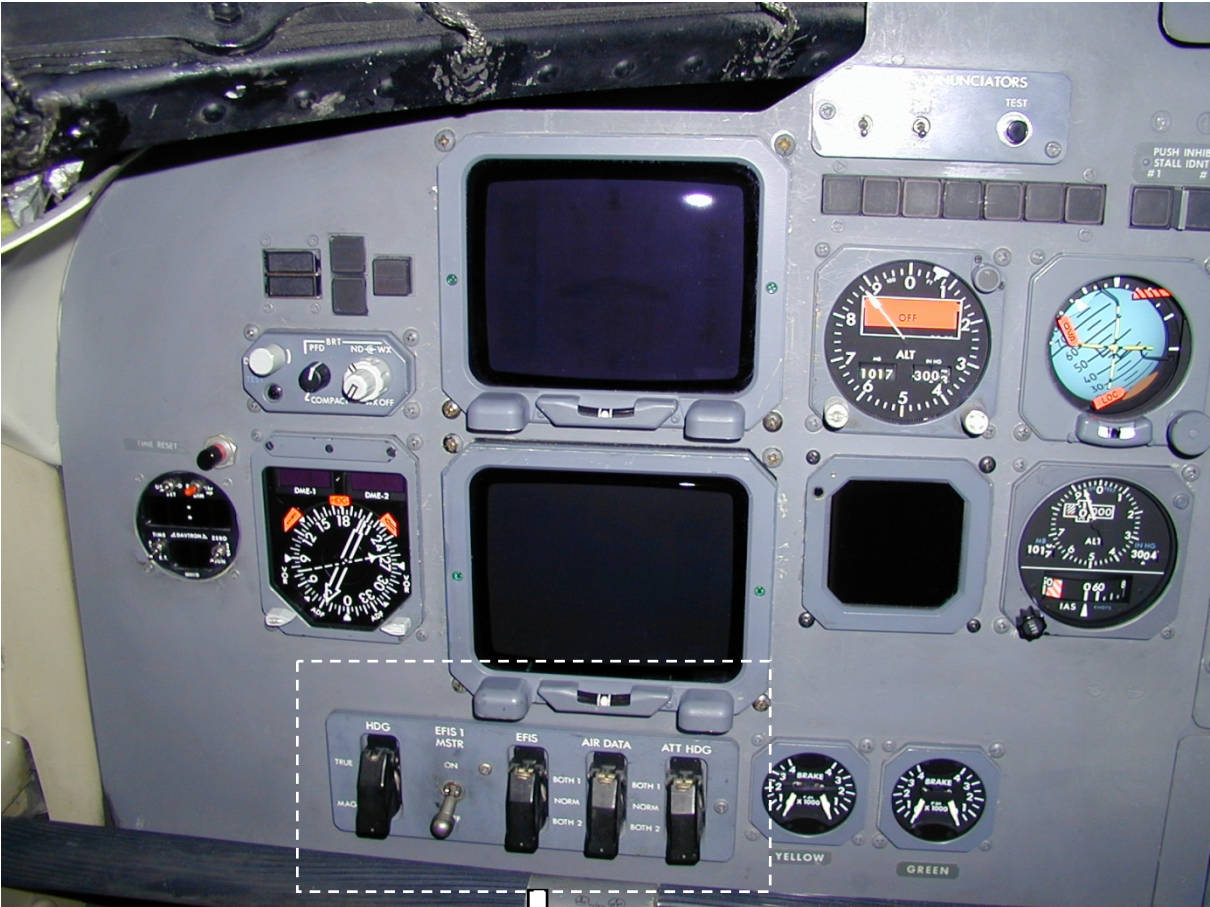
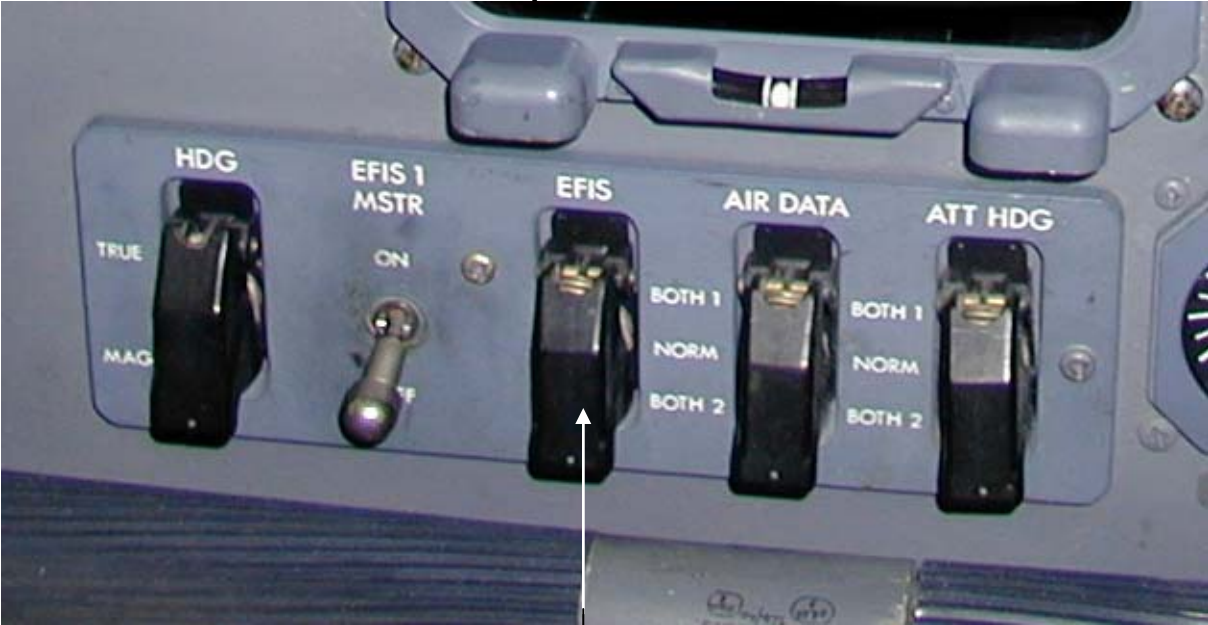
Annex 3: Commander's instrument panel

Switch for EFIS displays  
In "BOTH 2" position, for example, the data from PFD2 / ND2 are copied to PFD1 / ND1.
