# **Final Report No. 2160** **by the Swiss Accident** **Investigation Board SAIB**

concerning the accident involving the  
Piper PA-32R-300 aircraft,  
registration HB-PRE

on 26 August 2010

Oey, Saanen/BE municipality

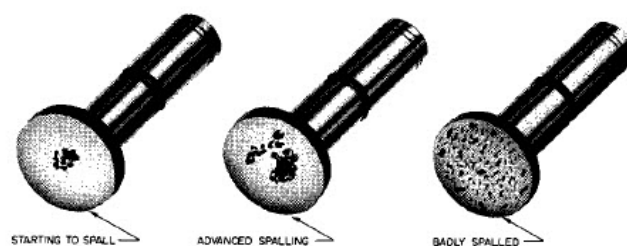
Figure 6-17. Appearance of Spalling Marks on Face of Hydraulic Tappet Bodies

6-45. Check the face of the tappet body for signs of spalling or pitting (figure 6-17). Any face which shows this condition is cause for rejection, and the tappet body must be replaced with a new tappet body. It is recommended, that a magnifying glass (min. 10 power) be used for this purpose.

6-46. When a tappet body is rejected because of spalling, a visual inspection of the nose of the cam lobe with a magnifying glass (min. 10 power) must be made.

Any indication of distress, surface irregularity or feathering at the edge of the lobe is cause of rejection of the cam shaft."

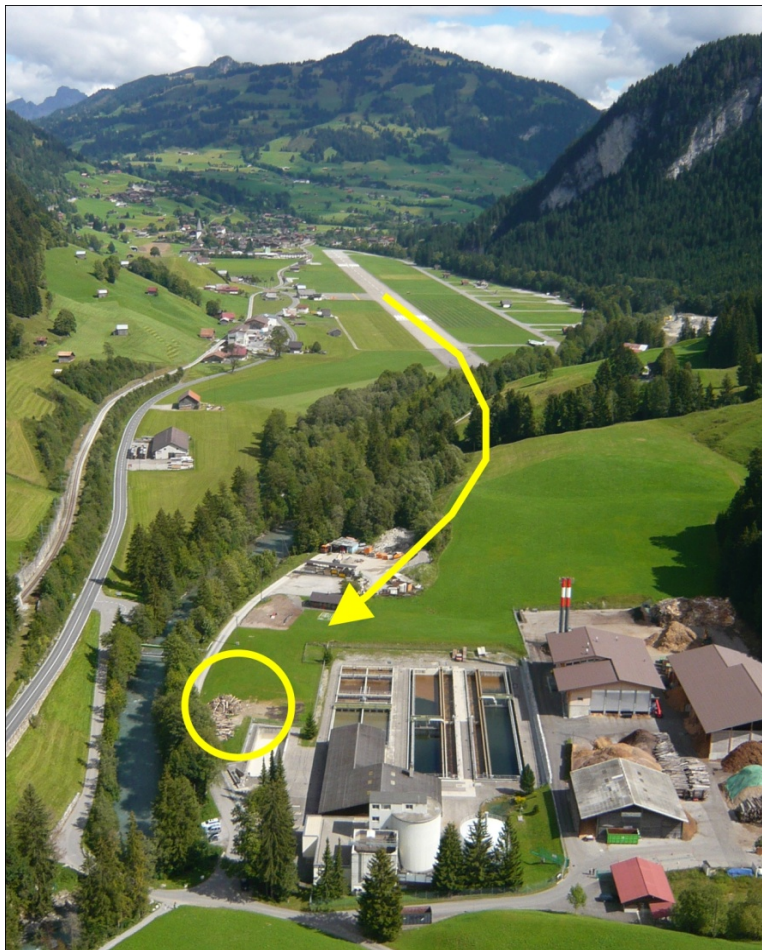
The site of the accident was on a meadow next to the Saanen waste water treatment plant.

Figure 2: Flight path (yellow arrow) and site of the accident (yellow circle)
