Final Report No. 2166 by the Swiss Accident Investigation Board SAIB

concerning the serious incident – Airprox

involving the Airbus A320-232 aircraft,
under radio call sign CFG 366

and the Airbus A340-642 aircraft,
under radio call sign QTR 020

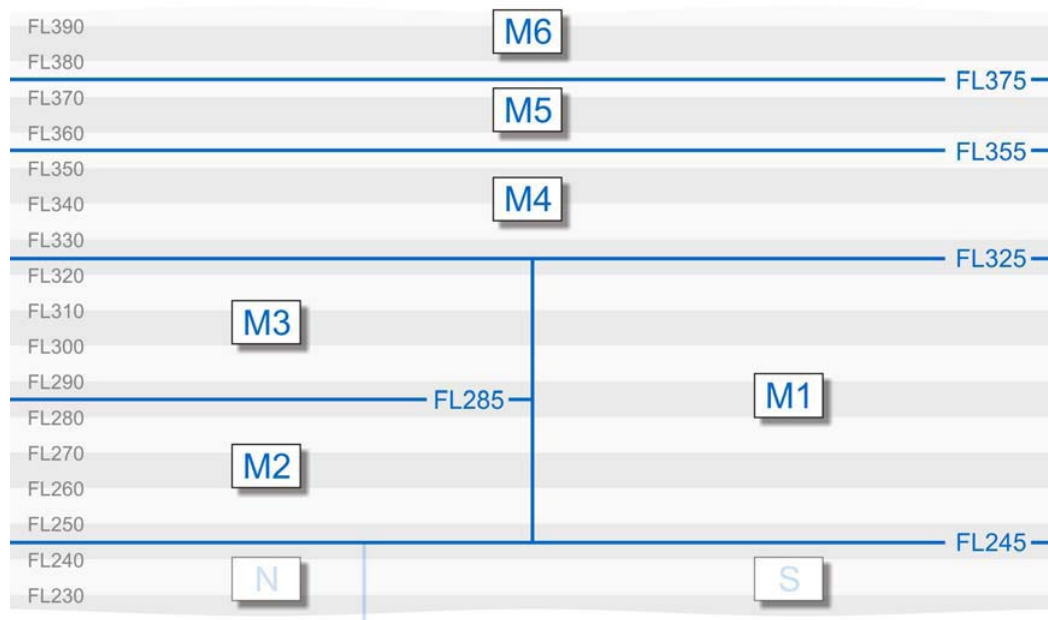
Figure 1: Schematic representation of the distribution of upper airspace in ACC Zurich.

In air traffic control, Zurich Area Control Centre (Zurich ACC) was involved with the combined workstations M5 and M6.
