Final Report No. 2169 by the Swiss Accident Investigation Board SAIB

concerning the accident involving
the Aero AT-3 R100 aircraft,
registration HB-SRA

on 12 August 2011

Worboden, Worb/BE

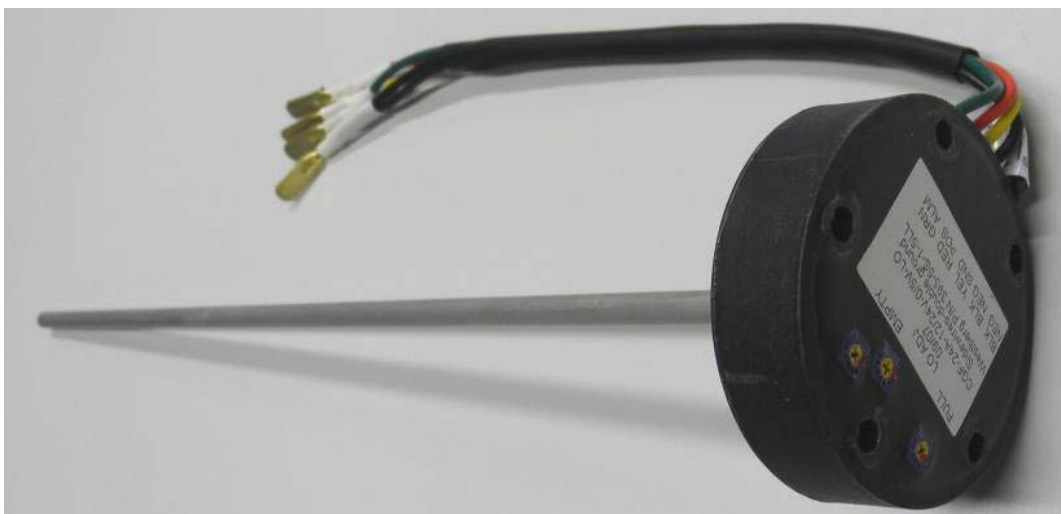
Figure 2: Sensor "Variant III"

Originally HB-SRA was equipped with a capacitive sensor. With this sensor, after it was correctly calibrated, on the one hand the quantity of fuel in the tank is measured and on the other hand the signal is generated for the red warning lamp when the tank level falls below ten litres.

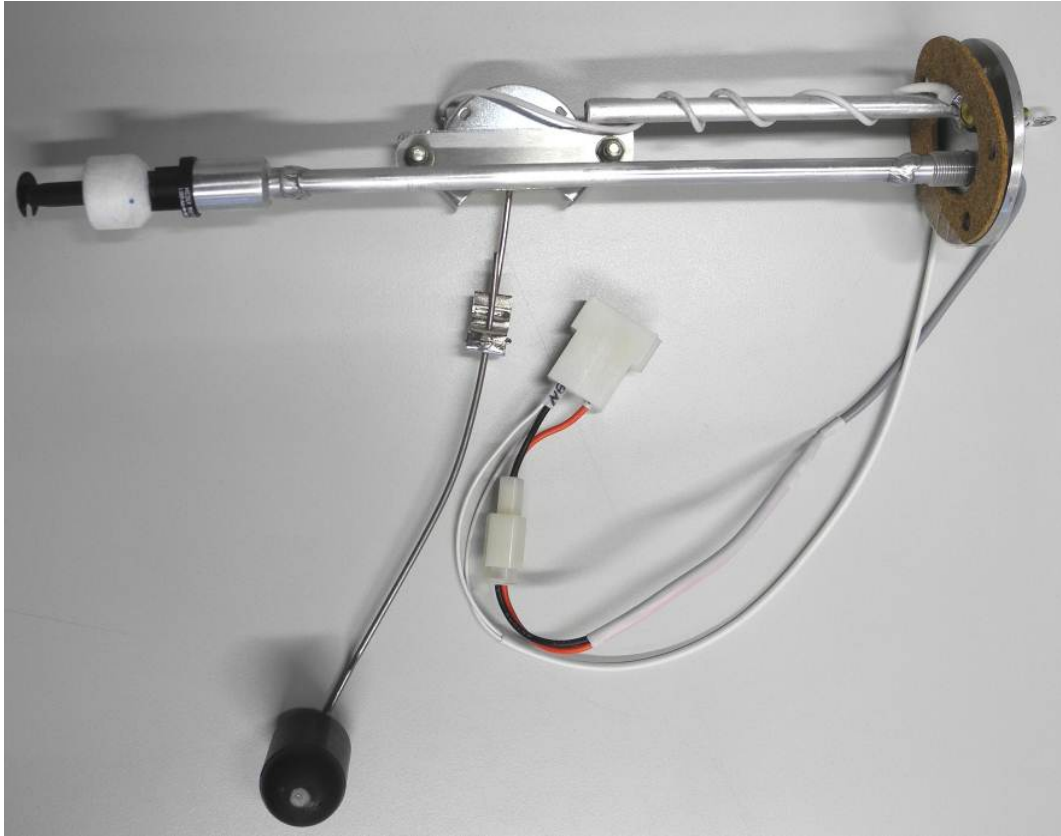
Figure 4: Sensor "Variant IV", P/N AT3.61.500.0 for aircraft from S/N AT3-054

In September 2009 the capacitive sensor on HB-SRA was replaced by the manufacturer with a sensor with a different operating principle. This sensor, designated the Variant IV has a float, which measures the tank content by means of a potentiometer. With this type of sensor, the signal for the red warning lamp is generated via the corresponding float position by the position of the potentiometer.

The sensor consists of a cover which is screwed onto the tank. In the middle of this cover there is a thread with a sleeve. An aluminium tube is inserted into this sleeve. At the lower end of the aluminium tube, a plastic housing in which the potentiometer is located is screwed on. A 21 cm long float is mounted on the axis of rotation of the potentiometer.

On the measuring sensor of the fuel tank, it was found that the aluminium tube to which the float is attached could be twisted clockwise, without any significant force, by up to 40° from its original position.

It was also found that as a result of this twisting, the float was resting in the tank on the connecting tube which carries through the throttle linkage of the pilot sitting on the right in the cockpit. The float was able to move freely upwards and was able to indicate fuel levels from full down to one-third.

The fuel gauge in the cockpit received the signal from a sensor in the tank. The capacitive sensor originally fitted was replaced by the manufacturer with a sensor fitted with a float. This sensor had design shortcomings in that as a result of incorrect insertion of the dipstick the float could be twisted so that it ended up lying on a connecting pipe in the tank, as a result of which the indication in the tank remained blocked at approximately 1/3. Since the "FUEL RESERVE - 10 L" warning lamp also received its signal from the same float potentiometer, the corresponding warning would never be triggered in this situation. It is expected of a system with a low level warning lamp that the corresponding signal is generated by an independent system.

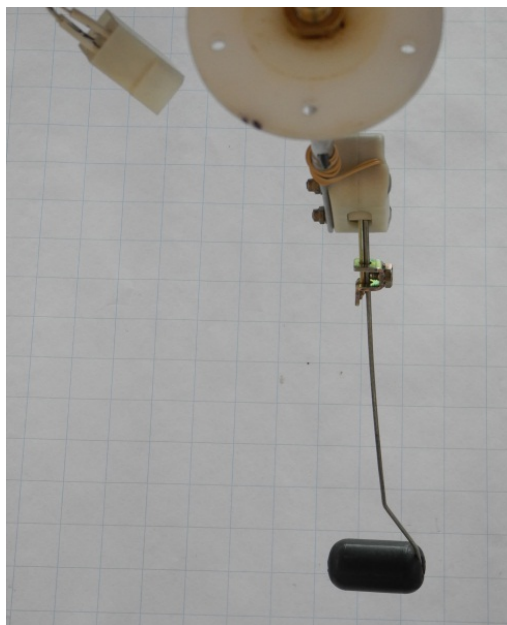
Figure 9: Float in normal position

If the dipstick was inserted into the left half of the tank, it could come into contact with the left side of the float linkage. When the tank filler cap was closed, the aluminium tube of the float was twisted clockwise to such an extent that the float was brought above the connecting tube and rested on it as the level dropped.

This incorrect state may persist even if the dipstick is subsequently inserted correctly.
