Final Report No. 2199 by the Swiss Accident Investigation Board SAIB

concerning the serious incident involving
the AVRO 146-RJ100 aircraft, registration
HB-IXW

on 2 July 2012

24 NM south-east of omni-directional radio
beacon Rolampont (RLP), France

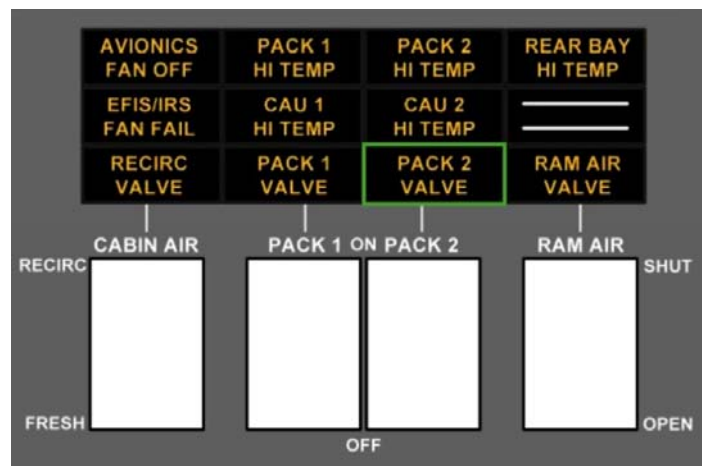
- a flow switch reports a low air pressure and the corresponding pack is switched ON
- or
- with pack 1 or pack 2 switched to OFF, the associated PACK VALVE annunciator will illuminate when the airflow is maintained (i.e. the PACK VALVE fails to close) until the pressure in the pack decreases to a level where the flow switch contacts open.

Figure 1: Air conditioning panel with PACK 1 and PACK 2 ON-OFF switches and PACK VALVE 1 and PACK VALVE 2 annunciators.

- the PACK 2 VALVE warning light (cf. Figure 1).

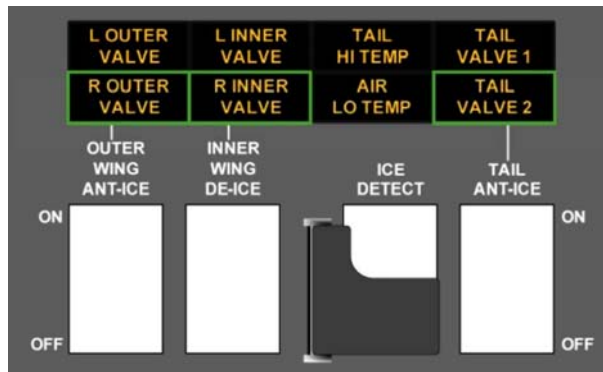
- the R INNER VALVE warning light (cf. Figure 2).
- the R OUTER VALVE warning light (cf. Figure 2).
- the Tail Valve 2 warning light (cf. Figure 2).

The warning lights above the switches illuminate if one of the valves is automatically closed. In the present case the two valves in the right wing and one valve in the tail were closed automatically as a result of a leak in the duct system (cf. Chapter 1.6.2.4).

Figure 2: Ice protection panel (lower part).

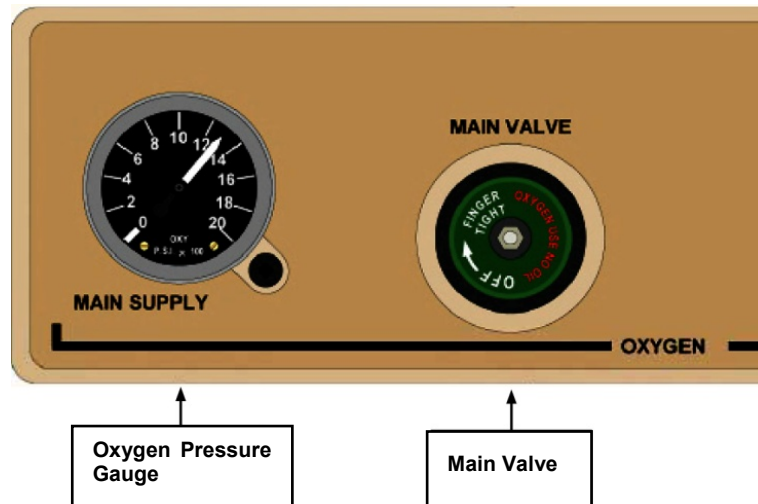
Figure 3: Right oxygen panel with main valve and pressure gauge.

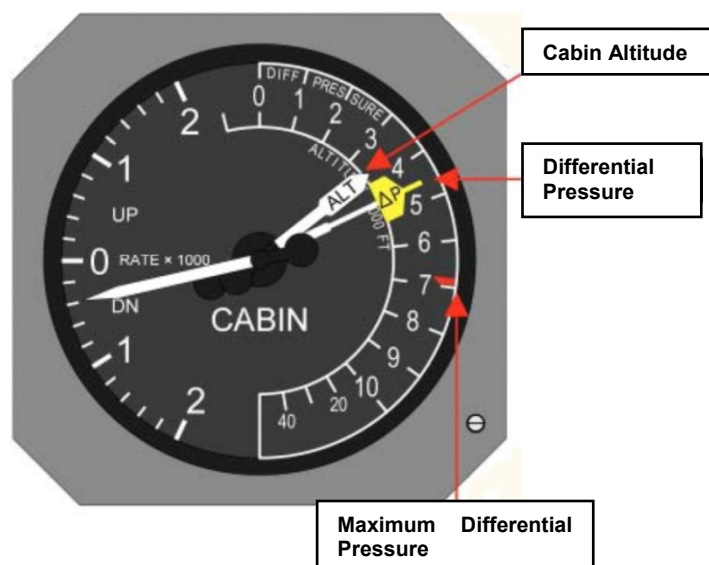
If a technical problem causes the cabin altitude to increase to over 9300 ft (2835 m), the CABIN HI ALT warning light illuminates in red on the central warning panel (CWP) and a triple chime sounds. In the present case, the pressure in the cabin, at the time of the failure of the cabin pressurisation system, corresponded to an altitude of approximately 7000 ft (2134 m).

Figure 4: Cabin triple indicator

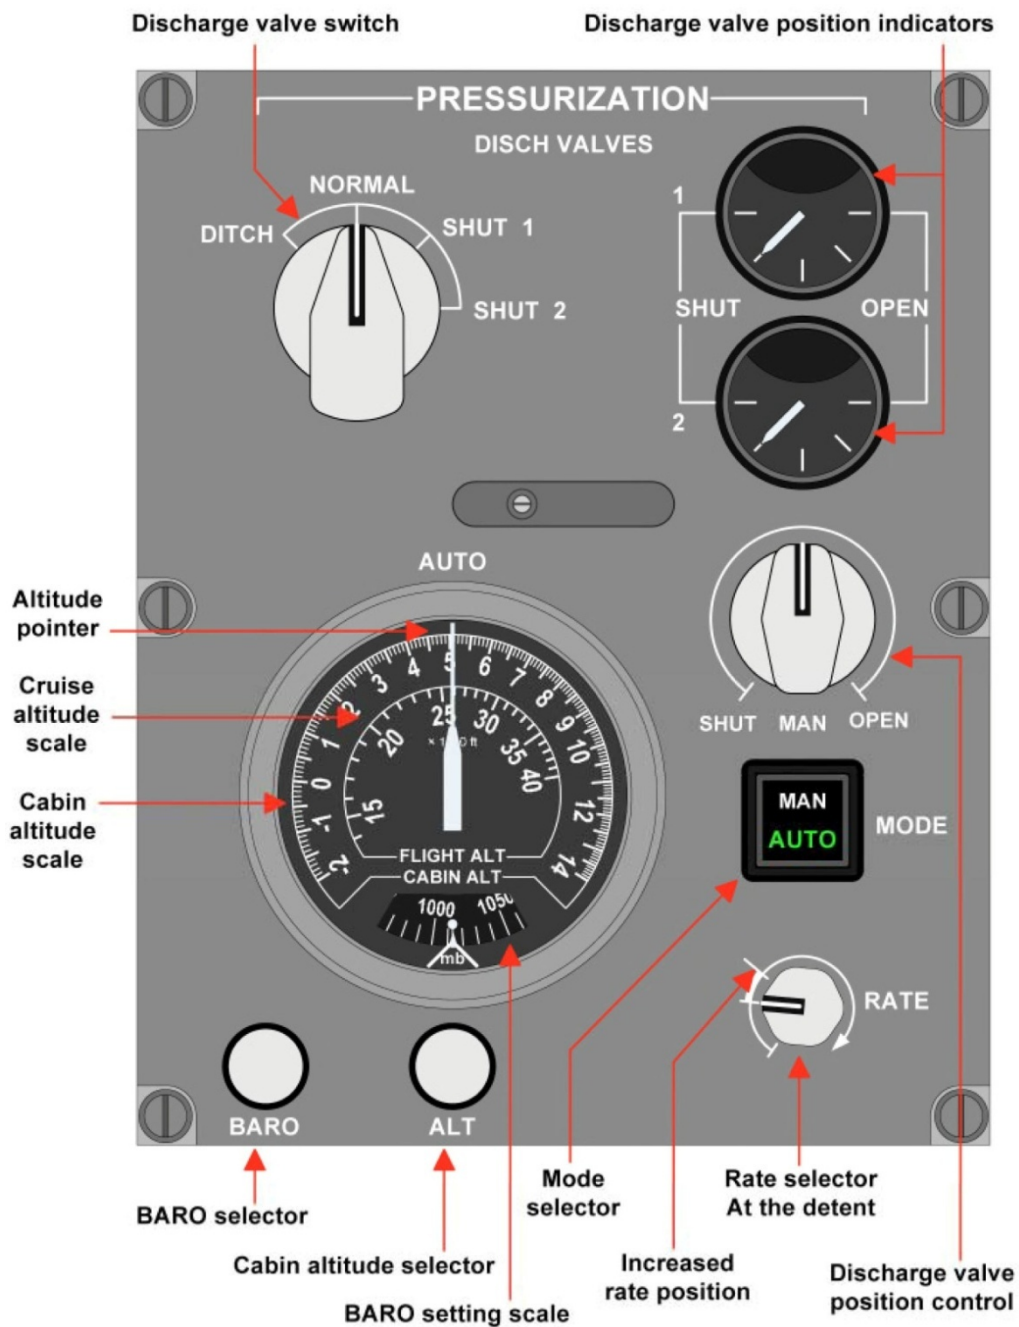
Annex 9: Pressurization control panel

During the serious incident, the cabin pressurization system was in AUTO mode (cf. Annex 9)

The investigation assumes the following settings during the serious incident:
