# **Final Report No. 2208** **by the Swiss Accident** **Investigation Board SAIB**

concerning the serious incident (near collision)

involving the Airbus A340-313 aircraft, registration HB-JMN, under flight plan call sign SWR 39

and the ASW 20 glider, registration HB-1519

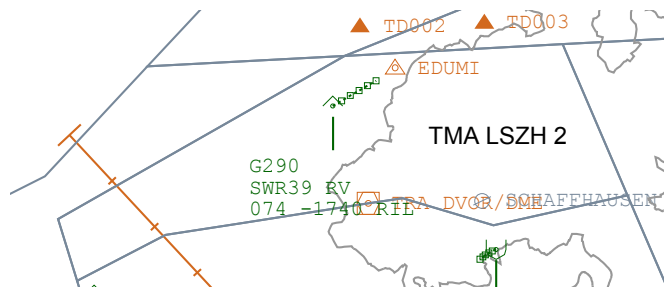
**Radar screen at 13:31:22 UTC**

SWR 39 reported to the ATCO at 13:31:21 UTC and received clearance to descend to 5000 ft at 13:31:24 UTC

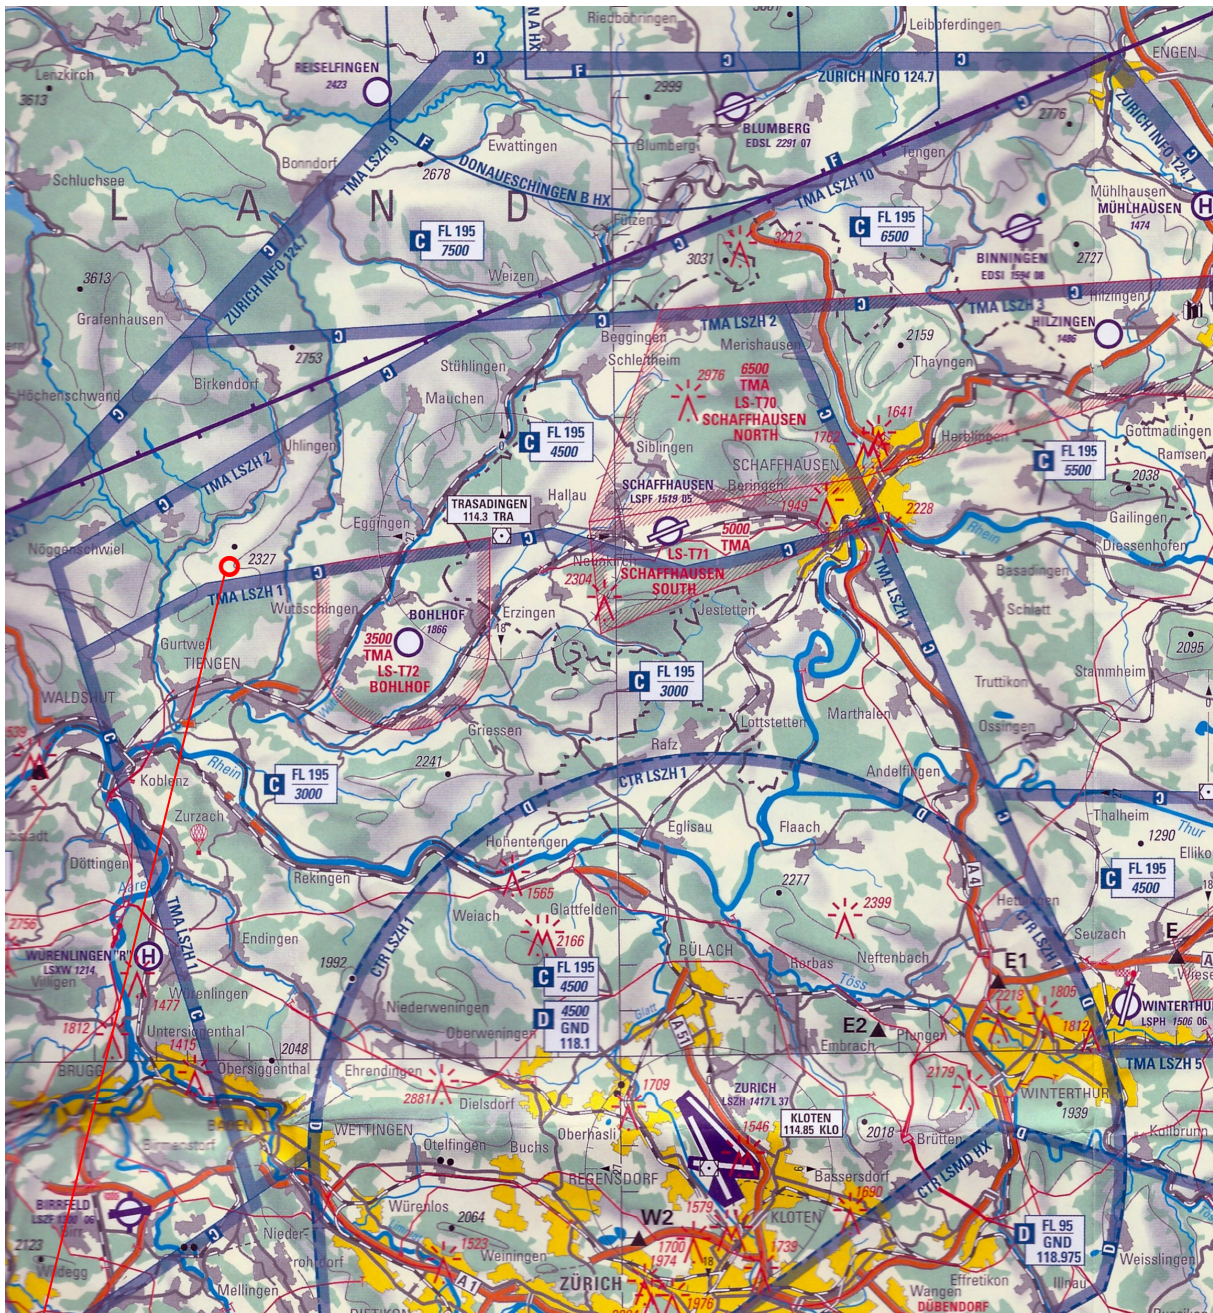
## Annex 8: Division of the Zurich control zone

○ Location of the serious incident

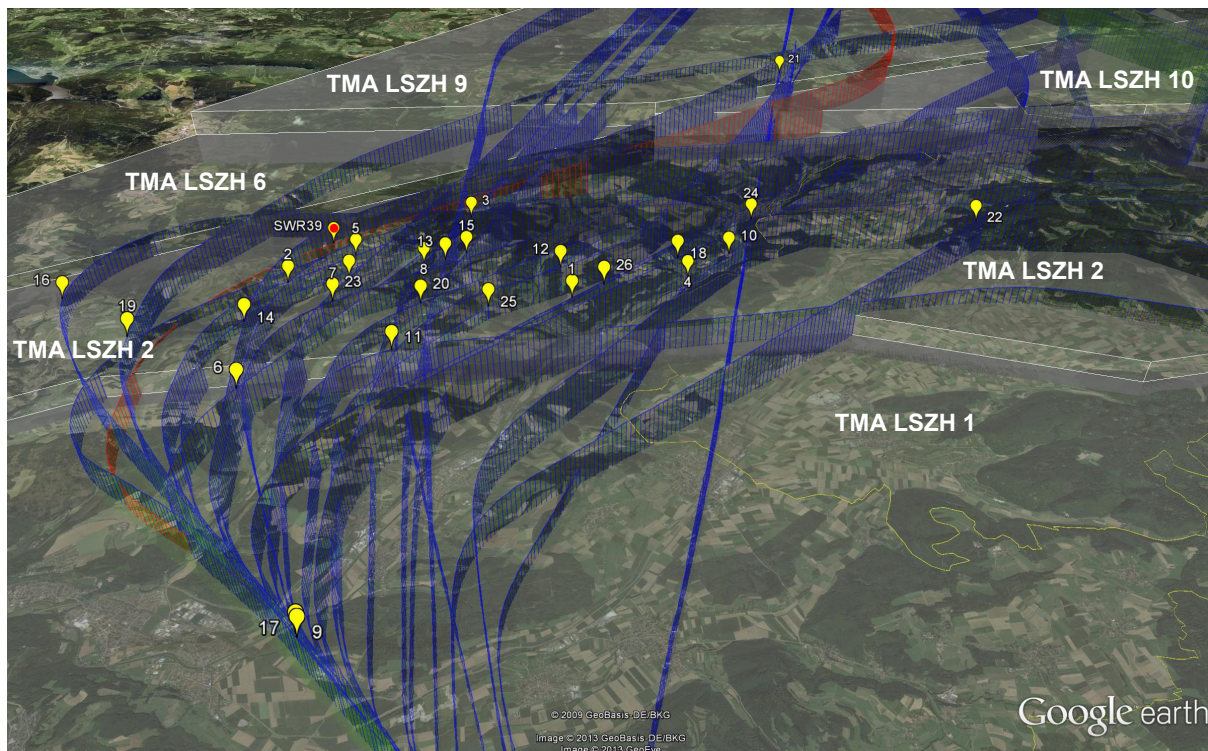
## Annex 12: Clearance to descend to 4000 QNH

**Figure 12:** On the corresponding three-dimensional display of the flight path the yellow beads indicate the flight number and the position at which the crew selected the altitude of 4000 ft QNH after having received corresponding clearance. Flight 21 received clearance to 4000 ft QNH north of TMA LSZH 2, while flights 6, 9, 11 and 17 received clearance within TMA LSZH 1.

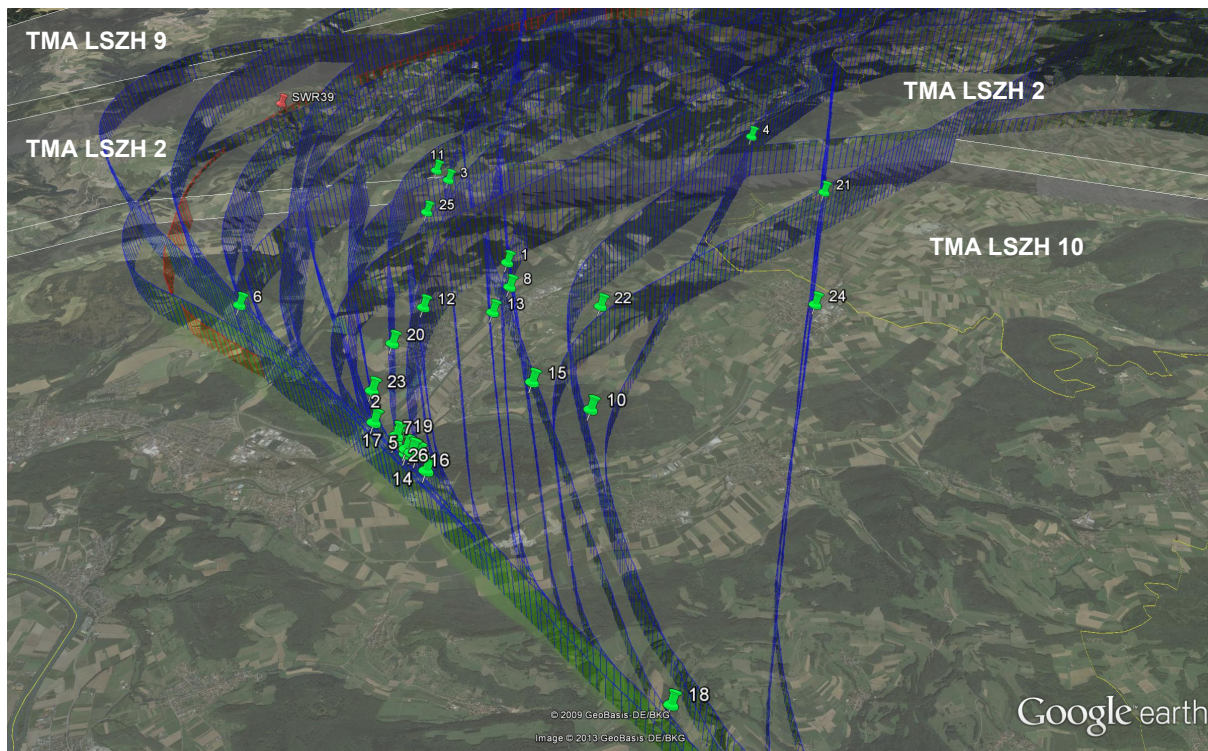
# Annex 14: Altitudes of the 26 flights when passing from TMA LSZH 2 to TMA LSZH 1

**Figure 17:** On the corresponding three-dimensional display of the flight path the green pin indicates the flight number and the position where the aircraft passed 5000 ft QNH while descending. With the exception of SWR 39 every flight passed 5000 ft QNH within TMA LSZH 1 and were therefore above 5000 ft QNH in TMA LSZH 2.

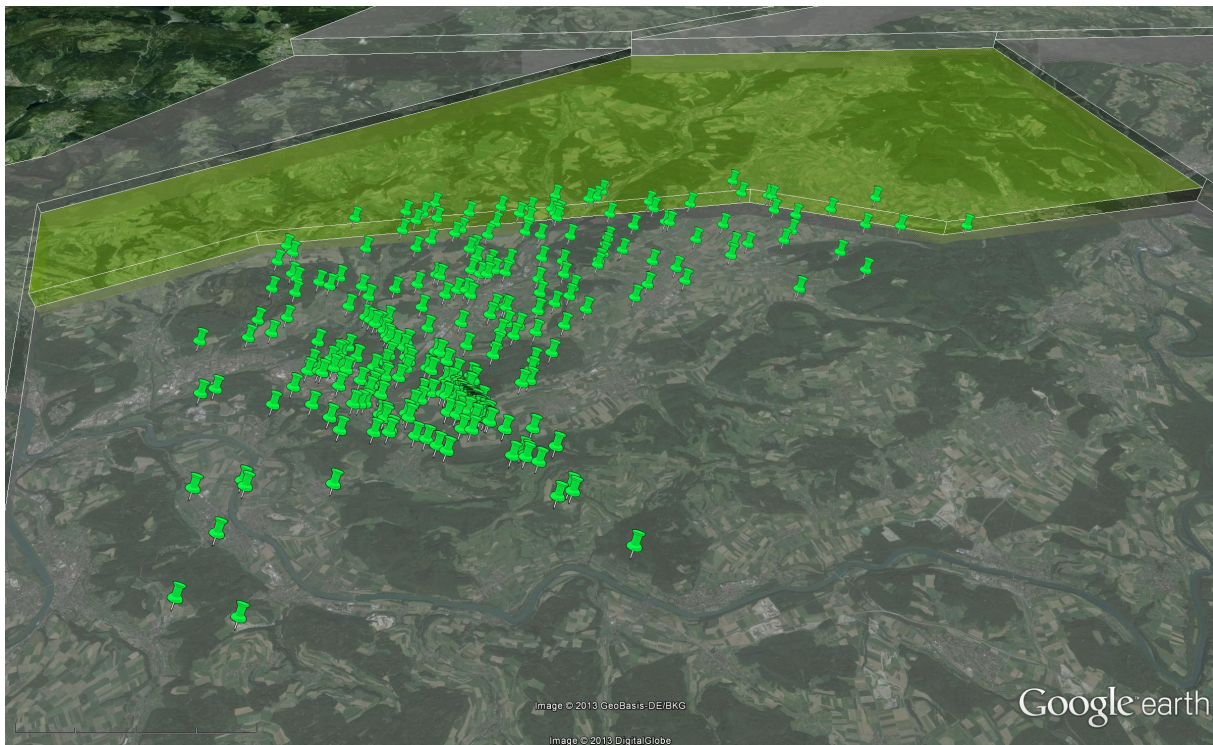
**Figure 18:** 311 approaches on 3 December 2012 with positions outside TMA LSZH 2 when passing below 5000 ft QNH for the first time.

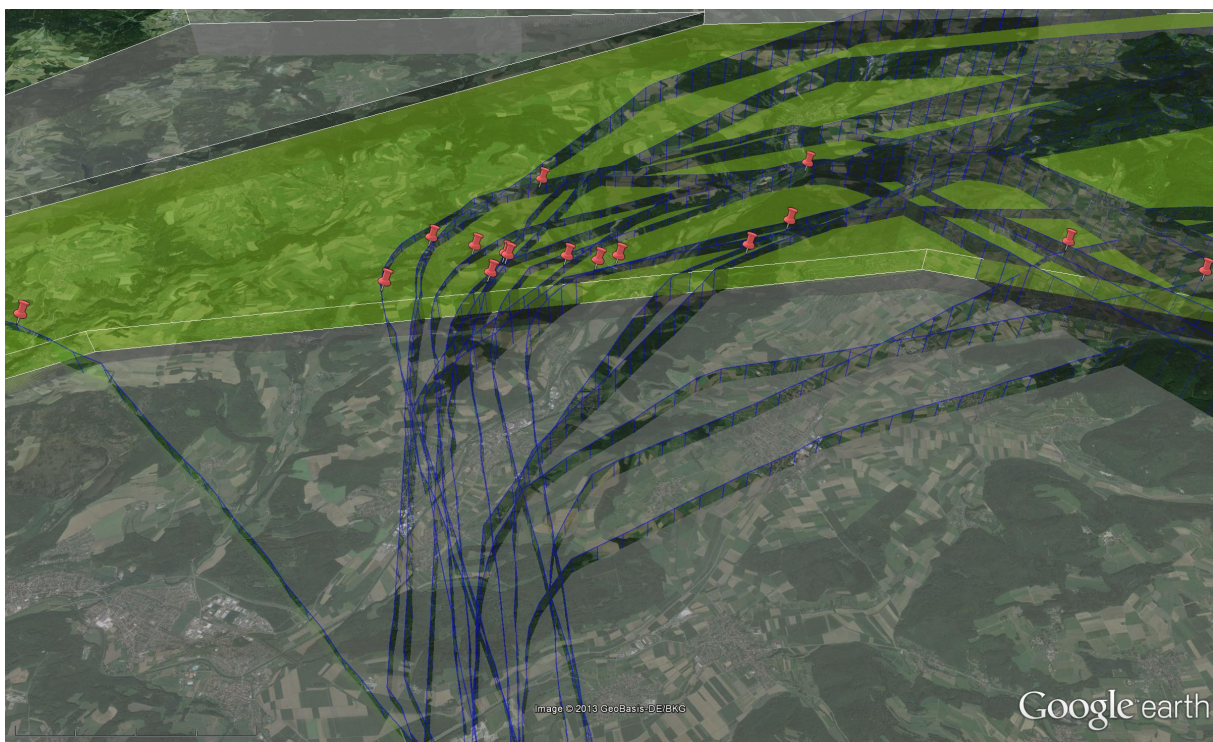
**Figure 19:** 17 approaches on 3 December 2012 with positions within TMA LSZH 2 when passing below 5000 ft QNH for the first time.

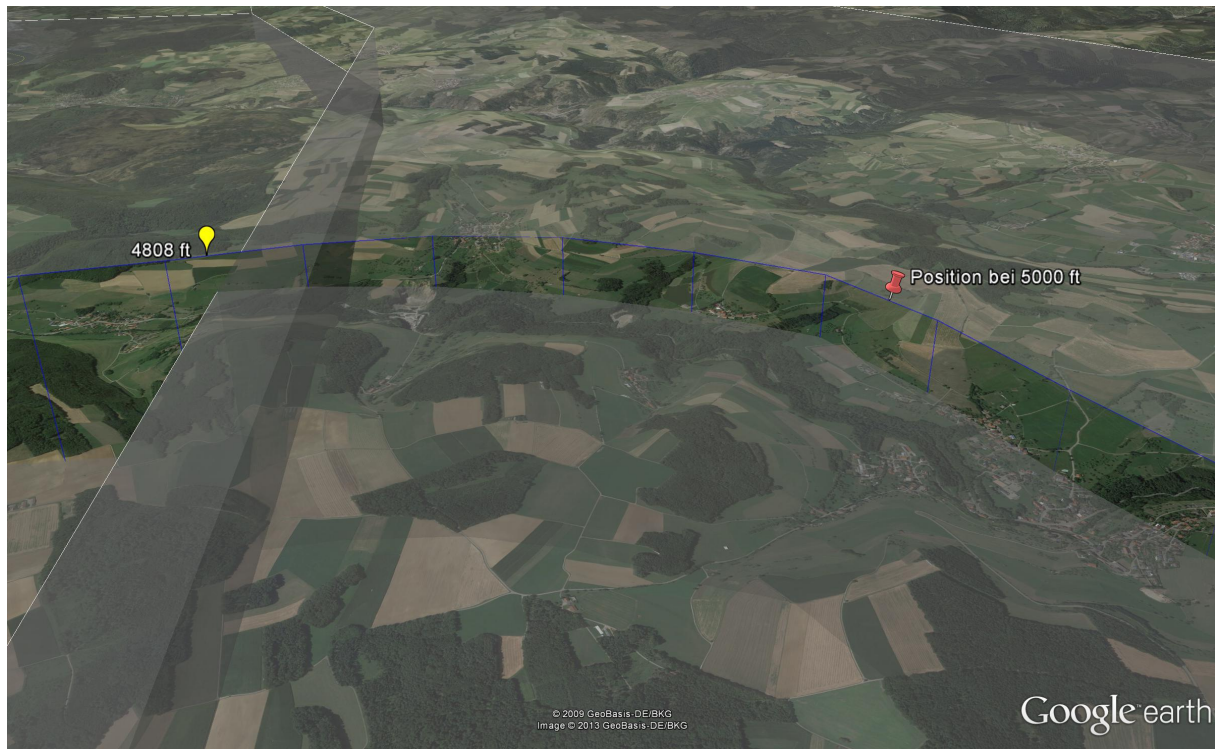
**Figure 20:** Example flight path from the investigation with a position when passing below 5000 ft QNH for the first time within TMA LSZH 2 (red pin) and the altitude when passing the boundary between TMA LSZH 1 and TMA LSZH 2 (yellow bead)
