Final Report No. 2215

by the Swiss Transportation Safety investigation Board STSB

concerning the serious incident involving
the B737-400 aircraft, registration TC-TLE

on 11 October 2013

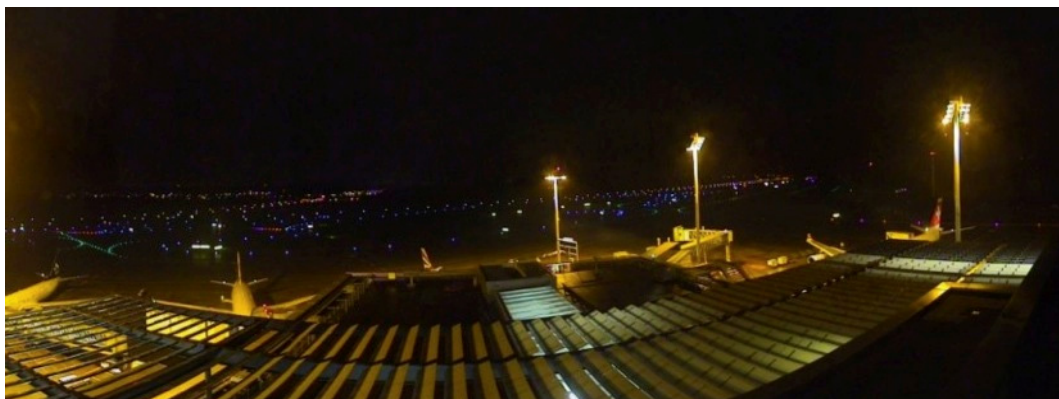
Figure 3: Webcam image from the roof of dock E (midfield terminal) of Zurich Airport at 04:30 UTC, looking north-west

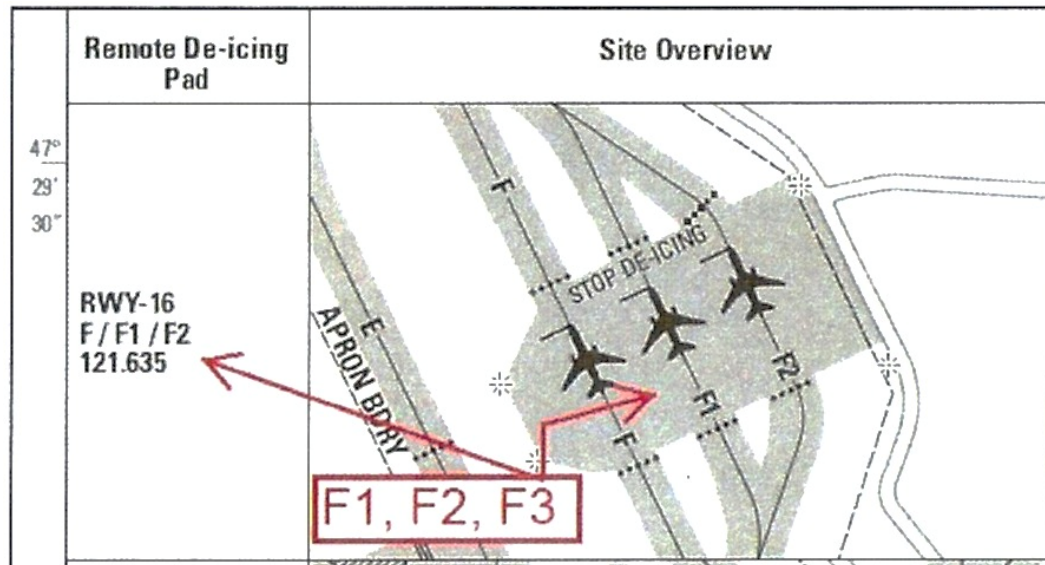
Figure 5: Detail from the taxiway designation concept LSZH 2011, Version 5 April 2012, as commissioned on 22 August 2013 (cf. Figure 2 chapter 1.1.3).
The de-icing lanes have red crossbar lights on the northern and southern edges of the de-icing pad. The purpose of this is to improve taxiing traffic control when de-icing the aircraft.

A safety assessment determined that changing the designations F, F1 and F2 to F1, F2 and F3 (cf. Figure 5, chapter 1.10.5) to be an improvement. The Concept also addressed the issue of possible uncertainties among crews who were unfamiliar with Zurich Airport, but this was deemed to be rather negligible. The safety assessment gave greater weight to the clarity achieved as a result of the new taxiway designation during de-icing operations on Apron North.

In light of the serious incident, it seems appropriate to reassess this point in the safety assessment. The designations of taxiways with taxiway signs are misleading in that TWY F suddenly becomes TWY F3 and then de-icing lane F3 (cf. Annex 1, Figure 11 and Annex 2, Figures 13 and 14). One complicating factor is that at night the green taxiway centre line lights for all three de-icing lanes are illuminated and north of DIP F there are no red stopbars immediately after the respective turn-offs, which could prevent taxiing onto a specific taxiway.

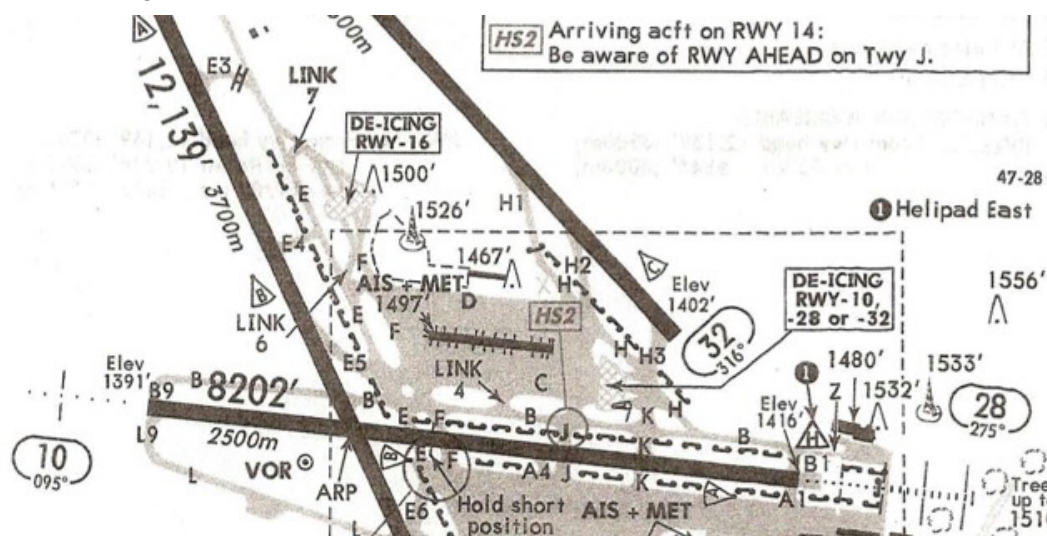
Figure 7: Excerpt from the Jeppesen LSZH/ZRH (10-9) chart dated 16 August 2013

For taxiing after landing the crew normally uses the LSZH/ZRH (10-9) chart, which gives a general overview (cf. Figure 7). However, this chart does not give the crew any indication as to where TWY F begins after exiting runway 34 via TWY E3 or E. This is visible only on the DE-ICING PADS "LSZH/ZRH (10-9E)" chart (cf. Figure 8), which is not usually consulted for taxiing after landing but before taxiing-out in the case of de-icing before taking off.

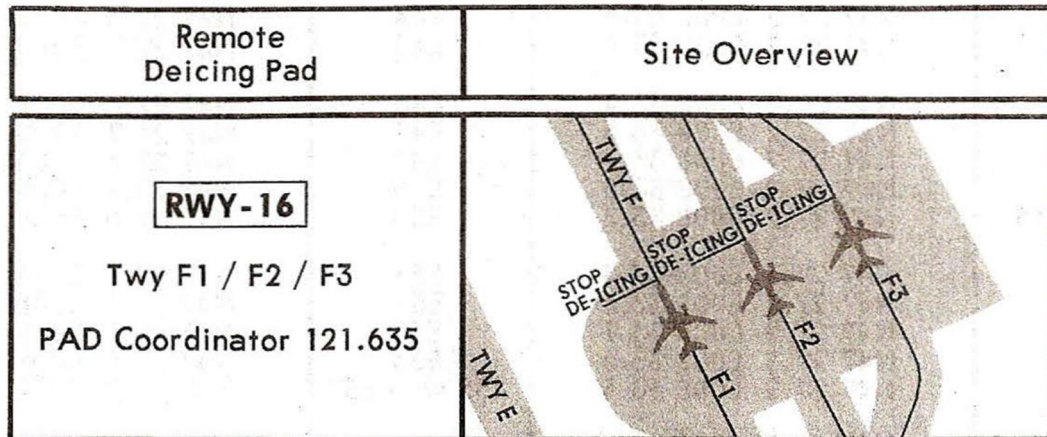
Figure 8: Excerpt from the Jeppesen LSZH/ZRH (10-9E) chart dated 16 August 2013

In some representations, the southern and northern parts of de-icing lane F1 are displayed as belonging to TWY F (see Figures 8 and 9, chapter 1.18.3). Although this is certainly in accordance with the concept of using TWY F via de-icing lane F1, as was the case before the taxiway designation was changed (cf. chapter 1.10.5), but contradicts the designation on the taxiway signs (yellow with a black background, respectively black with yellow background).

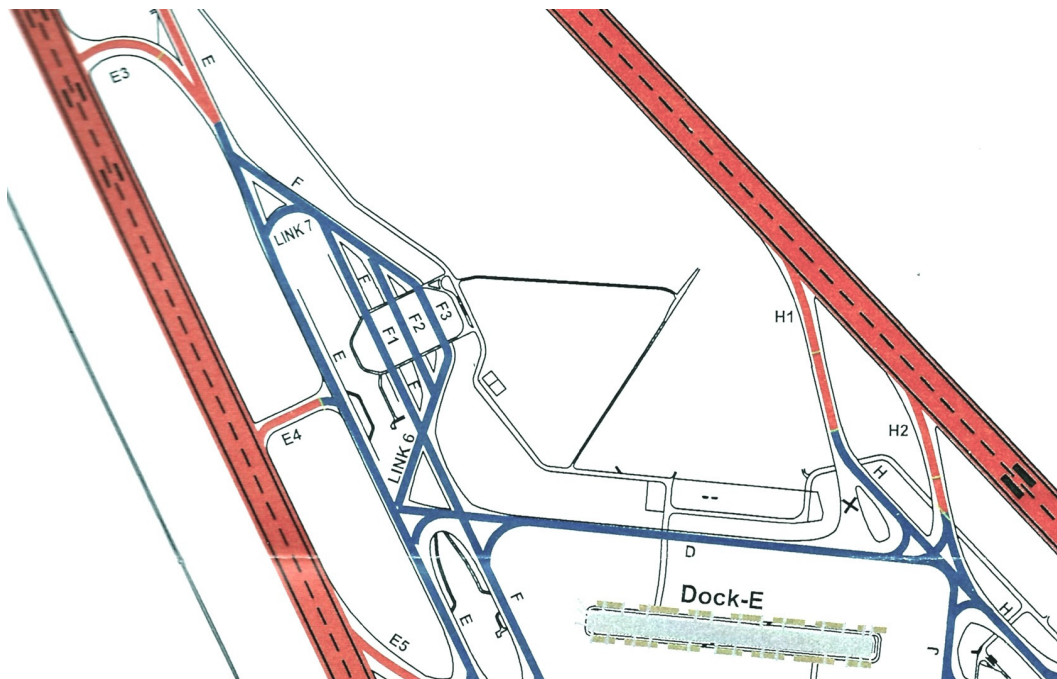
Figure 9: Excerpt from the Zurich Airport "Runway and taxiway designation system with areas of responsibility" documentation dated 16 May 2013

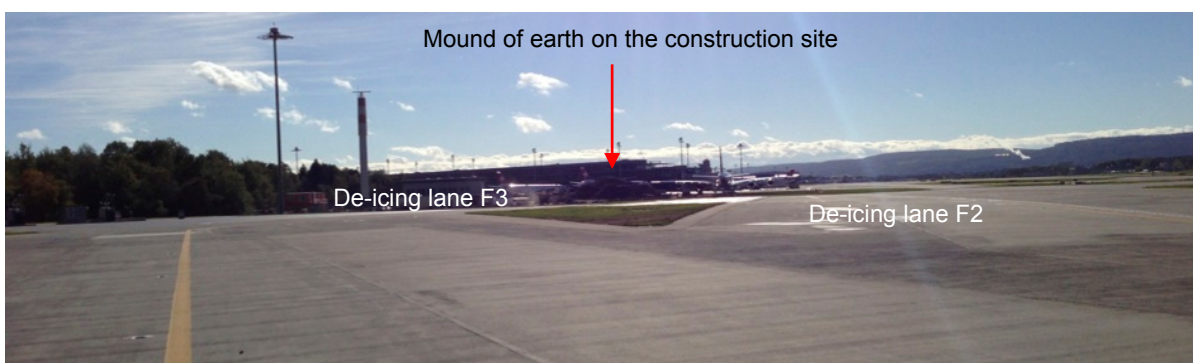
An inspection at the same time of day as the serious incident five days later, found that the mound of earth to the south of DIP F appeared more threatening when backlit by the floodlights of dock E (midfield terminal) at night than in daylight (cf. Annex 3, Figures 16 and 17). From this point of view the reaction of the commander is understandable, but it should not have caused him to leave the green illuminated taxiway centre line. Informing his copilot of his intention corresponded to the principles of working methods in a two-man cockpit.

Figure 17: For comparison: view in daylight
