Final Report No. 2222

concerning the serious incident involving
the DO328-100 aircraft,
registration HB-AES

operated by SkyWork Airlines AG
under flight number SRK 600

on 14 March 2012

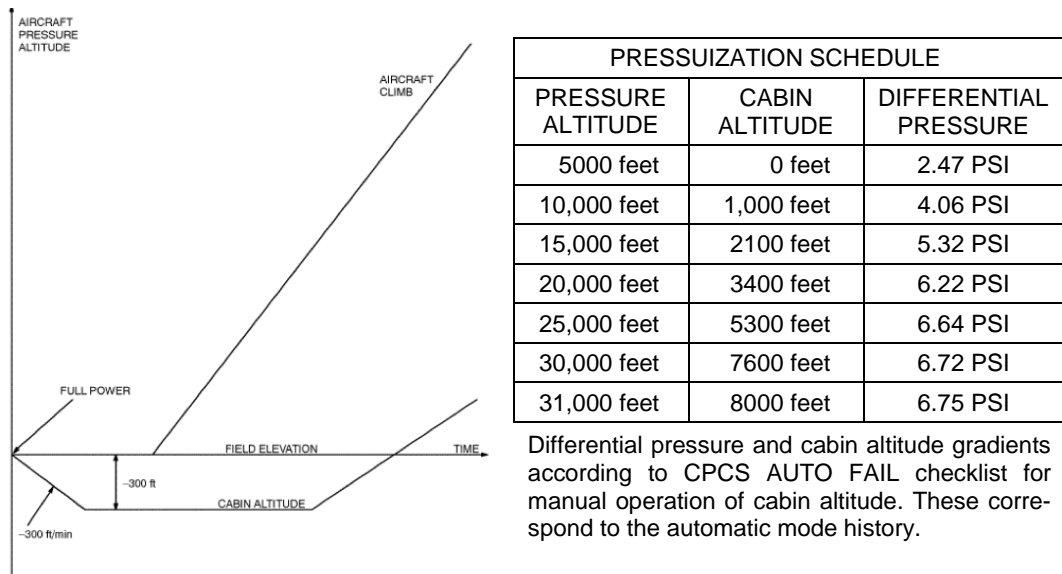
Figure 3: Pre-pressurization phase and take-off sequence

In automatic mode the cabin pressure control system (CPCS) controls the cabin pressure. When setting take-off power, a pre-pressurization phase occurs. This increases the differential pressure in the cabin until a cabin altitude has been reached that is 300 ft lower than the elevation of the take-off aerodrome (cf. figure 3). Once the aircraft has taken off and is in the air, the take-off sequence begins and the differential pressure is increased while the cabin altitude remains the same. The cabin altitude only begins to rise when the aircraft reaches an altitude of approximately 10 000 ft, but latest 10 minutes after take off. There is then an automatic switchover from take-off sequence to cruise mode and the cabin altitude increases at a rate of 450 ft/min, whereby the CPCS ensures that the value of 550 ft/min is not exceeded. The pressure gradient is controlled in such a way that the maximum differential pressure of 6.75 psi is reached at an altitude of 31 000 ft. This corresponds to a cabin altitude of 8000 ft (2438 m). At an altitude of 25 000 ft and a differential pressure of 6.62 psi, the cabin altitude reaches 5325 ft (1623 m).

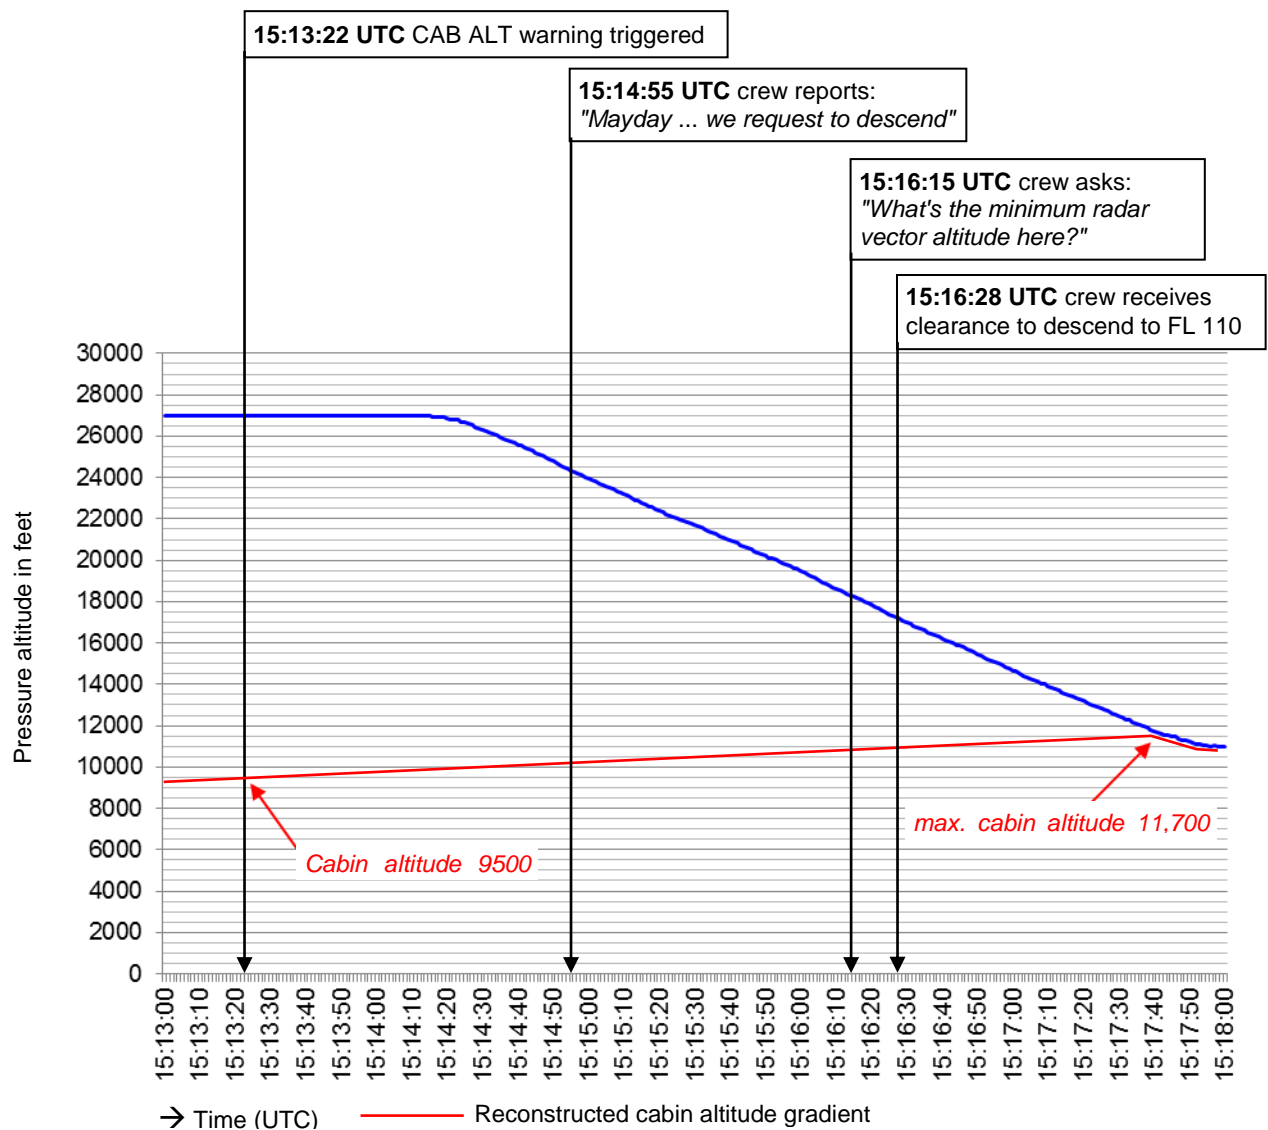
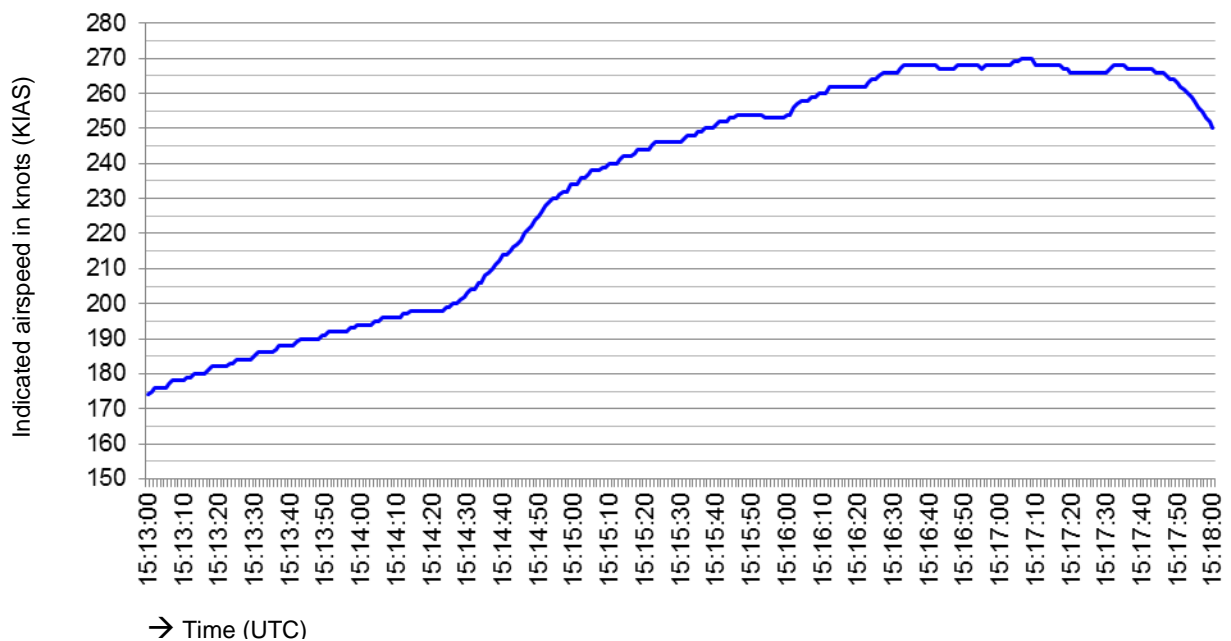
Annex 3: Flight path profile at the time of the serious incident

15:14:55 UTC crew reports: "Mayday ... we request to descend"
