# **Final Report No. 2232**

## **by the Swiss Transportation Safety Investigation Board (STSB)**

concerning the serious incident involving  
the commercial aircraft A319-112,  
registration HB-IPX

on 11 December 2012

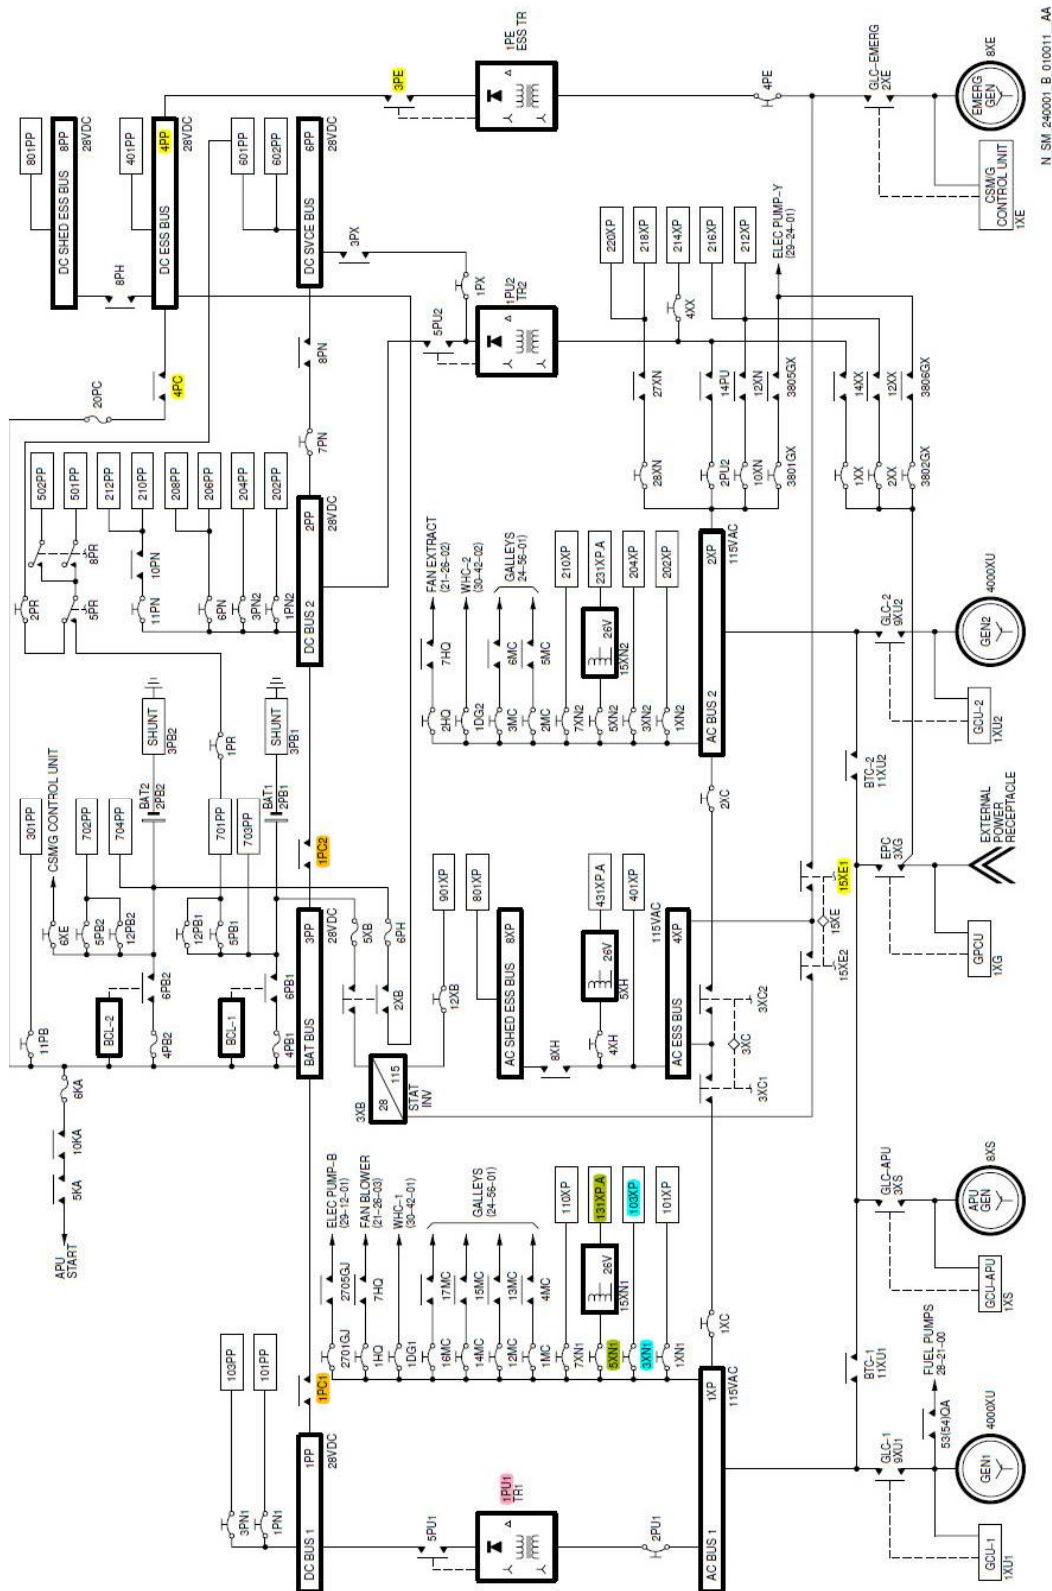
Annex 2: Block diagram of the electrical system

The individual fault events (FE) are highlighted in colour: yellow (FE-1), orange FE-2 and 4 respectively, pink (FE-3), light blue (FE-5) and green (FE-6) (cf. Annex 5). Source: A318/A319/A320/A321, Aircraft Schematic Manual, Figure 24-00-01, P 0005, Sheet 1, "Generation and Distribution (AC/DC)".

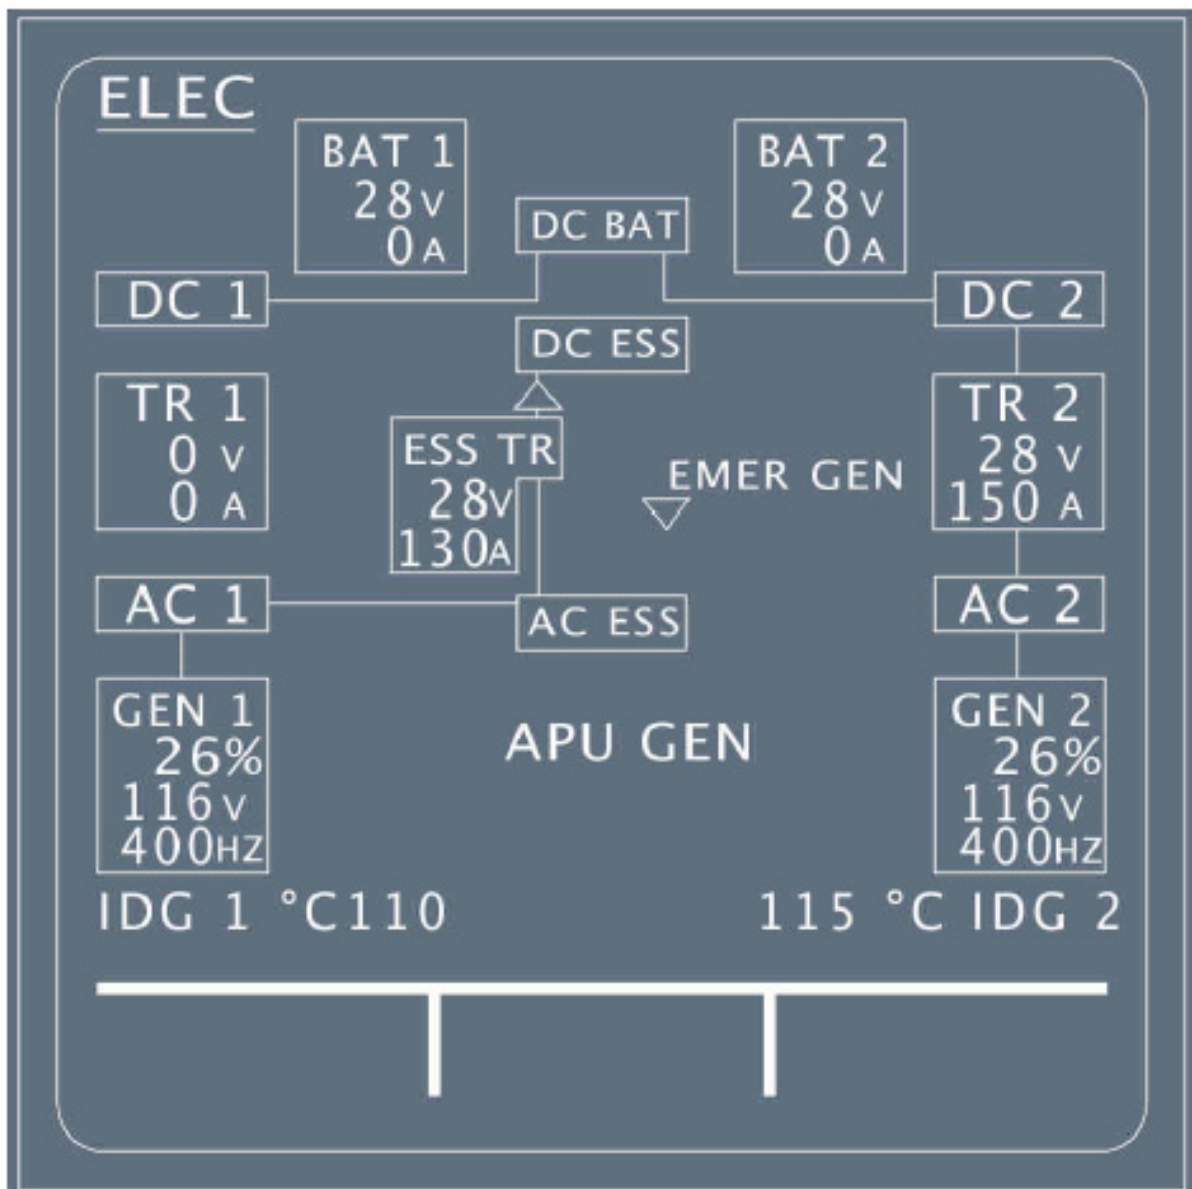
## Annex 4: ECAM ELEC system page – Power supply after 13:56 UTC

- Generator (GEN) 1 supplies AC BUS 1, AC ESS BUS and ESS TR with three-phase alternating current.
- Generator (GEN) 2 supplies AC BUS 2 and transformer rectifier (TR) 2 with three-phase alternating current.
- TR 1 is inactive.
- TR 2 supplies DC BUS 2, DC BAT BUS and DC BUS 1 with direct current.
- The essential transformer rectifier (ESS TR) supplies DC ESS BUS with direct current.
- The generator (APU GEN), driven by the auxiliary power unit (APU) is not in use.
