Final Report No. 2240

concerning the serious incident involving
the Fokker F28 Mk 100 aircraft,
registration HB-JVH

on 15 July 2013

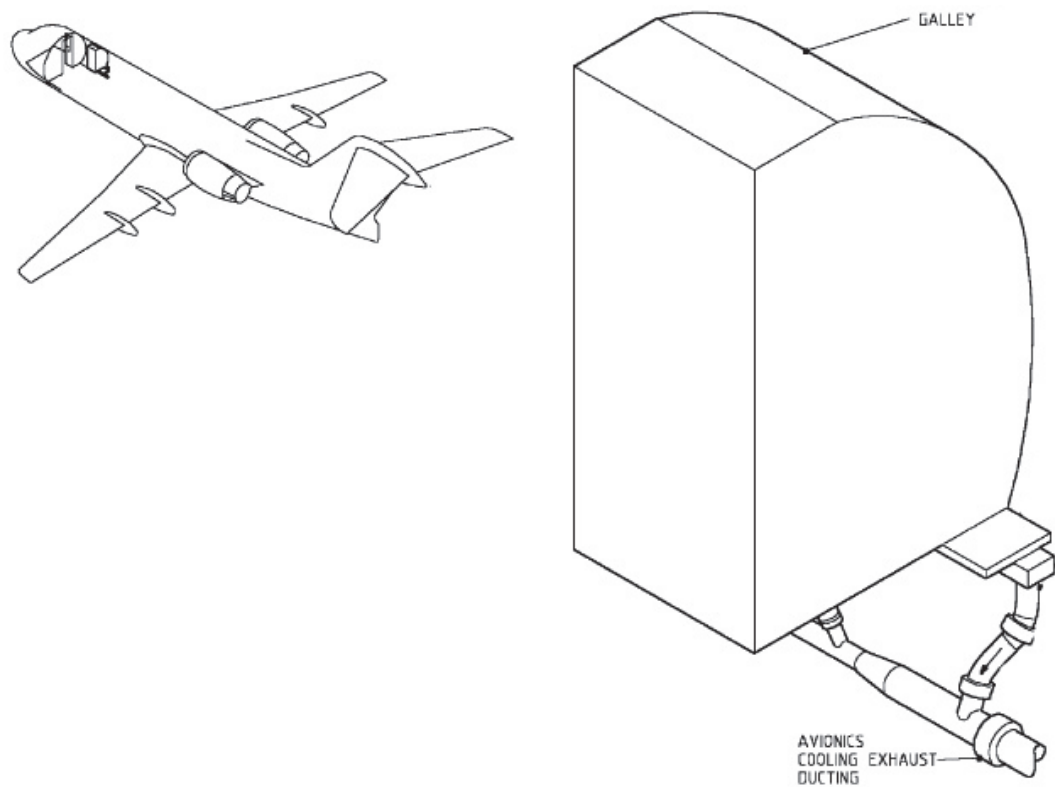
Figure 3: Detailed view of the galley ventilation.

The exhaust air from the cabin exits via the outflow valves. The exhaust air from the galley enters the avionics cooling exhaust duct independently of the cabin exhaust air and is fed overboard together with the avionics exhaust.
