Final Report No. 2245

concerning the accident involving the
Bombardier DHC-8-402 aircraft, registra-
tion 9A-CQC,

on 27 September 2013

on runway 14 of Zurich Airport

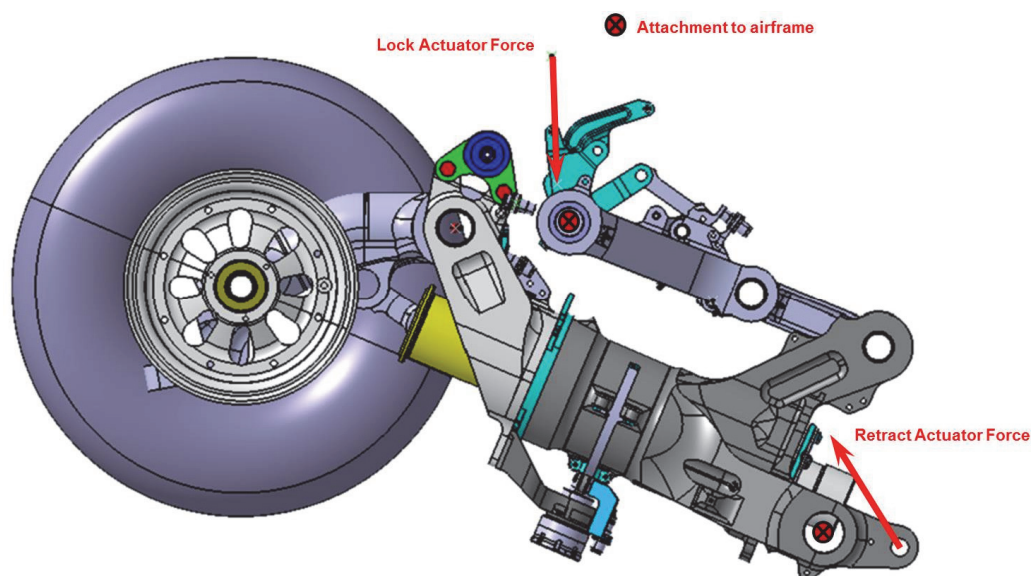
Figure 2: Nose landing gear in retracted position (image from the gear manufacturer, adapted by the STSB). Taxi light and WOW cover plate not shown (cf. chapter 1.16).

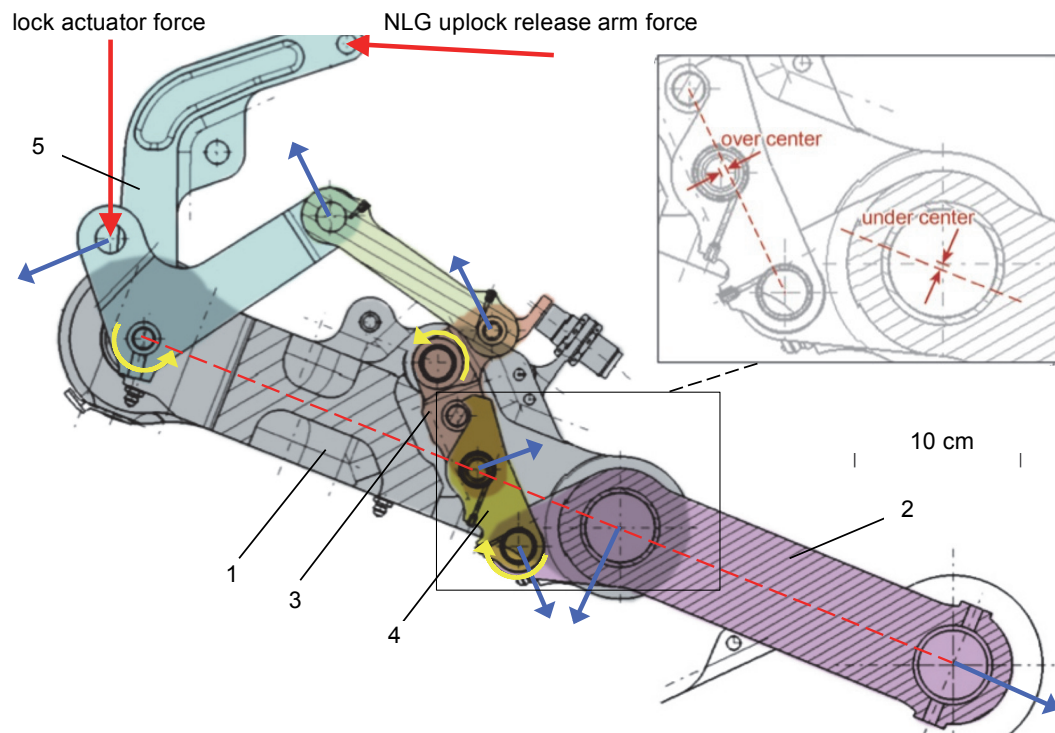
Figure 3: Unlock mechanism, drawn by the manufacturer and adapted by the SUST. The respective parts are color dyed for better recognisability. The movement and the rotation direction of the respective parts, as a result of the external forces (red arrows) are schematically pictured by blue/yellow arrows.

- 1: upper drag strut
- 2: lower drag strut
- 3: upper lock link
- 4: lower lock link
- 5: pitot tube assembly

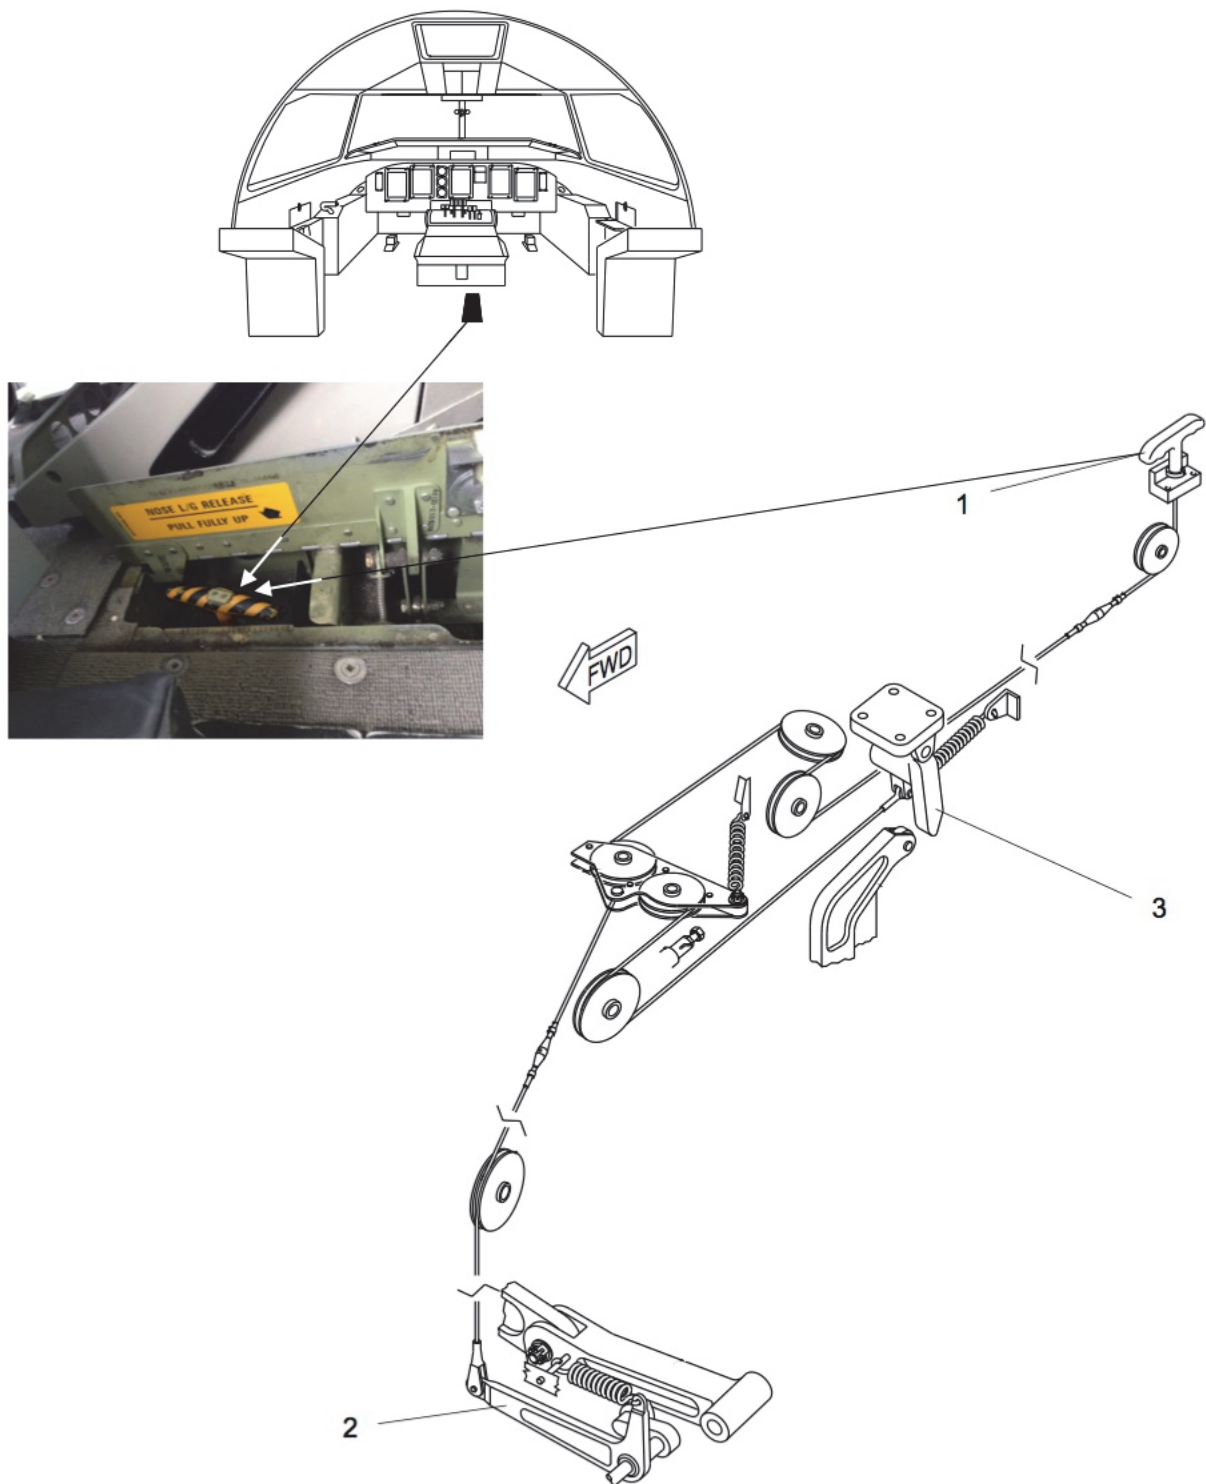
Annex 8: Nose gear alternate release detail

Figure 16: Schematic picture of the alternate nose gear extension mechanism (Image from the gear manufacturer, adapted by the STSB). The photo shows the opened landing gear alternate extension door in the cockpit floor.

- 1: NLG alternate release handle
- 2: front door alternate operating arm
- 3: NLG uplock release arm
