Final Report No. 2254

concerning the serious incident involving
the AgustaWestland AW109SP helicopter,
registration HB-ZRS,

on 6 June 2013

Zurich Airport

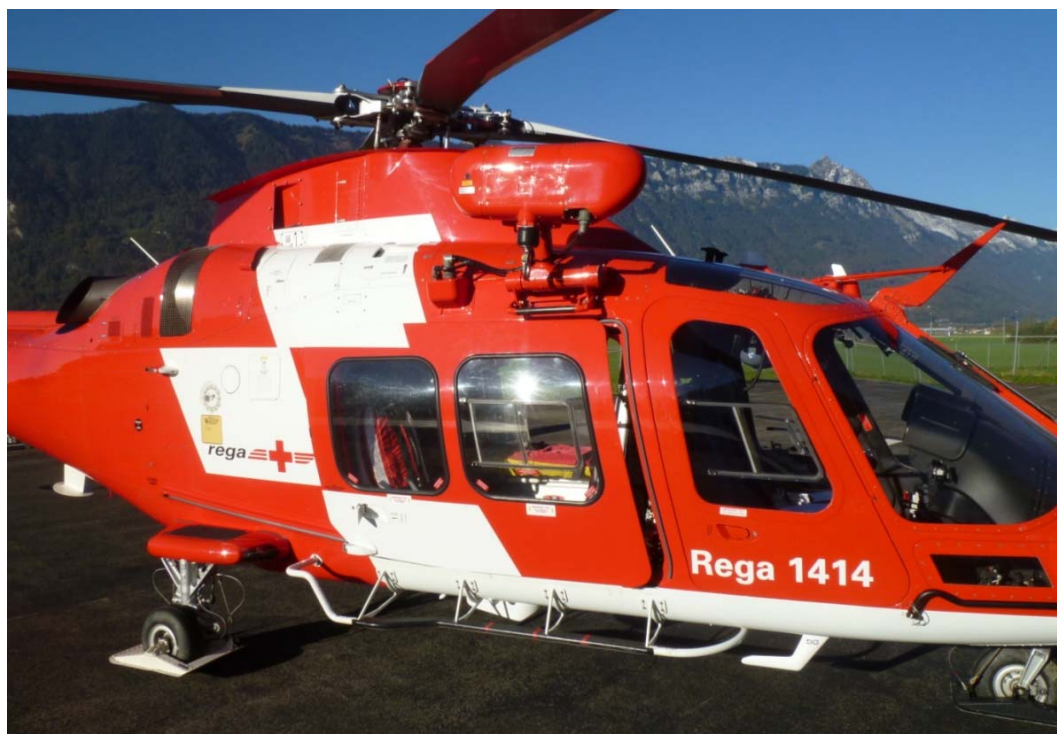
Figure 1: Overview of the rescue hoist installation. The picture is of an identical helicopter type.
