# **Final Report No. 2259**

concerning the accident involving the  
CSA Sportcruiser aircraft,  
registration HB-WYC,

on 26 May 2014

at Lommis airfield / TG

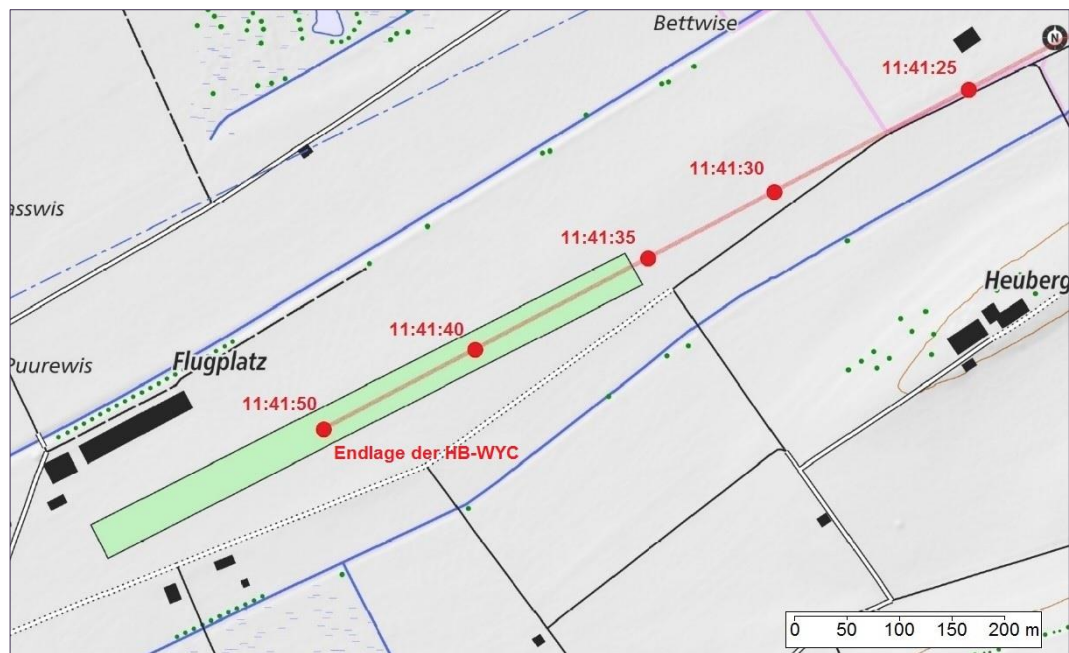
**Figure 1:** Approach of HB-WYC to grass runway 24 of Lommis airfield and final position of HB-WYC according to the GPS position data recorded by the EFIS<sup>3</sup> (Base map reproduced by permission of the Federal Office of Topography Swisstopo (JA150149)).

Correlating these values to the GPS position data which was also recorded (cf. Figure 1) is possible only to a limited extent, because the recording of the GPS position data is subject to an inaccuracy of approximately 1 second due to the EFIS. Considering this limitation, at an airspeed of 60 KIAS an additional inaccuracy of approximately 30 m must be expected.

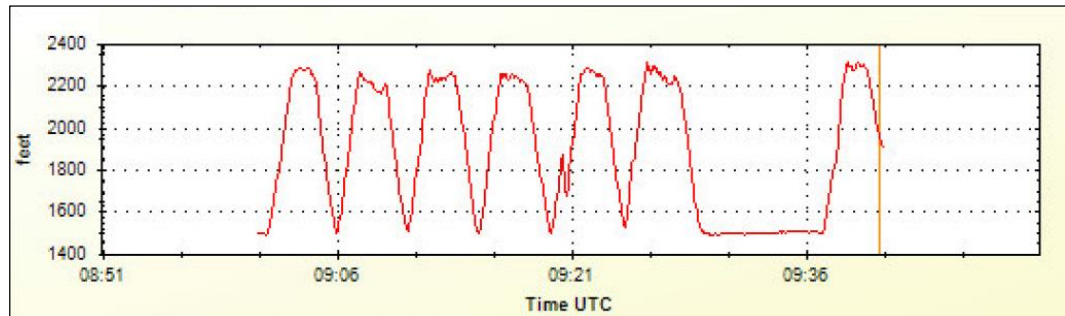
An altitude profile was generated from the recorded flight path data. This provides an overview of the total of seven aerodrome circuits, with an emergency landing exercise at the beginning of the fifth circuit and the short break on the ground before taking off on the flight which ended with the accident (cf. Figure 5).

**Figure 5:** Altitude profile of the flights recorded by the Flarm

The recordings end briefly after the turn into the final approach on the seventh circuit. This is due to a feature of the Flarm which stores flight path data in packets. Since the power supply was interrupted just after the accident, the last data packet could not be saved to the memory anymore.

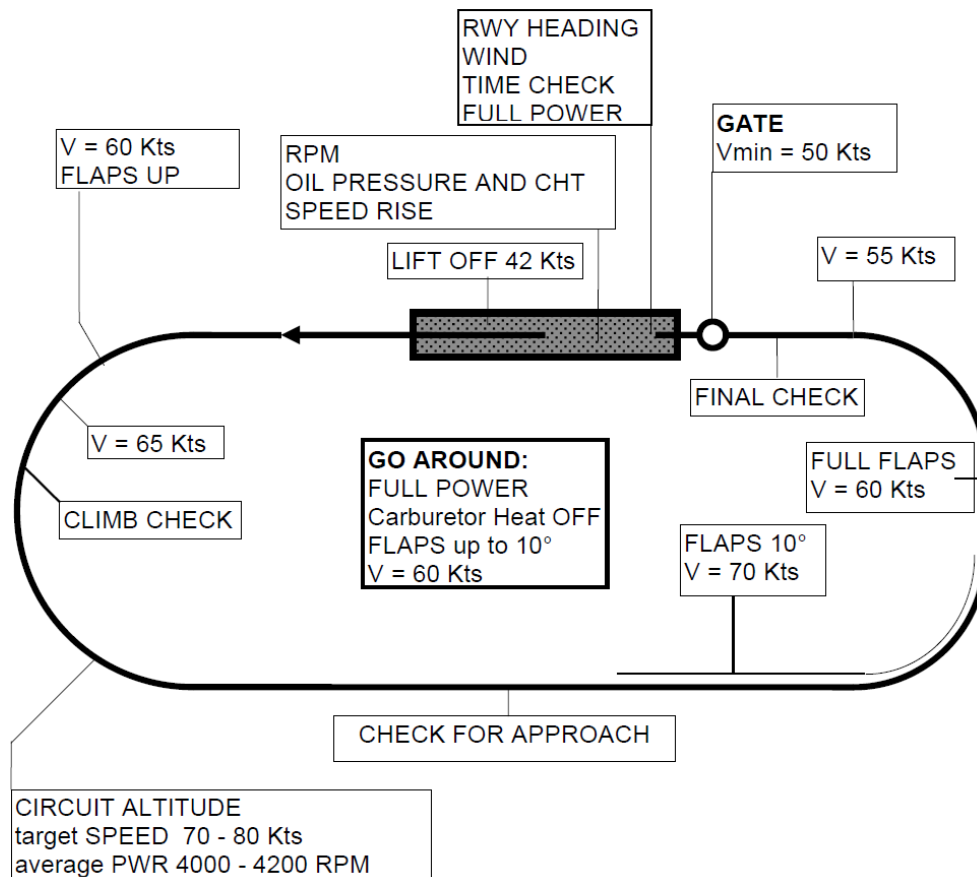
The flying school operates the Sportcruiser according to its own checklist. This contains a pictorial summary of the standard procedures for a circuit of the aerodrome (cf. Figure 11).

It indicates an airspeed of 55 KIAS for the final approach with full flaps; this must not drop below 50 KIAS in the short final approach (gate).

The flight instructor recommended increasing these prescribed speeds by 5 knots for zero flap approaches.

**Figure 11:** Standard procedures of the flying school for an aerodrome circuit (extract)
