# **Final Report No. 2261 of the Swiss Transportation Safety Investigation Board STSB**

concerning the accident involving the  
Cameron Z-120 hot-air balloon, HB-QOW,

on 6 August 2013

at la Comba d'Avau  
north of Montbovon  
Haut-Intyamou / FR municipality

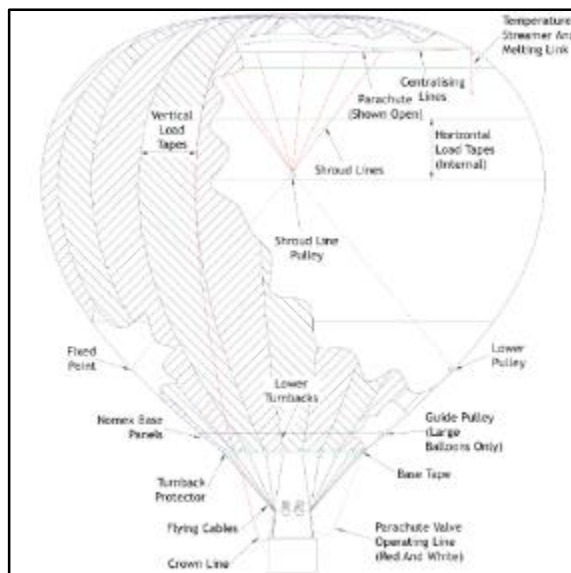
The balloon is equipped with a deflation valve, which may be activated by two different manners by means of a white and red rope or a red rope (figures 5 and 6).

**Figure 5:** Description of an envelope without an RDS system.

A melting link attached to a streamer is fitted inside the envelope, usually close to the top (figure 5). If the temperature in the envelope reaches 127 °C (261 °F), the link melts releasing the streamer which falls through the balloon mouth into the basket, warning the pilot of the danger of overheating.

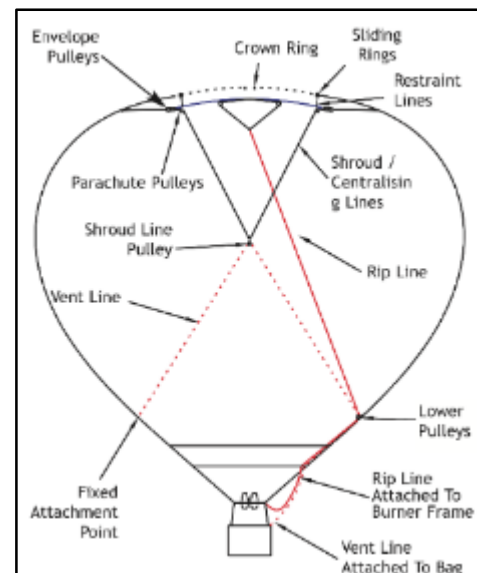
To enable the emergency services to intervene easily, the balloon's control lines were cut, with their ends remaining attached to the basket socket (figure 4) at the front right of the basket. The envelope was moved to the side of the house (figure 3). The positions of the RDS and the parachute valve (figures 5 and 6) could not be determined with certainty.

By pulling on the red rope, the rapid deflation system (RDS) is activated. The parachute gathers in a column in the middle of the opening in the shape of a tulip and causes the rapid deflation. This deflation action can be stopped by pulling on the red and white cord for closing the parachute valve.

**Figure 6:** Description of an envelope with an RDS system.
