Final Report No. 2267 by the Swiss Transportation Safety Investigation Board STSB

concerning the accident involving the
helicopter Cabri G2, HB-ZLJ,

on 13 July 2013

Neuhaus, Municipality Wichtrach/BE

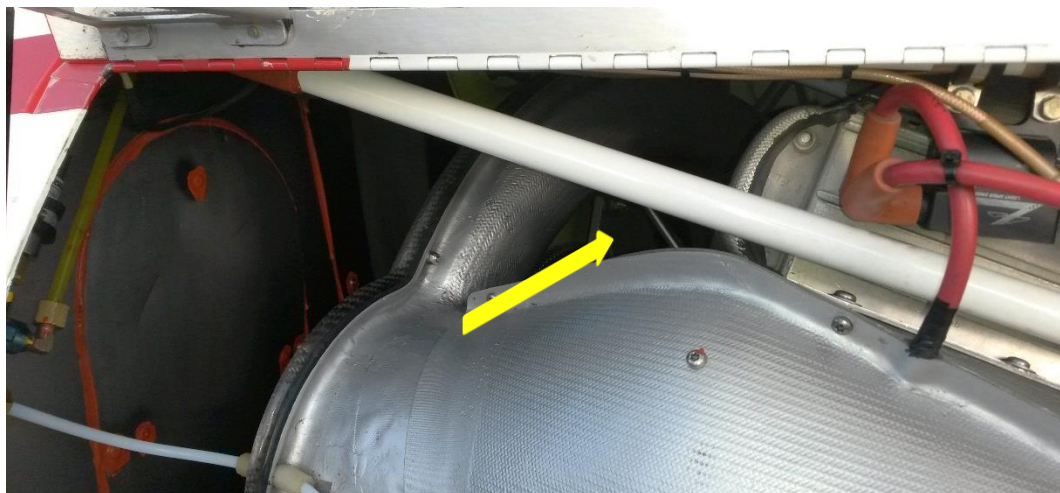
When the cowling of the engine bay is open, the area of the air intake opening is not easily visible. In particular, only a small part of the back of the front disc is visible (see illustration 3). Visibility is additionally restricted by the air inlet grille and other engine components. The rear ring is not visible in any case.

Illustration 3: View of the air cooling system in the engine bay. The yellow arrow points to the area of the air intake.

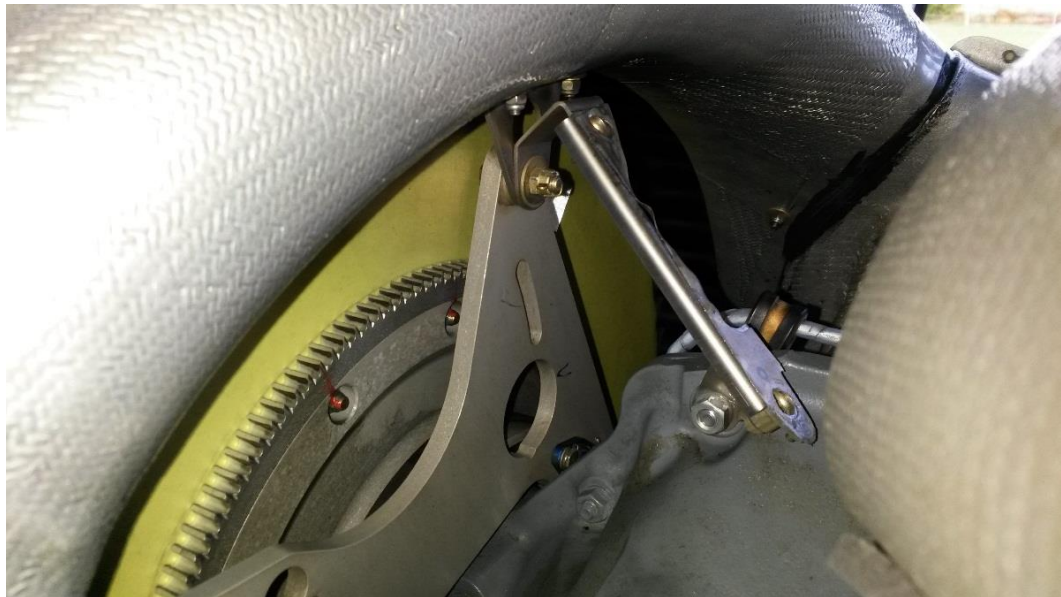
Illustration 4: Close-up view of the air intake with the grille removed.

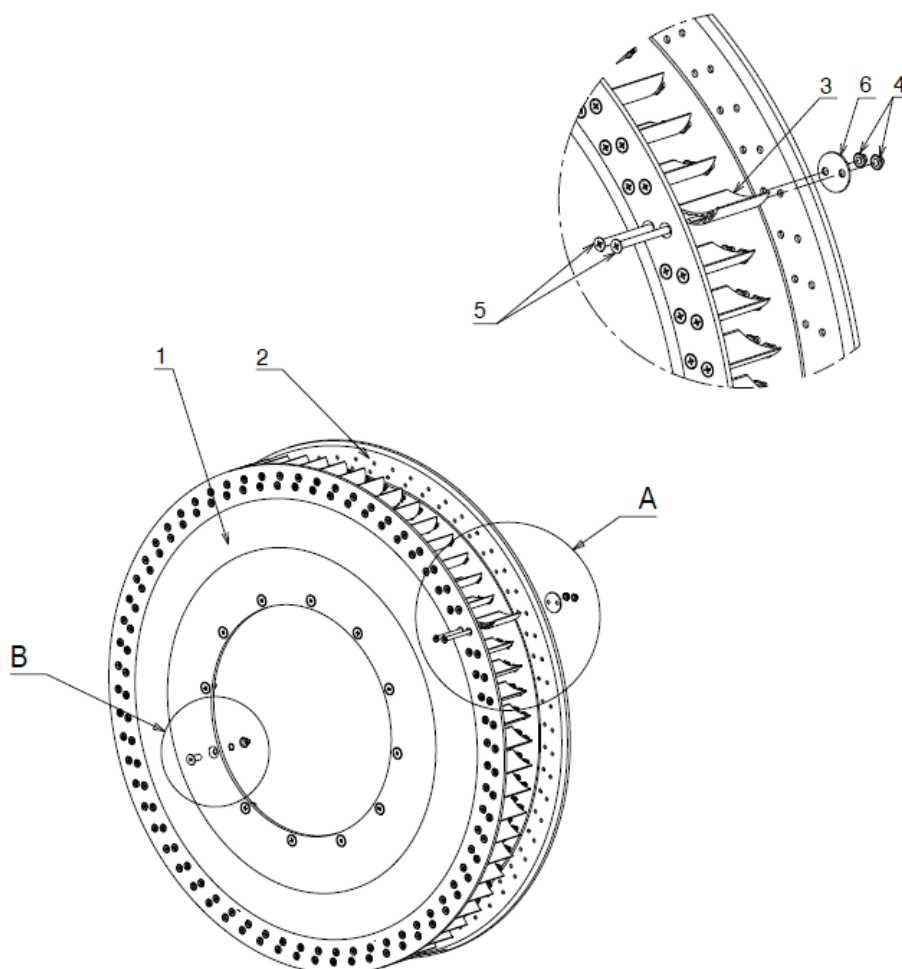
Détail A

5.7.1 VENTILATEUR / COOLING FAN

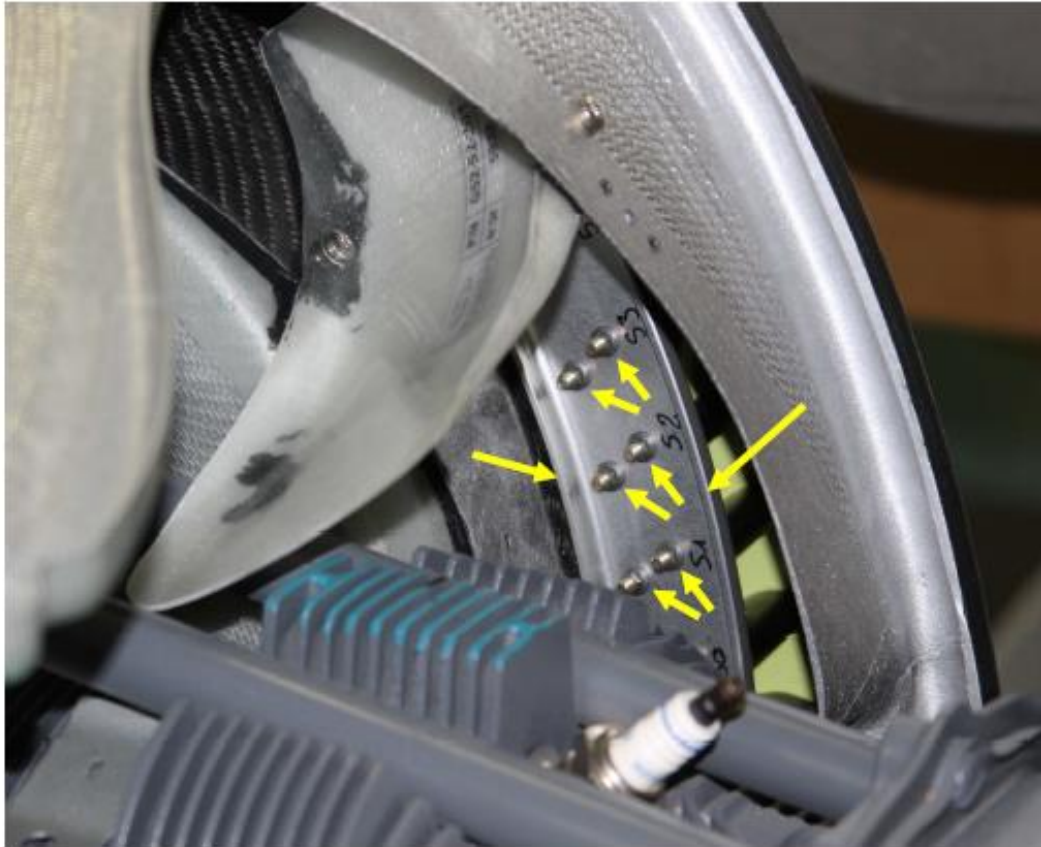
Specifically check :

- Around each bolt,
 - Along the inner and outer rims of the ring.
- Proceed to the next sector until reaching the initial mark again : Total 64 blades.

Starting the engine and subsequent flight is not permitted if any damage is found. Proceed to the replacement of the ring.

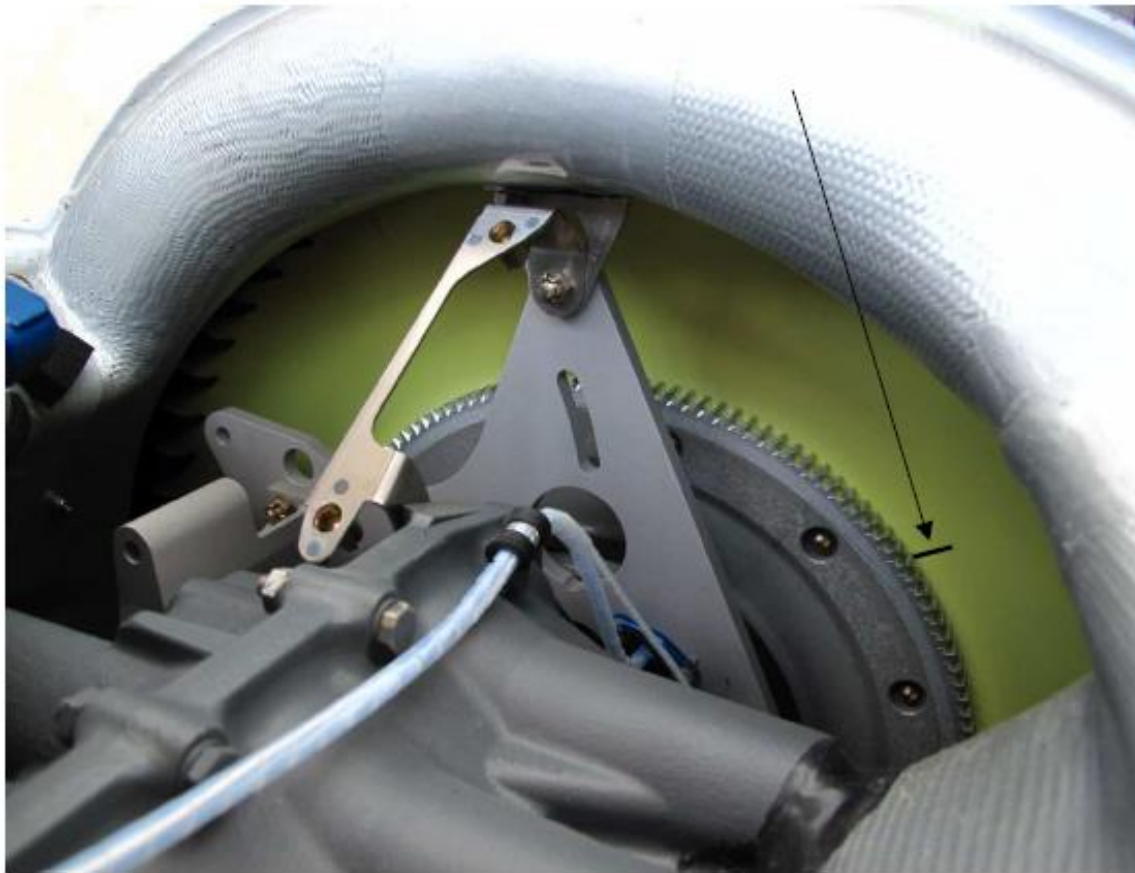
- Remove the scroll inlet screen with the two Camlocs,
- Closely inspect the fan front flange :
 - Clean the visible portion with a cloth dampened with petrol,
 - Using a torchlight, look for any crack, specifically around the starter ring gear,
 - Turn the crankshaft approximately 90° and reiterate until the complete flange is inspected.
