Final Report No. 2273

concerning the accident involving the
PA-28RT-201T aircraft,
registration HB-PLC,

on 30 May 2015

Grenchen/SO regional airport

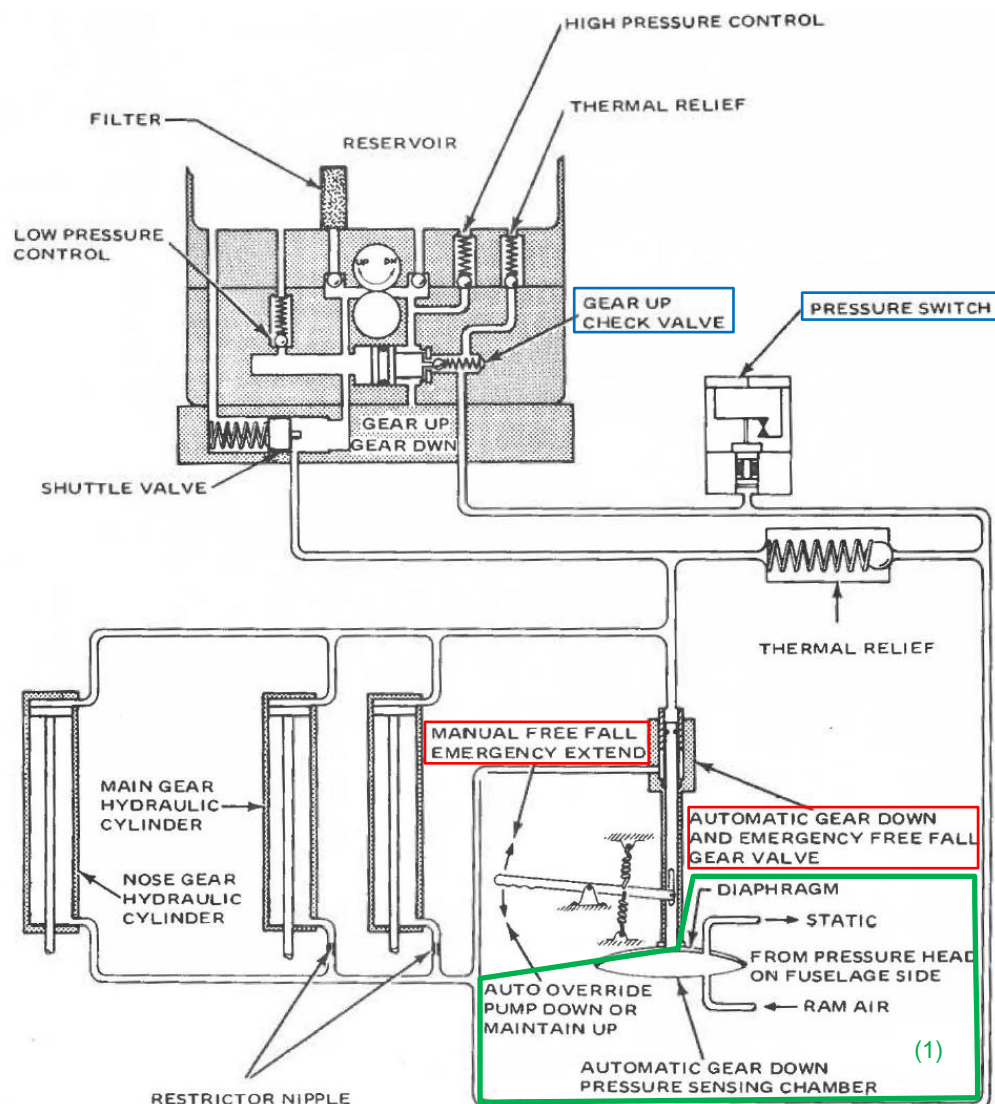
Figure 3: Schematic diagram of the hydraulic system with the back-up gear extender (1).

The alternative landing gear extension procedure is the manual free fall emergency extend (cf. Figure 3). This involves depressurising the entire hydraulic system using the automatic gear down and emergency free fall gear valve. It allows the landing gear to descend into the extended position due to gravity and then lock automatically.

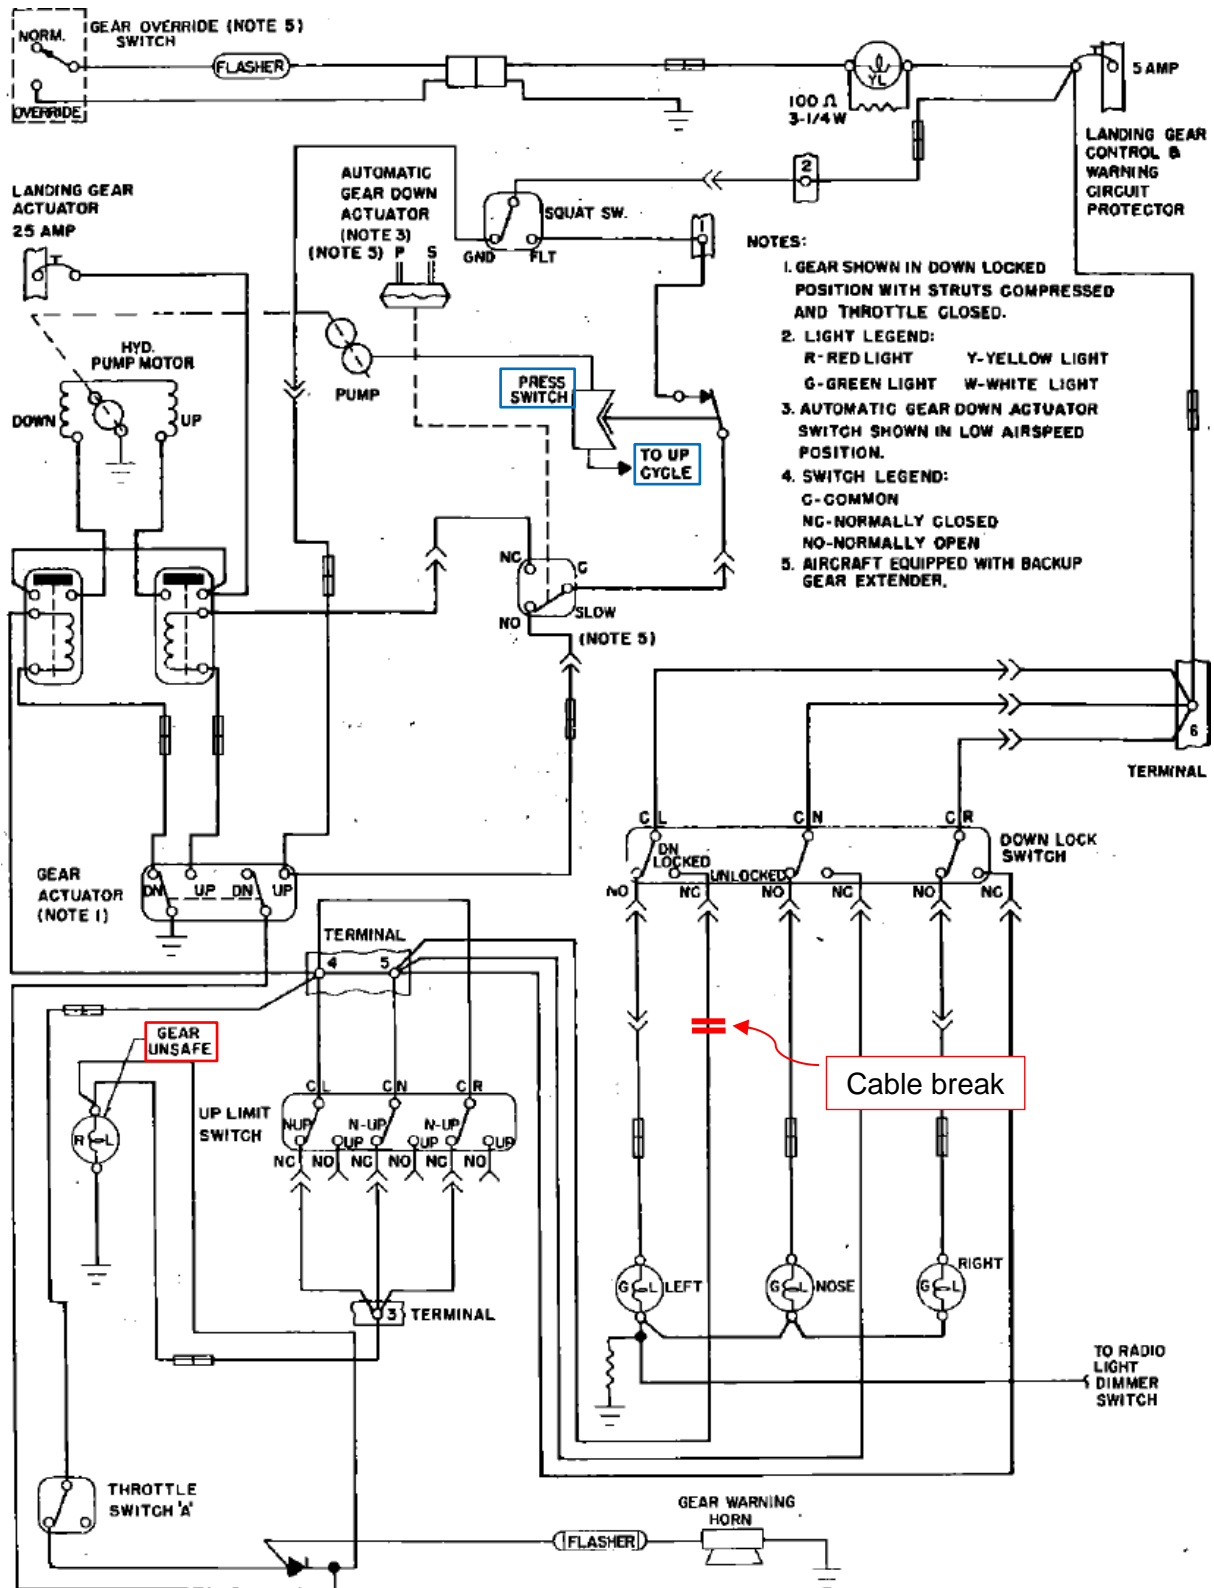
Annex 3: Electrical wiring diagram for landing gear leg from manufacturer's maintenance manual

- Upon operation of the down lock switch of both the nose landing gear and the right main landing gear, the pump started immediately.
- Upon operation of the down lock switch of the left main landing gear, the pump did not respond.
- A workshop inspection of the removed down lock switch for the left main landing gear revealed that it was functioning normally.
- Upon further investigation, it was found that there was a fault in an electrical cable leading from the left main landing gear down lock switch to the pump motor which could not be seen from the outside. Electrical power to the hydraulic pump was therefore interrupted even though the left main landing gear was not yet located in the final position and was therefore not locked (cf. Annex 3).
