Final Report No. 2275

Concerning the accident involving the Bell
UH-1H helicopter, registration HB-RXC

on 20 December 2012

Alberli Au, municipality Rüthi/SG

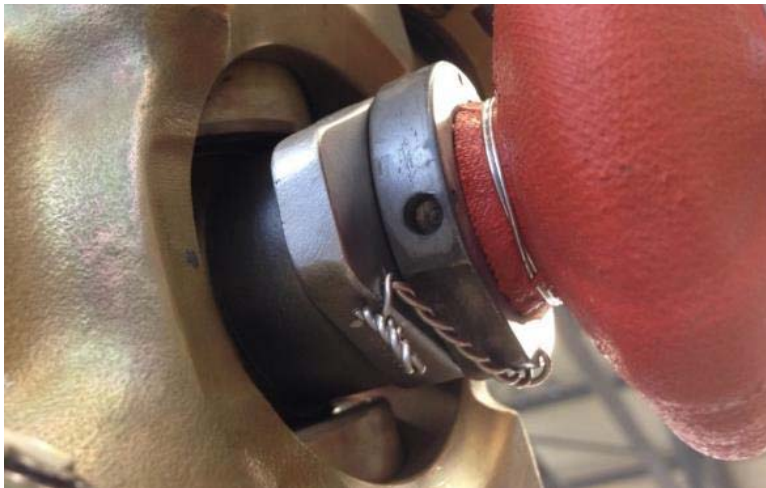
The tail rotor is two-bladed. Both blades are mounted on the hub and can be rotated on their longitudinal axis, which permits the adjustment of the blade pitch (see annexe 2). The hub is internally splined and located on the transmission's rotor shaft. This is then retained on the driveshaft using a static stop and retaining nut. The nut is tightened to a defined torque and wire-locked to prevent it from becoming loose. When assembled correctly, the connection between hub and shaft is rigid; the hub cannot be moved axially. The static stop has two flanges to restrict tail rotor wobble.

Illustration 5: Tail rotor hub with static stop and wire-locked retaining nut (picture of tail rotor system of same type).

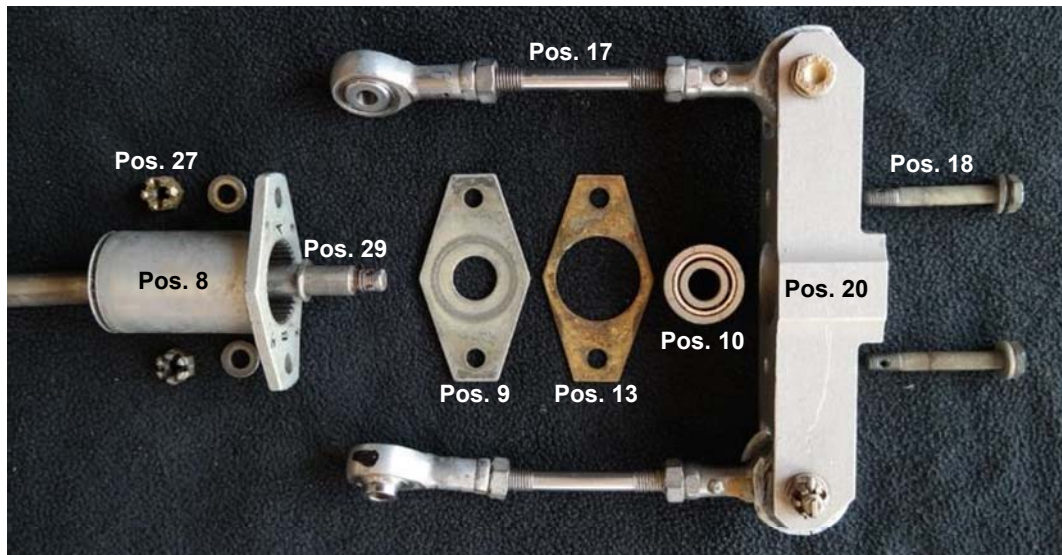
Illustration 6: Individual parts of the tail rotor's blade pitch mechanism. For the purpose of the illustration, the components not found on helicopter HB-RXC after the accident were added from an identical system. The positions of the individual components relate to annex 2.

The parts in pos. 4, 6 and 31 could not be found. The tail rotor had been mounted onto the transmission's tail rotor driveshaft with these (see annexe 2).

The parts in pos. 7, 9, 10, 11, 12, 13 and 22 as well in pos. 18, 19, 26 and 27 are part of the blade pitch mechanism and could also not be found (see annexe 2).

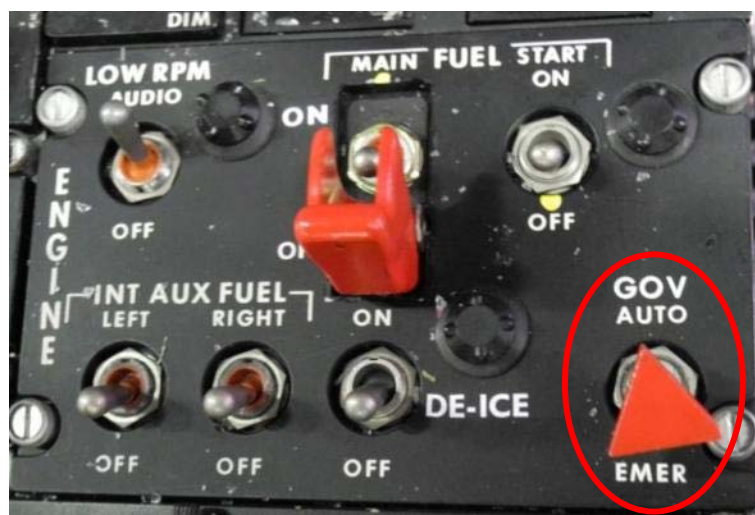
Illustration 8: Engine control panel with governor switch (circled red).

The control panel was installed properly and was functioning.

The power turbine governor switch on the engine control panel was found in the AUTO position.

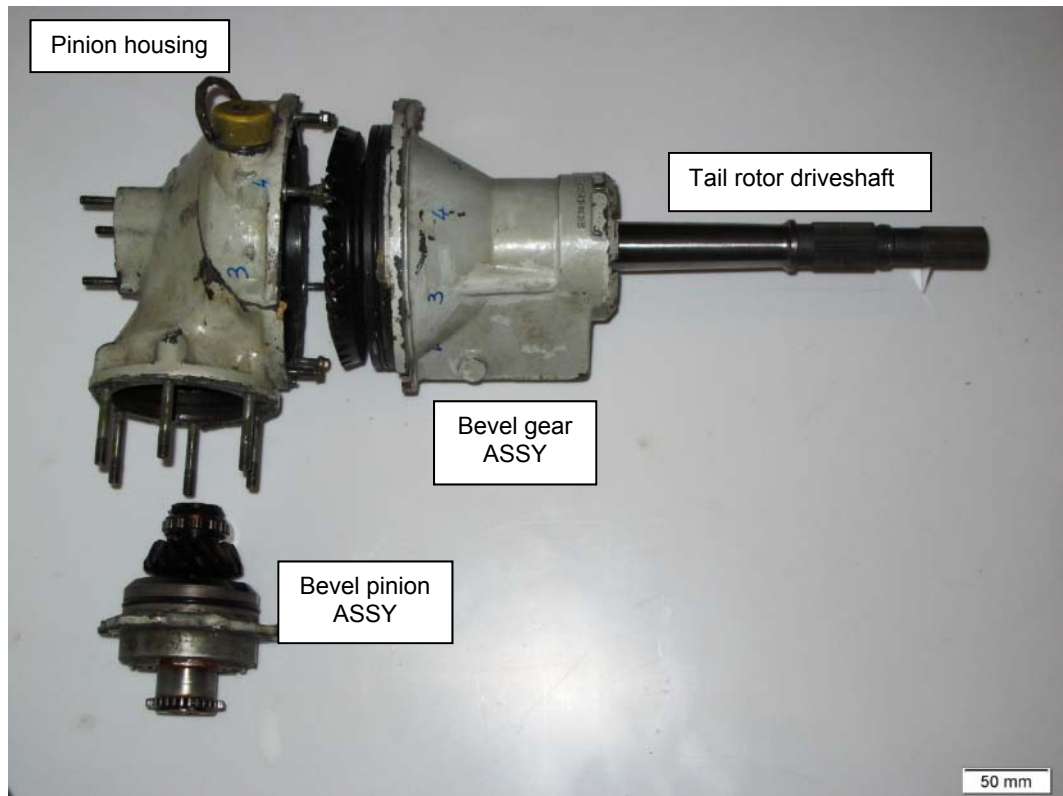
Illustration 13: Individual components of the tail rotor transmission
